# FACILITIES MANAGEMENT BUILDING

17307 Cannery Road, Milford, Virginia 22514

## Facility Condition Assessment

Caroline County Public Schools

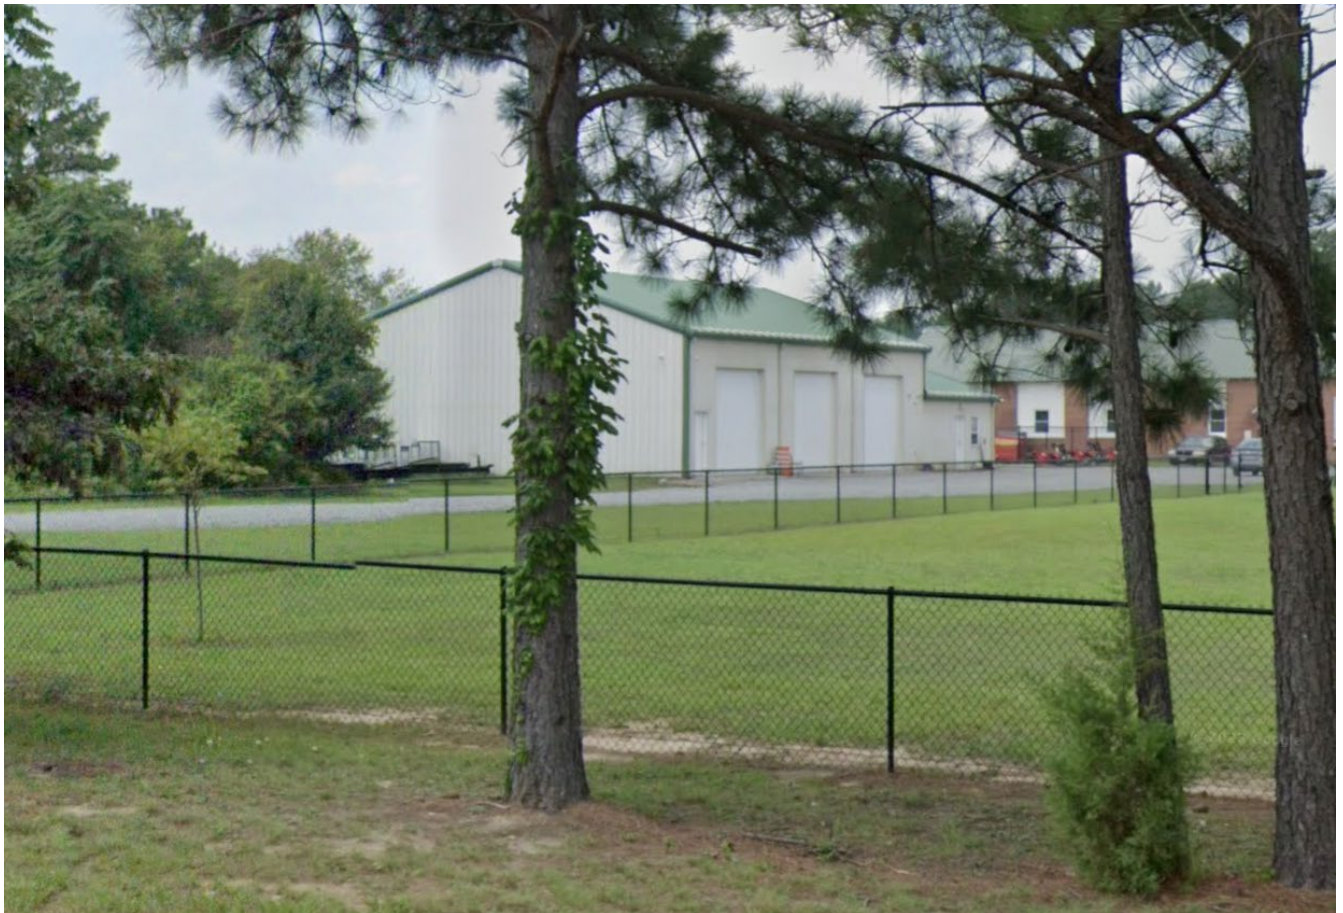
The exterior sheet metal and metal framed walls are in fair condition with limited deterioration including exterior dirt/algae growth and leaks at the downspout-to-gutter connections. By not efficiently directing water through the downspouts, water may prematurely erode and penetrate other building materials and lead to additional deficiencies in the coming years.

**PHOTO AE.01A**  
**EXTERIOR DIRT / ALGAE GROWTH**

*Condition: Fair*  
*Quantity: 100% Exterior Powerwash*

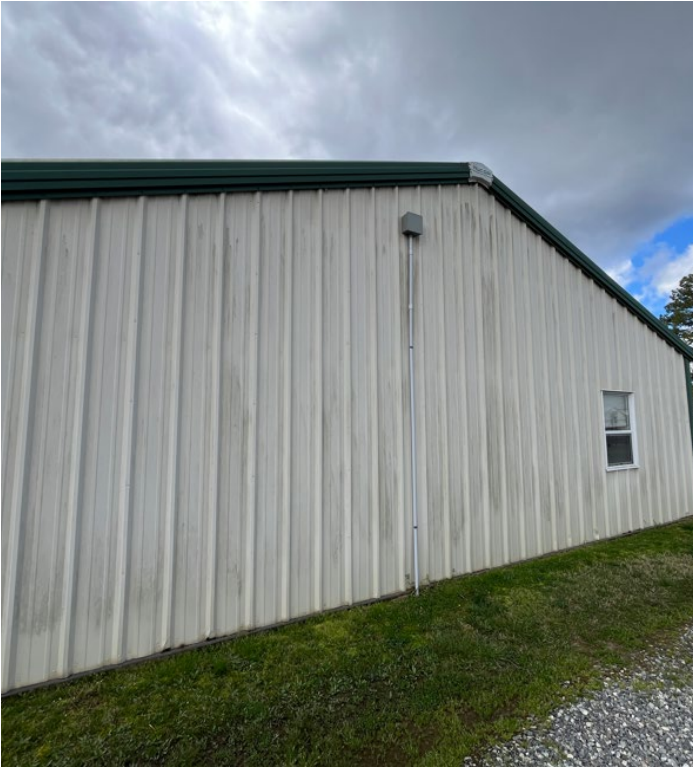
**PHOTO AE.01B**  
**EXTERIOR DIRT / ALGAE GROWTH**

*Condition: Fair*  
*Quantity: 100% Exterior Powerwash*

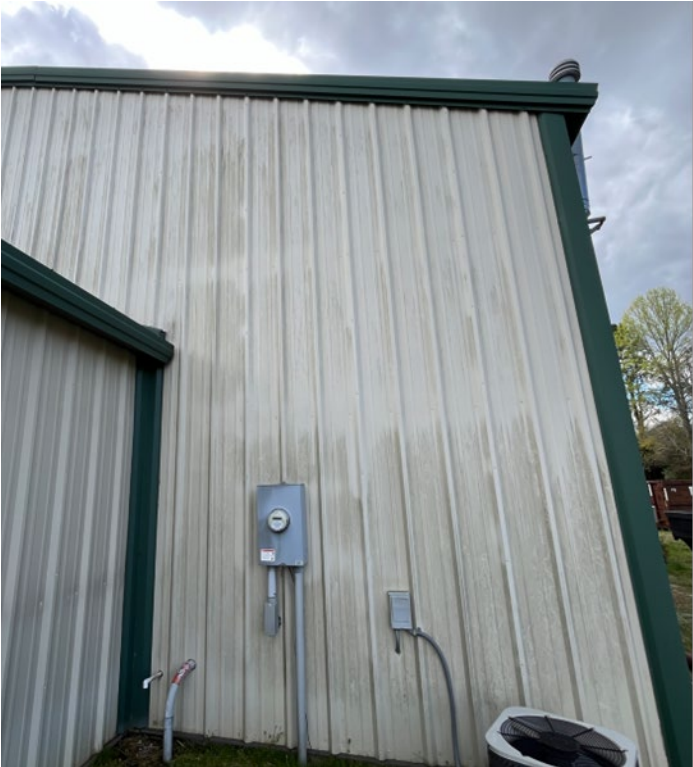
**PHOTO AE.02A**  
**DETERIORATED GUTTERS & DOWNSPOUTS**

*Condition: Fair*  
*Quantity: Approx. 160 LF*

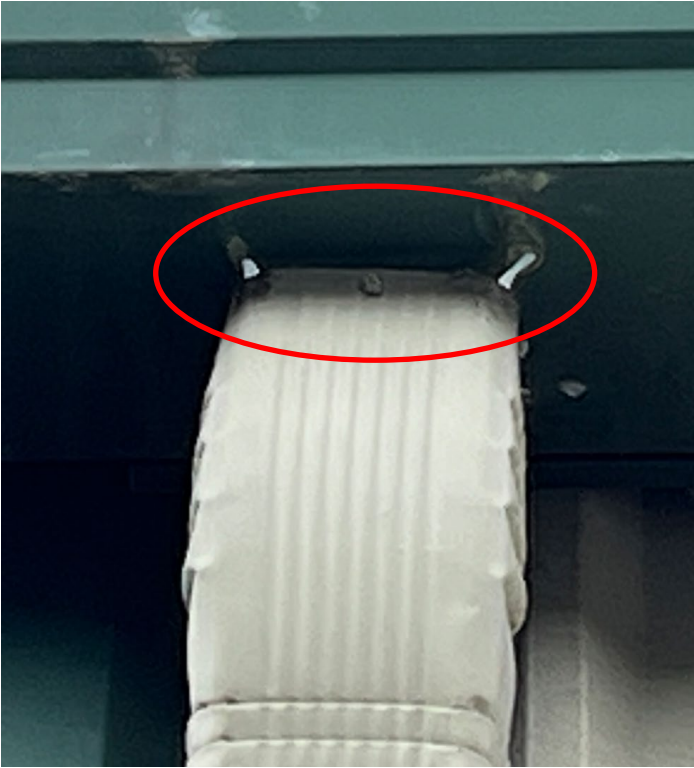
**PHOTO AE.02B**  
**DETERIORATED GUTTERS & DOWNSPOUTS**

*Condition: Fair*  
*Quantity: Approx. 160 LF*

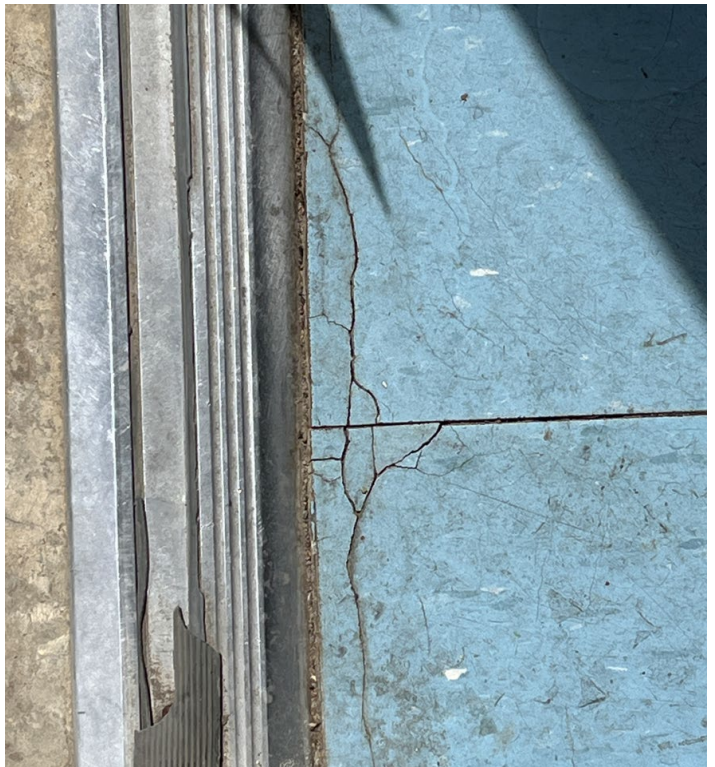
**PHOTO AI.01**  
**DAMAGED FLOORING (VCT) AND DOOR**  
**WEATHER STRIP**

*Condition: Fair*  
*Quantity: Approx. 6 SF*

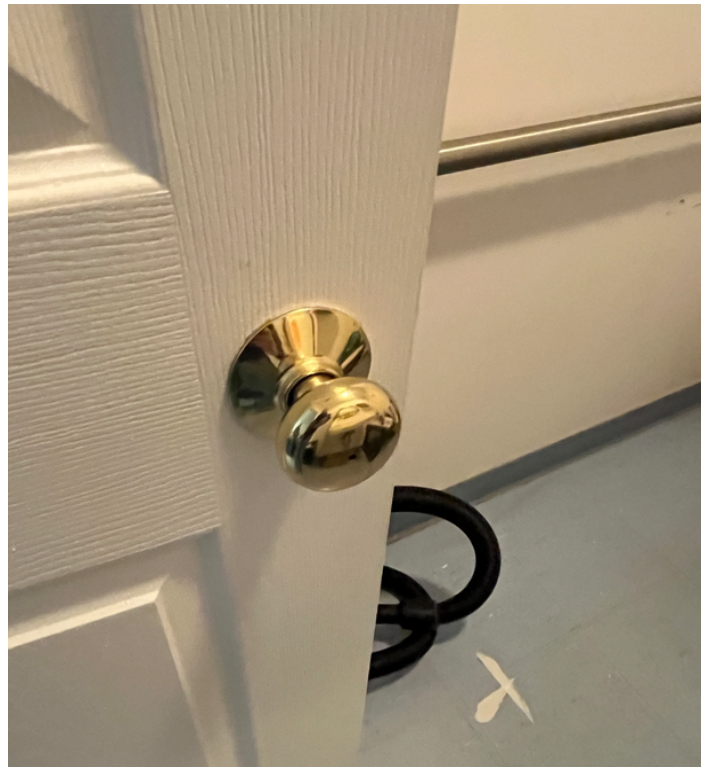
**PHOTO AA.01**  
**DOOR HARDWARE - OPERABLE PARTS**  
**(ADAAG 309.4)**

*Condition: Poor*  
*Quantity: (3) Locations*

1. Replace existing doorknobs with code compliant hardware.
2. Provide adequate/proper maneuvering clearances on pull and push sides of manual swinging doors.
3. Provide guards on exposed under sink piping.
4. Upgrade restroom to meet accessibility standards.

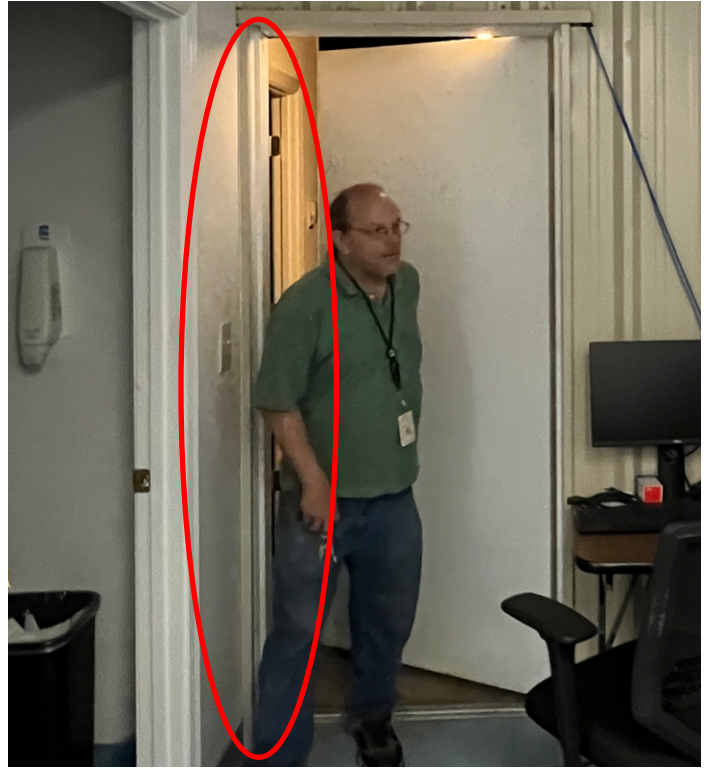
**PHOTO AA.02**  
**MANUEVERING CLEARANCES TO STORAGE**  
**BAY**  
**(ADAAG 404.2.4.1)**

*Condition: Fair*  
*Quantity: (1) Location*

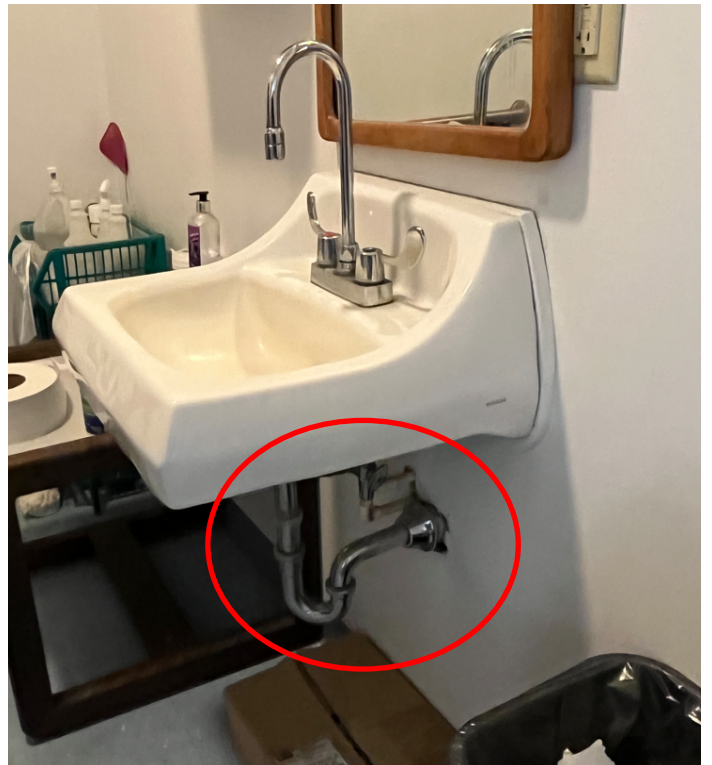
**PHOTO AA.03**  
**LAVATORIES & SINKS - EXPOSED PIPES**  
**(ADAAG 606.5)**

*Condition: Poor / Fair*  
*Quantity: (2) Sinks*

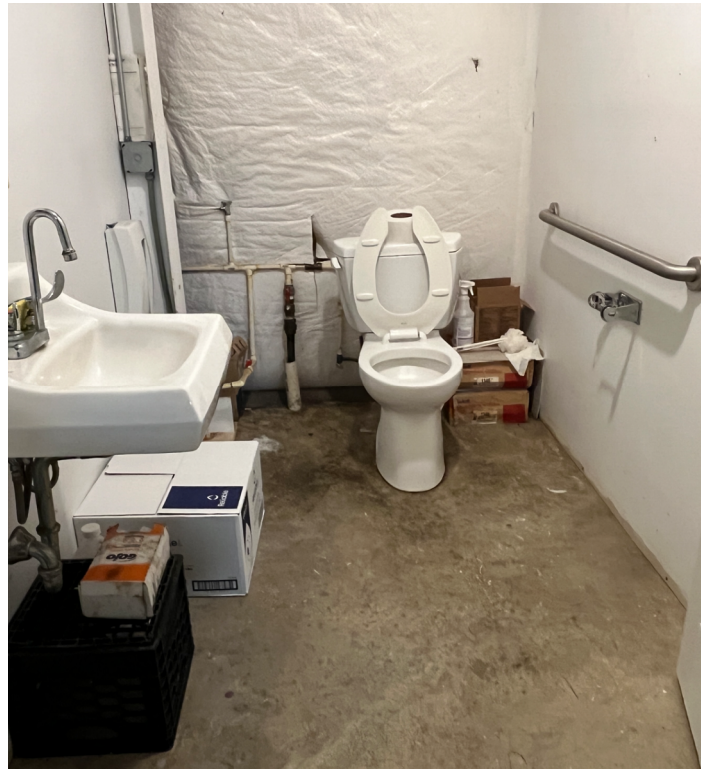
**PHOTO AA.04**  
**TOILET ROOM(S) - GRAB BAR SPACE,**  
**EXPOSED PIPES, AND REMOVE STORED**  
**MATERIALS**  
**(ADAAG 604.3, 604.5, 606.5 & 609.3)**

*Condition: Fair*  
*Quantity: (1) Restroom*

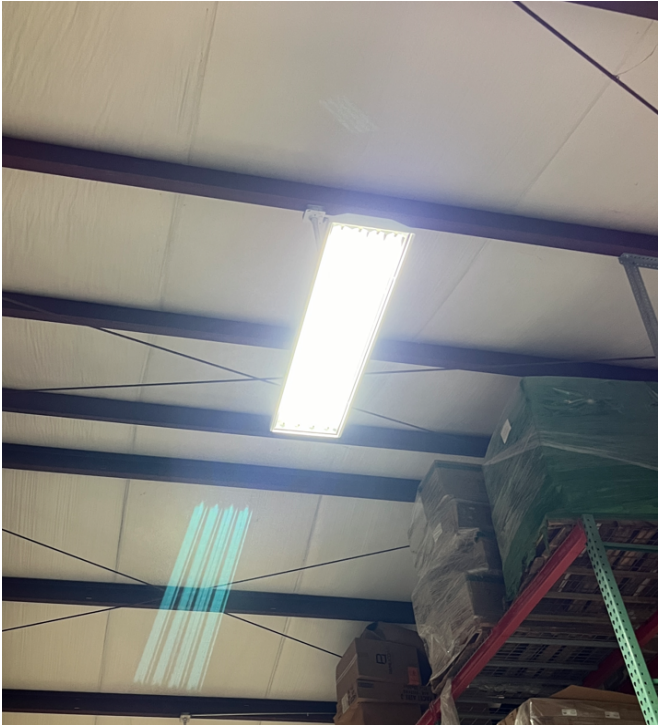
**PHOTO AB.01  
FLOURESCENT LIGHT GUARDS (OSHA)**

*Condition: Fair  
Quantity: Storage Area*

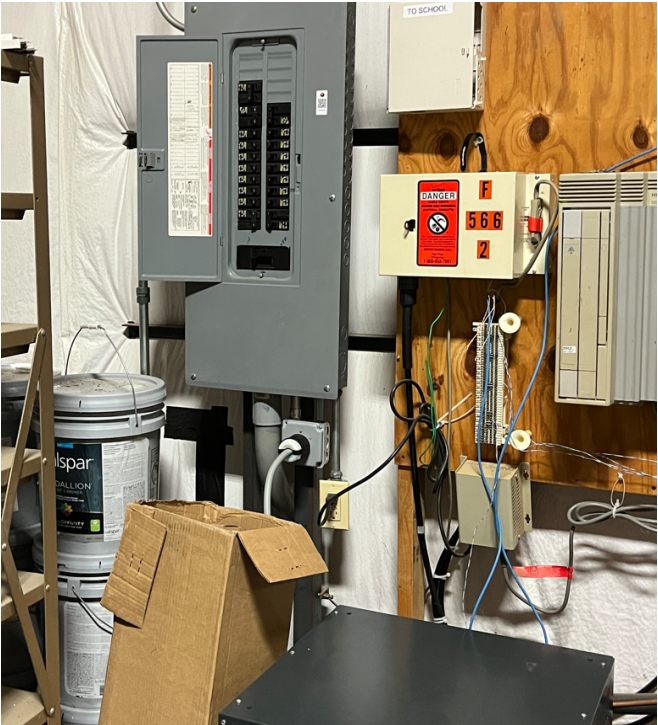
**PHOTO AB.02  
PROPER ELECTRICAL PANEL CLEARANCE  
(NEC 110-26)**

*Condition: Fair / Good  
Quantity: (1) Location*

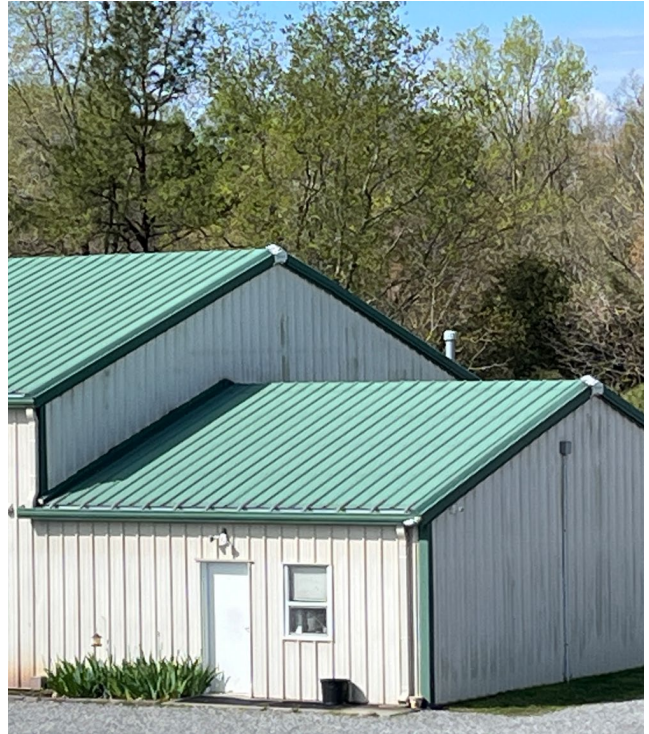
**PHOTO AR.01**  
**STANDING SEAM METAL PANEL ROOF**

*Condition: Good*  
*Quantity: 4,350 SF*

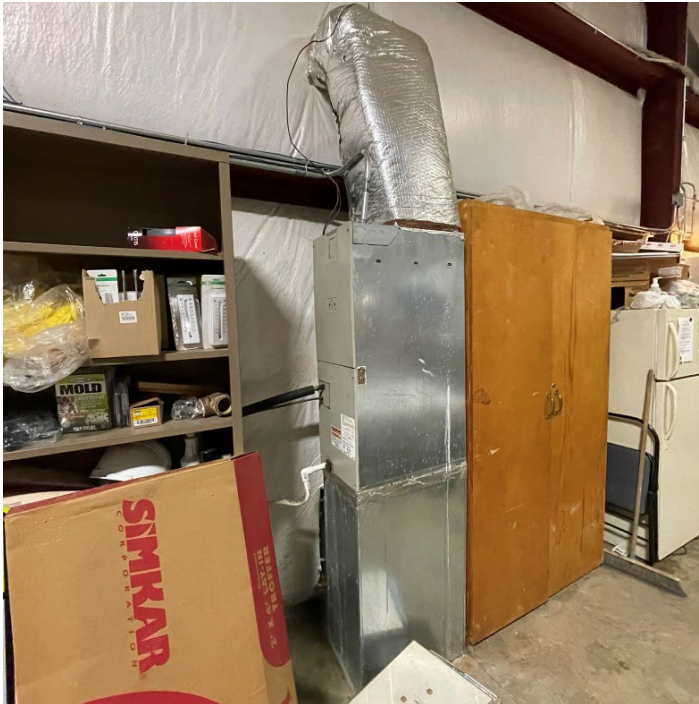
**Decentralized HVAC** equipment provides air conditioning and ventilation for the front office. The front office area of the building is served by a residential split air handling unit. This equipment was installed in 2005 and is nearing the end of its expected life and should be considered for replacement. There is also no outside air provided for ventilation. This should be added per code requirements.

**PHOTO M.03**  
**AIR HANDLING UNIT**

*Condition: Poor*  
*Quantity: (1)*

1. The residential split system should be replaced within the next three (3) years as it is nearing the end of its expected life.
2. Outside air needs to be added to the occupied spaces.
3. The ceiling exhaust fan should be replaced.
4. The terminal unit heater is in fair condition and should be replaced in four (4) to six (6) years.

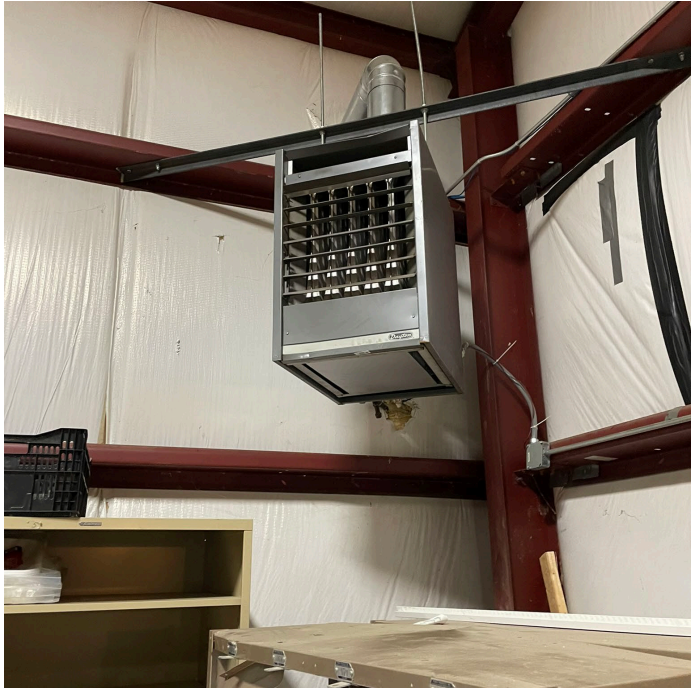
**Terminal heating** equipment provides heat for the warehouse. There is one propane fired unit heater that is in fair condition and should be considered for replacement in four (4) to six (6) years.

**PHOTO M.04  
UNIT HEATER**

*Condition: Fair  
Quantity: (1)*

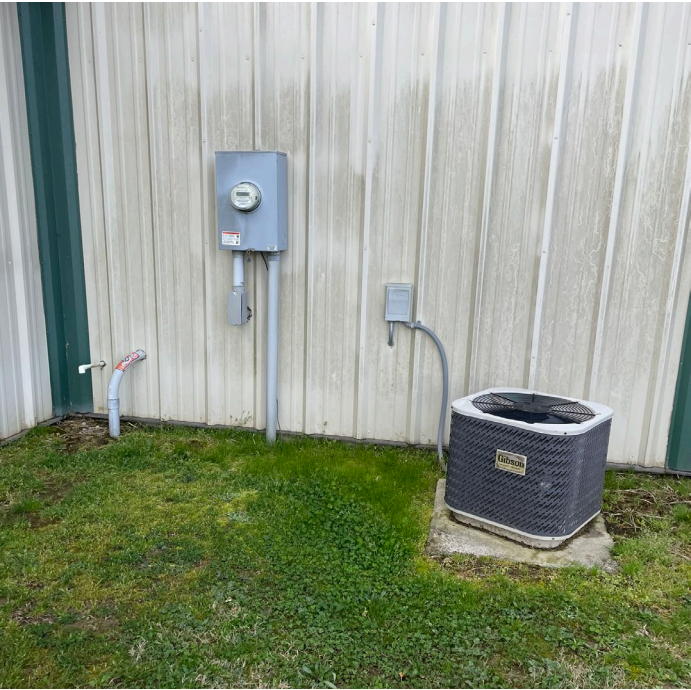
**PHOTO M.05  
AHU CONDENSING UNIT**

*Condition: Poor  
Quantity: (1)*

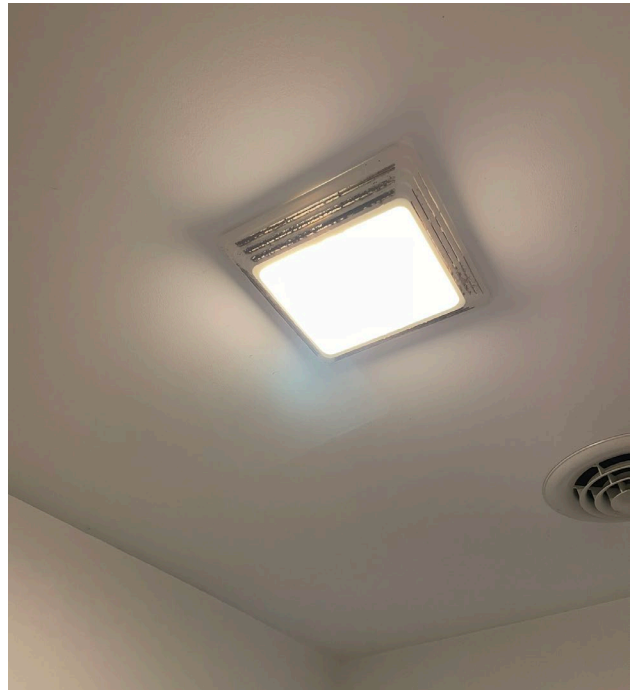
**Ductwork and Air Terminals.** The ductwork above the admin portion of the building was above a hard ceiling and was inaccessible. The air terminals in the admin area were in good condition. The exposed ductwork in the warehouse portion of the building is in good condition. There is a ceiling exhaust fan that is in poor condition and should be replaced.

**PHOTO M.06  
EXHAUST FAN**

*Condition: Poor  
Quantity: (1)*

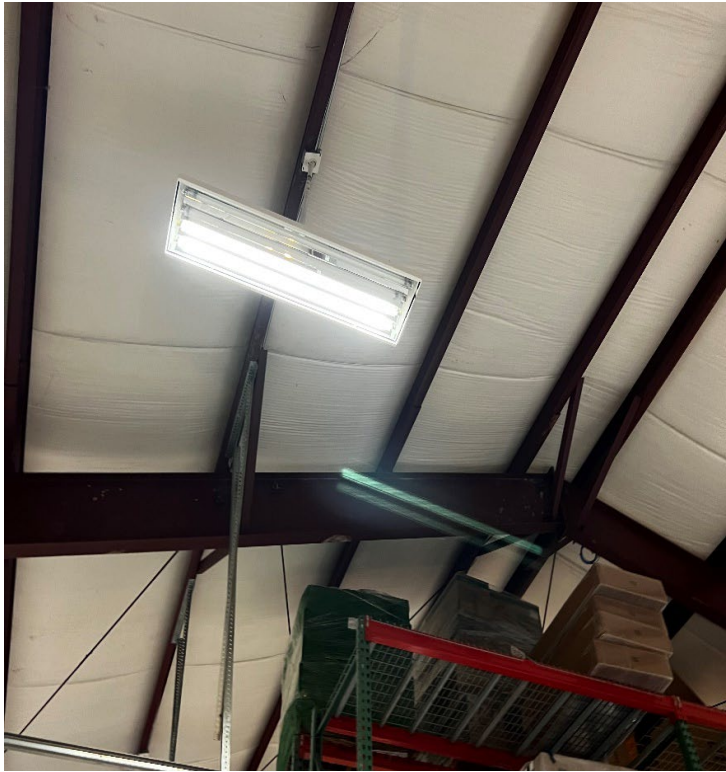
**Interior lighting** consists of a mixture of fixture types and lamp types, none seemed to be LED. The controllability is very limited and doesn't meet the current energy code, namely the International Energy Conservation Code (IECC). Multiple fixtures were either not working properly or some of the bulbs were not working. It is recommended that all non-led light fixtures should be replaced with efficient LED light fixtures and sufficient battery backup emergency lighting be added. Additionally, the associated occupancy sensing, dimming, and daylight harvesting lighting controls should be replaced/added to reduce energy usage of the building. The existing exit signs should be upgraded, as applicable, to LED type and supplemental signs added where needed.

**PHOTO E.02  
LIGHTING**

*Condition: Poor / Fair  
Quantity: Approx. 4,350 SF*

1. The existing service entrance MDP does not need be replaced.
2. Emergency backup lighting should be installed for better coverage.
3. All existing interior non-LED light fixtures should be upgraded to LED light fixtures that conform to the current version of the IECC.
4. It is recommended that existing toggle switch lighting controls be replaced with code compliant lighting controls consisting of dimming, occupancy sensing, and daylight harvesting controls as mentioned above.
5. Parking lot lighting should be added as needed for building usage.
6. Fire alarm system should be added to comply with code.
7. It is recommended that devices be checked and maintained, and broken parts be replaced.
8. It is recommended that the CCTV system be added/replaced in its entirety. The replacement system should meet the current cloud-based system standards of the school system.

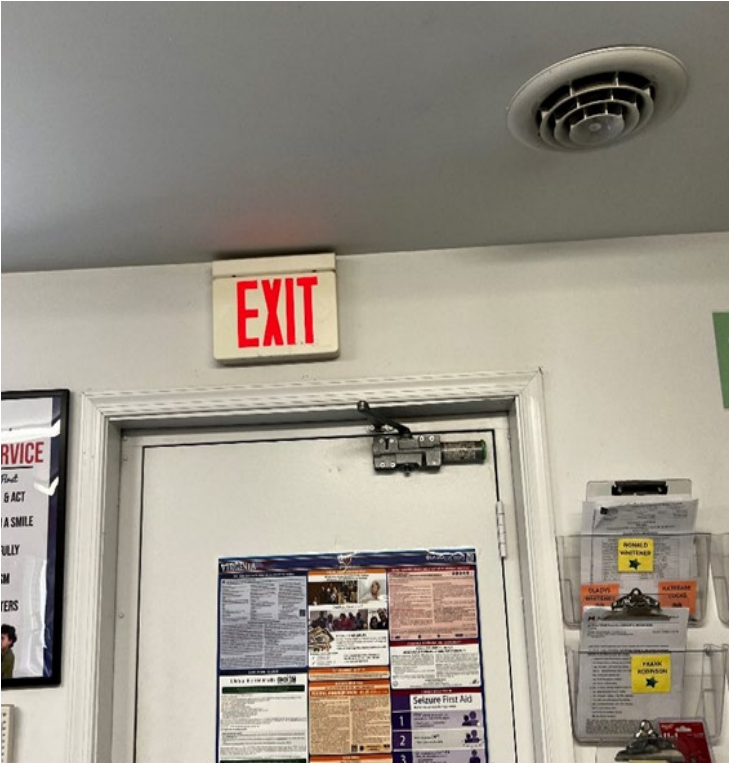
**PHOTO E.03  
EXIT SIGN**

*Condition: Fair  
Quantity: Approx. (4) Exit Signs*

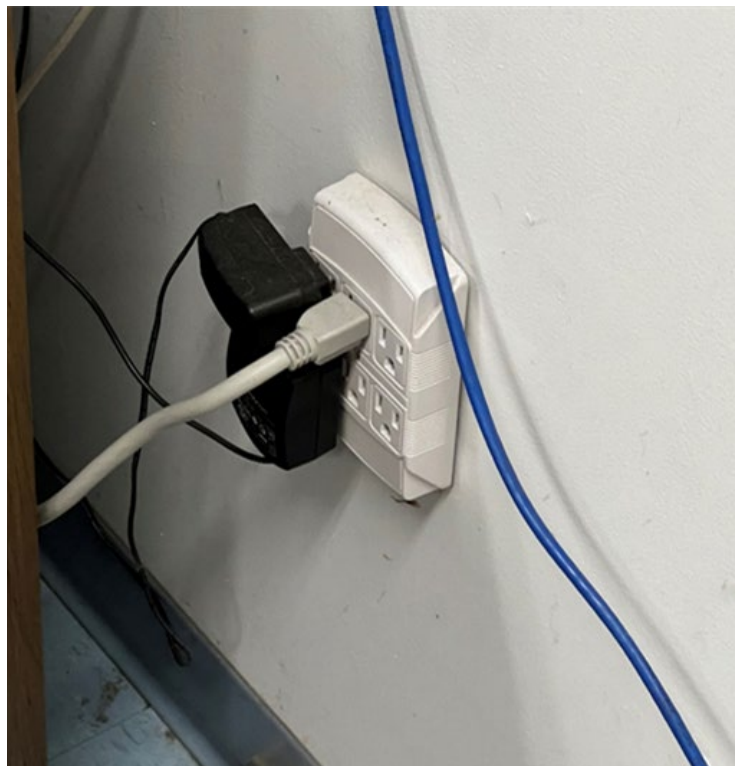
**Wiring devices** consist of devices original to the building and newer devices added overtime. There are areas where a water source is present, and the receptacles are not GFCI protected. Some existing conditions related to grounding and ground-fault protection do not comply with current NEC requirements and associated devices should be replaced. There also appears to be a lack of power outlets within rooms as there are multiple power strips throughout the office area. Additionally, outlets should be provided to avoid the use of power strips. It is advisable to replace all the devices and associated wiring.

**PHOTO E.04  
POWER STRIP**

*Condition: Poor  
Quantity: Approx. (3) Locations*

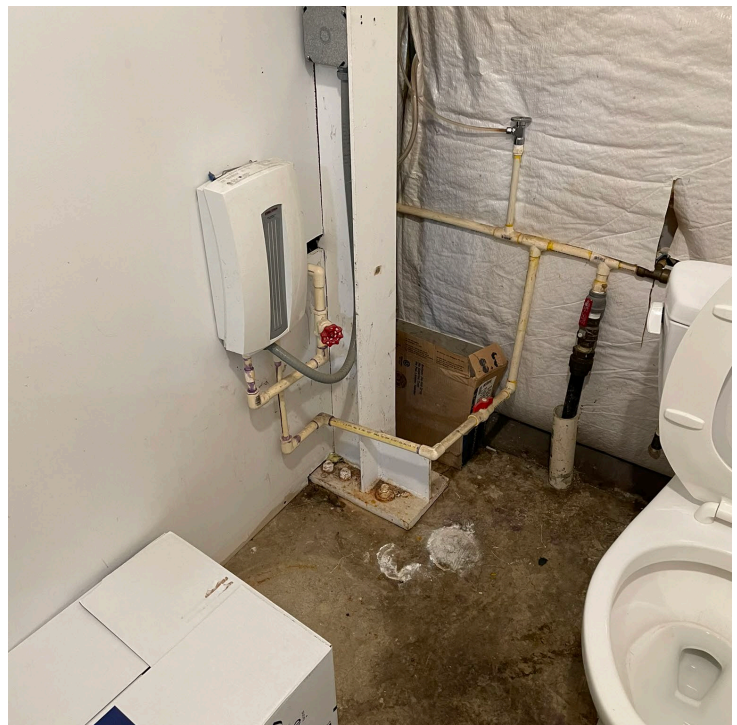
**PHOTO P.01A**  
**TANKLESS WATER HEATER AND**  
**PIPING**

*Condition: Poor*  
*Quantity: (1)*

1. The plumbing systems are at or near the end of their life and should be considered for replacement within the next three (3) to five (5) years.
2. The gas piping should be replaced immediately.
3. The sanitary piping below the slab was inaccessible and should be scoped with a camera to determine the condition.

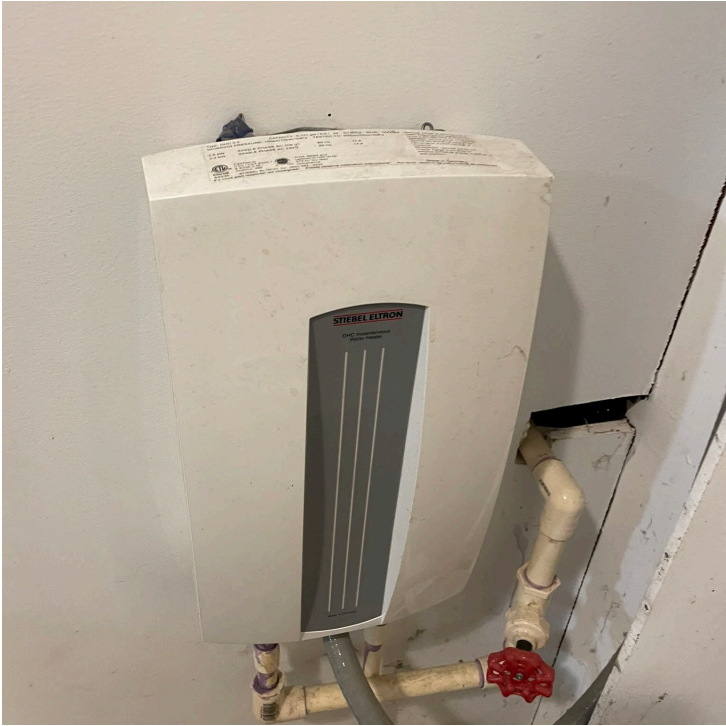
**PHOTO P.01B**  
**DOMESTIC WATER HEATER**

*Condition: Poor*  
*Quantity: (1)*

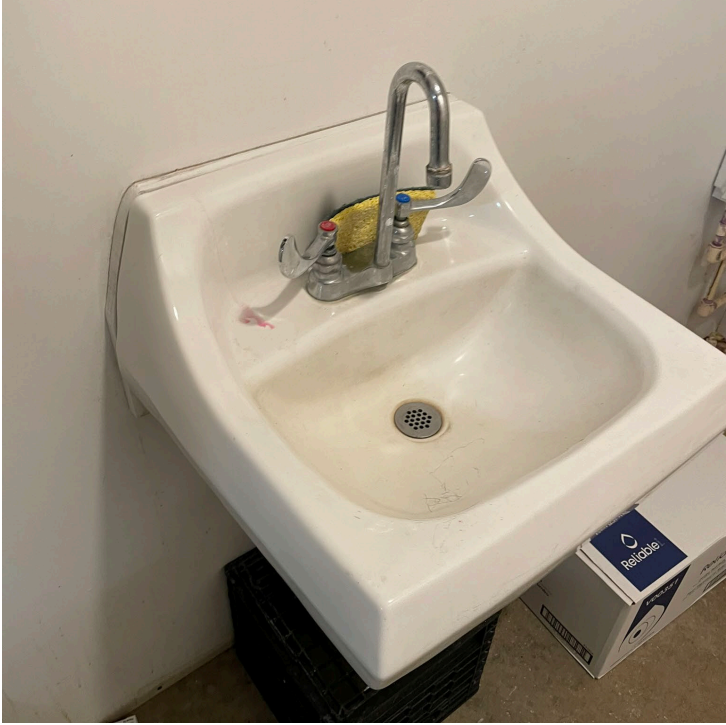
**PHOTO P.02**  
**LAVATORY**

*Condition: Fair*  
*Quantity: (2)*

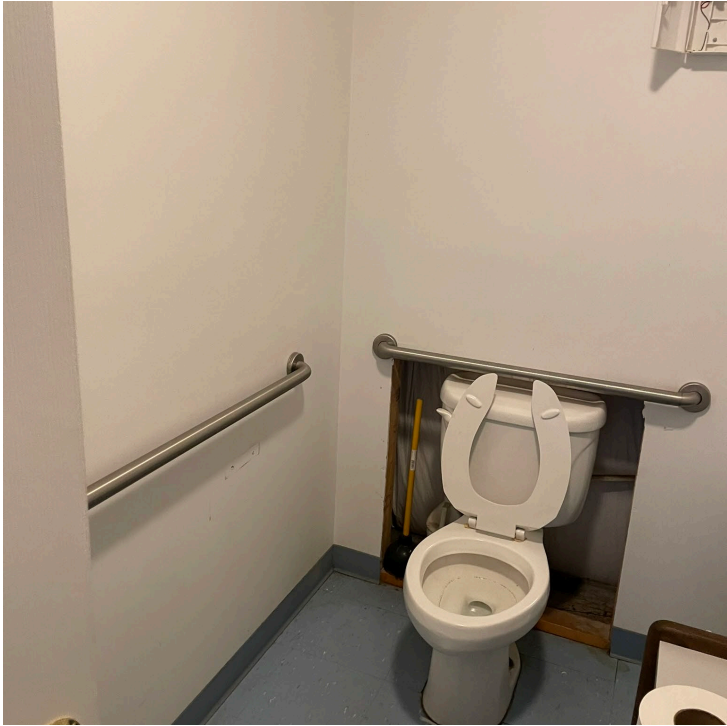
**PHOTO P.03A**  
**FRONT OFFICE WATER CLOSET**

*Condition: Poor / Fair*  
*Quantity: (1)*

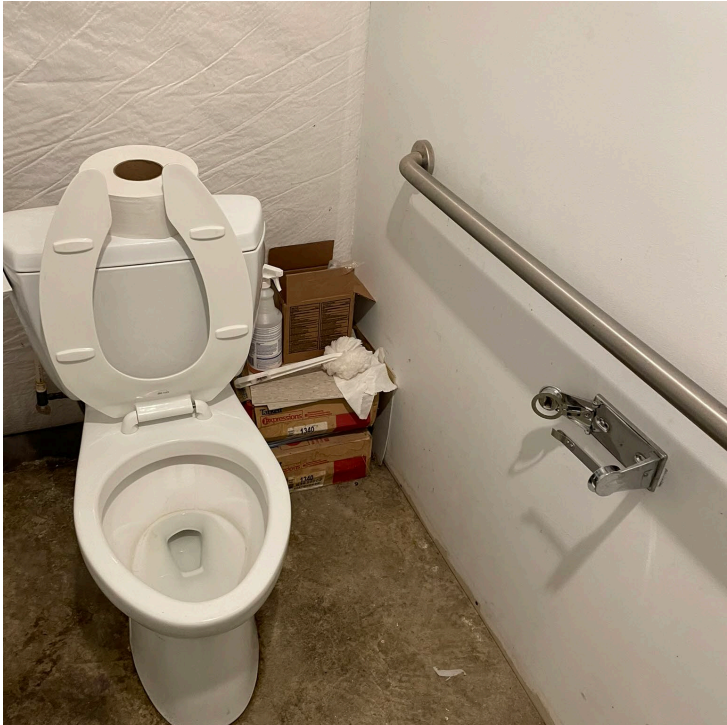
**PHOTO P.03B**  
**SHOP WATER CLOSET**

*Condition: Poor*  
*Quantity: (1)*

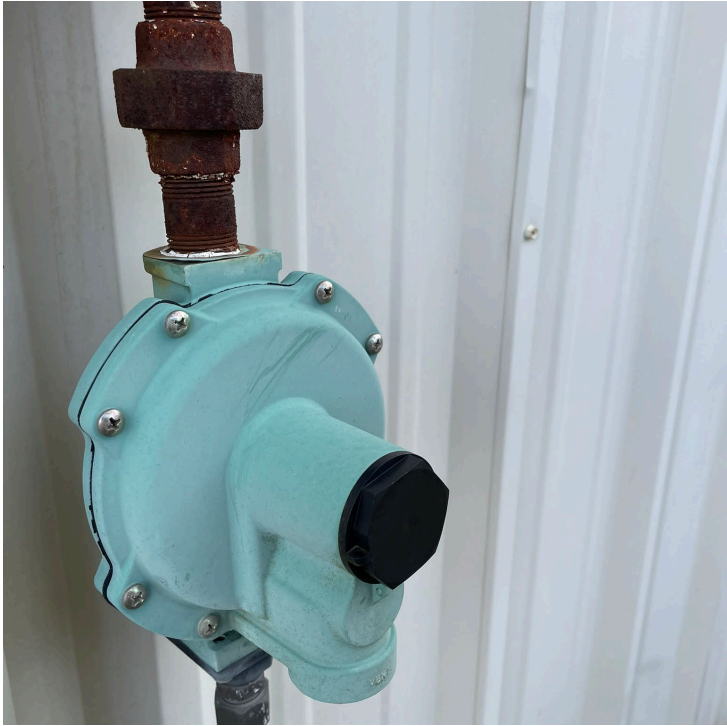
**Exterior gas piping** is completely rusted. The gas pipe is close to the end of its expected service life and should be replaced immediately.

**PHOTO P.04A**  
**GAS PIPING**

*Condition: Poor*  
*Quantity: Approx. 130 LF*

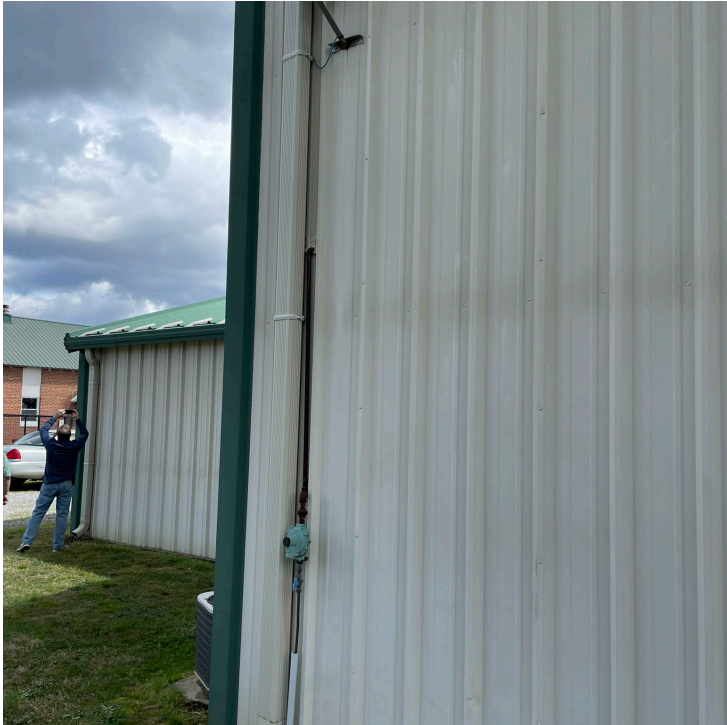
**PHOTO P.04B**  
**GAS PIPING**

*Condition: Poor*  
*Quantity: Approx. 130 LF*

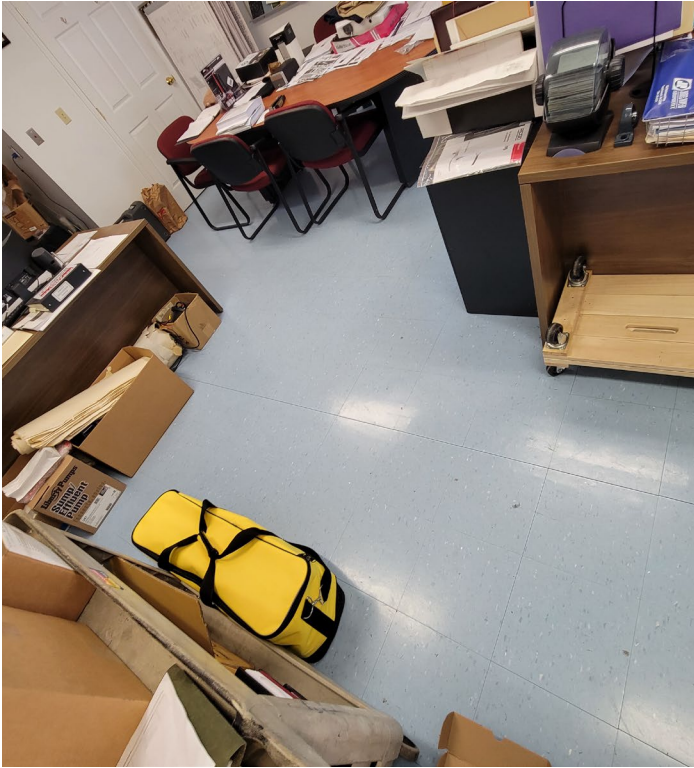
Interior structural issues were limited to the slab-on-grade. Uneven/sloping surfaces in the office was observed (Photo S.01) and cracking and spalling of the slab-on-grade in the maintenance bay was observed (Photo S.02).

The uneven slab-on-grade in the office is most likely due to improperly prepared subgrade or continual subgrade issues. The cracks in the maintenance bay slab-on-grade are most likely due to the concentrated point loads from the heavily loaded storage racks within the space or from heavy machinery/vehicles parked in the space.

**PHOTO S.01**  
**INTERIOR OFFICE SLAB-ON-GRADE**

*Condition: Good*  
*Quantity: Approx. 400 SF*

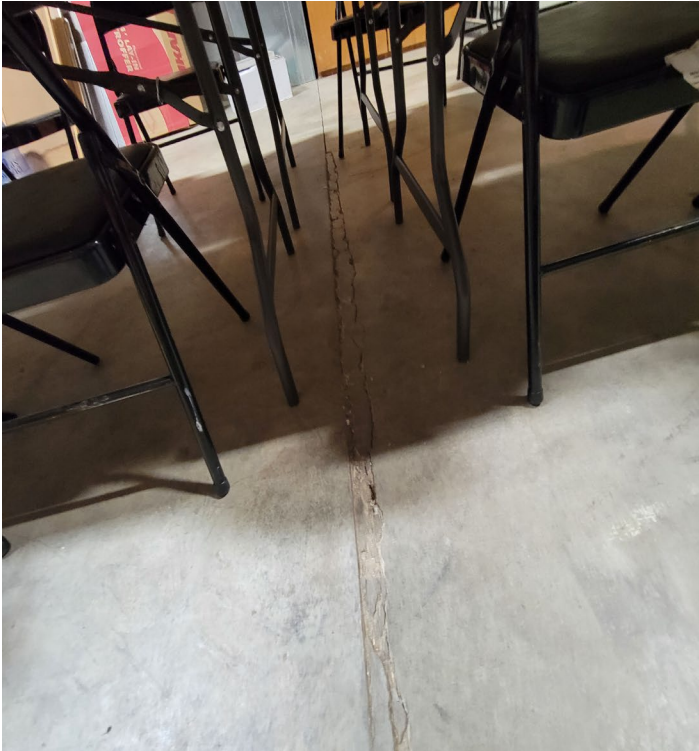
**PHOTO S.02**  
**INTERIOR MAINTENANCE BAY SLAB-ON-GRADE SLAB CRACK**

*Condition: Poor*  
*Quantity: Approx. 64 LF*

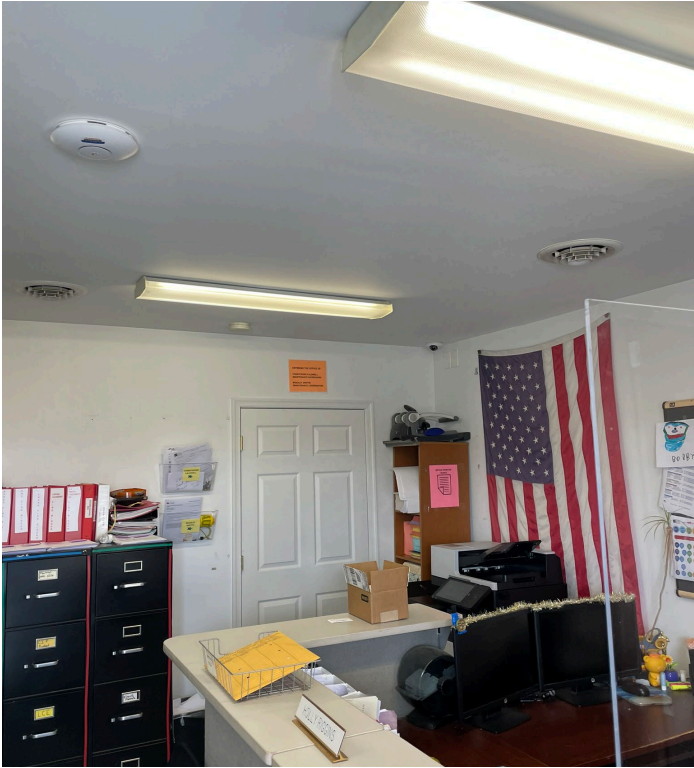
The Maintenance Building is not protected with a fire suppression (sprinkler) system. Major renovations may require the need for a full NFPA fire suppression (sprinkler) system. It is recommended that the fire protection system be upgraded to provide adequate fire suppression coverage throughout the warehouse and administration portion of the building. There were no fire extinguishers easily accessible in this building. They should immediately be added near the exits and throughout the warehouse.

**PHOTO FS.1  
ADMINISTRATION AREA**

*Condition: Not Applicable  
Quantity: None*

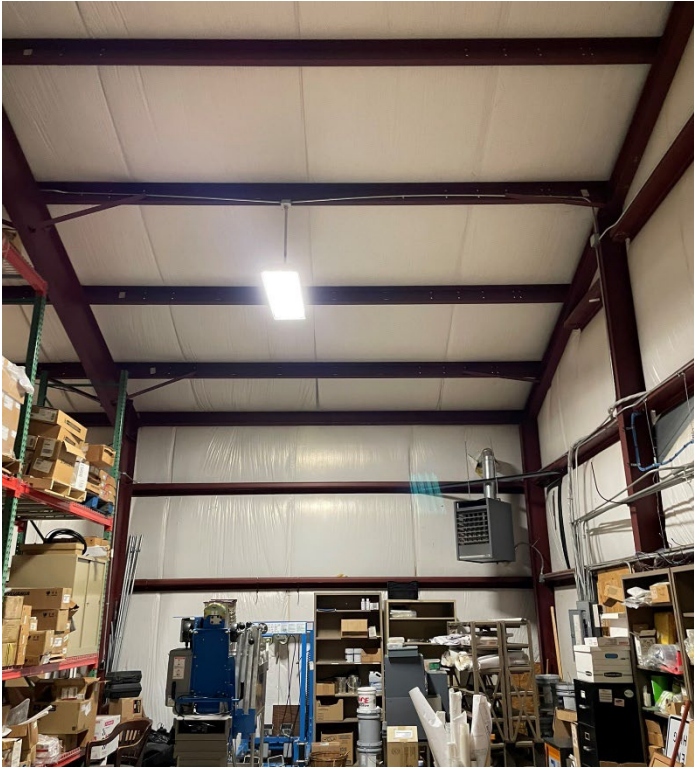
**PHOTO FS.2  
WAREHOUSE AREA**

*Condition: Not Applicable  
Quantity: None*
