MADISON ELEMENTARY SCHOOL

Facility Condition Assessment

Caroline County Public Schools

April 2, 2024

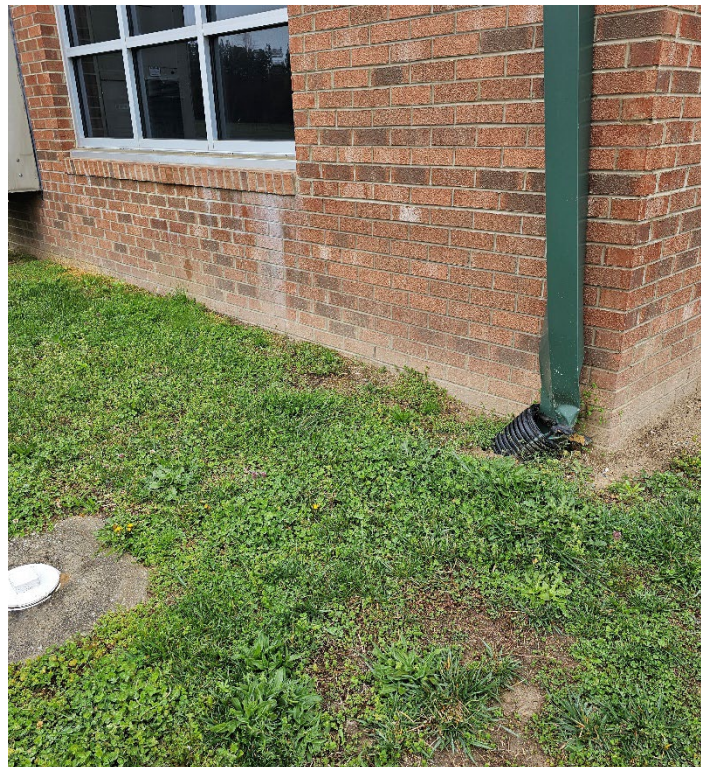
PHOTO C2.1
REPLACE/REPAIR DOWN SPOUT
CONNECTIONS

Condition: Fair

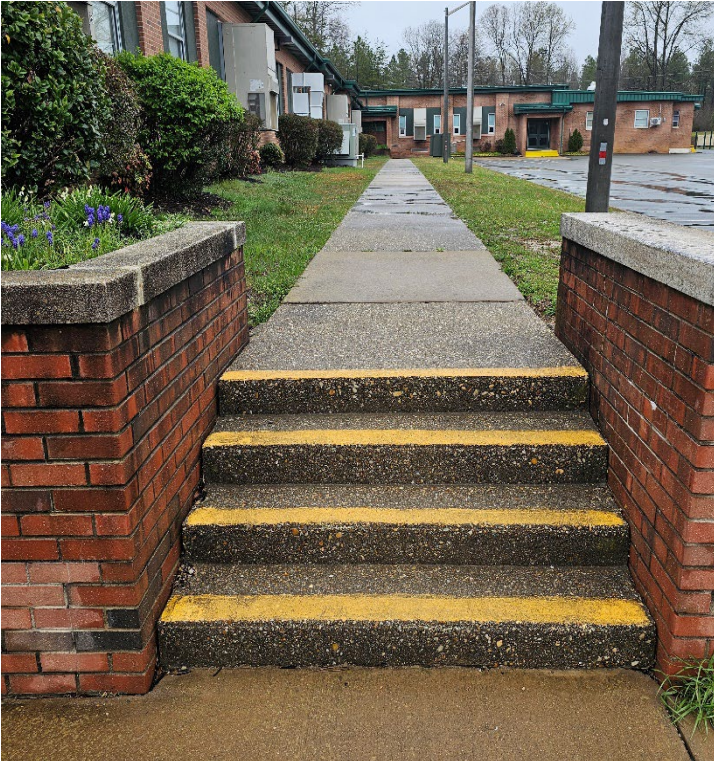
**PHOTO C4.3
INTALL HANDRAILS AT THREE STAIR
LOCATIONS**

*Condition: Poor
Quantity: Approx. 100 LF of Railing*

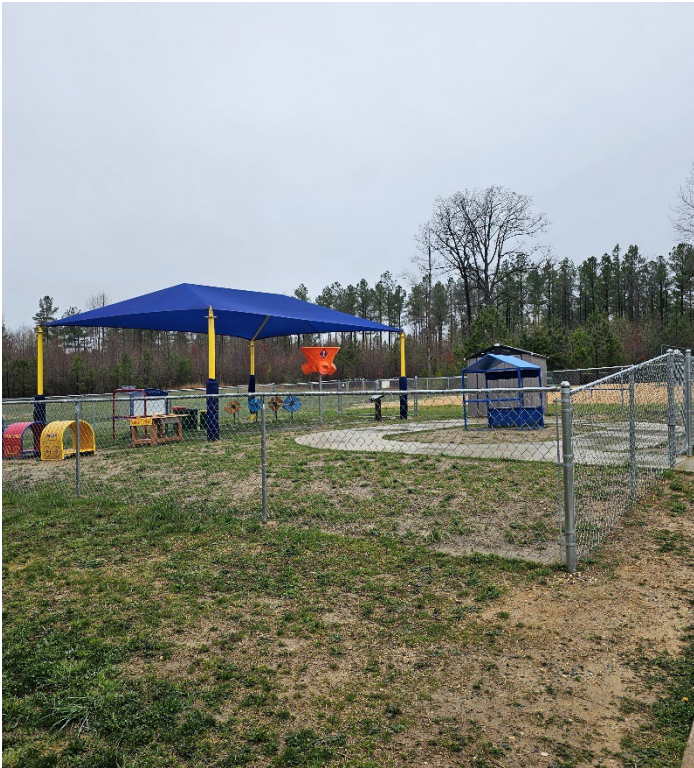
**PHOTO C5.2
MULCH PLAY AREAS THAT GETS HEAVY USE**

*Condition: Fair
Quantity: Approx. 20 CY*

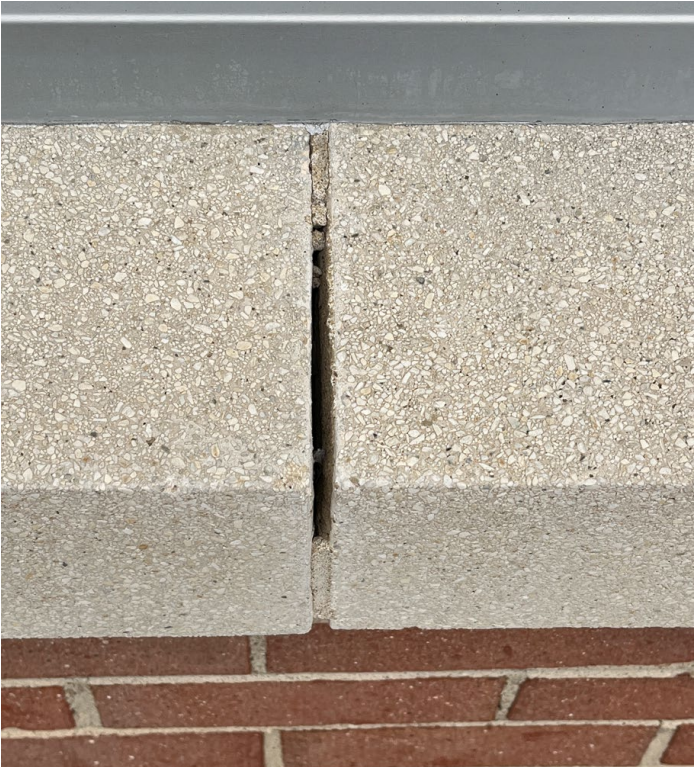
PHOTO AE.01
MORTAR DETERIORATION @ STONE SILLS

Condition: Fair
Quantity: Approx. 40 LF

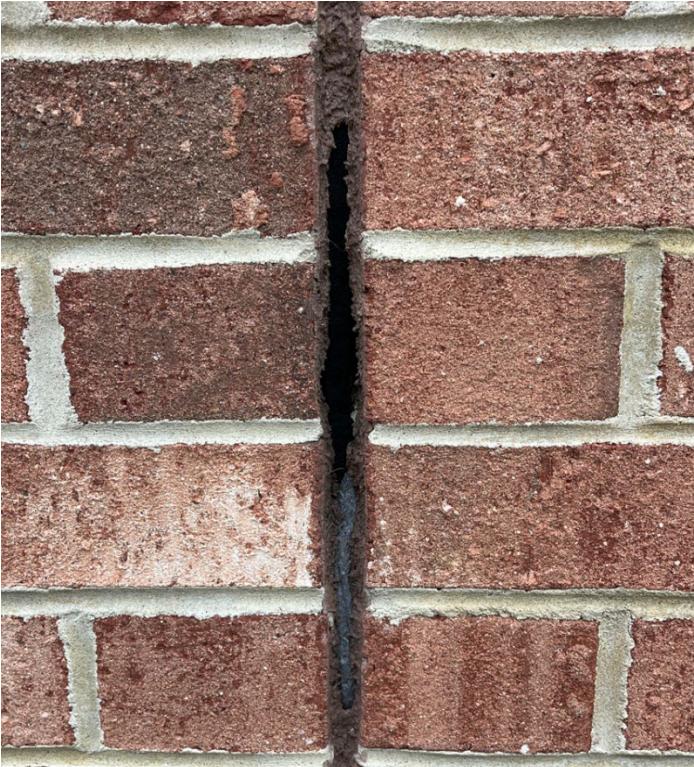
PHOTO AE.02
EXTERIOR CAULKING FAILURE
(CONTROL JOINTS)

Condition: Poor
Quantity: Approx. 500 LF

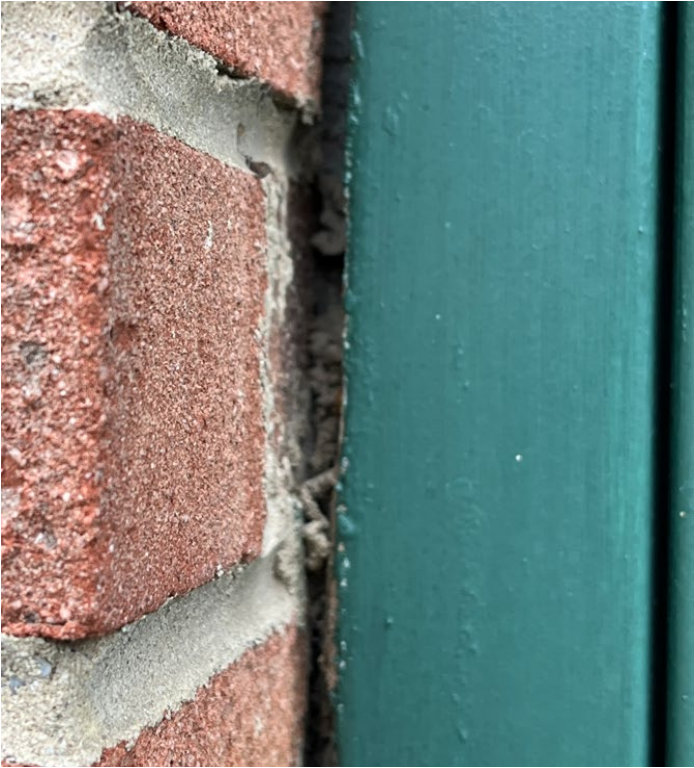
PHOTO AE.03
EXTERIOR CAULKING MISSING
(DOOR FRAMES)

Condition: Poor
Quantity: Approx. 100 LF

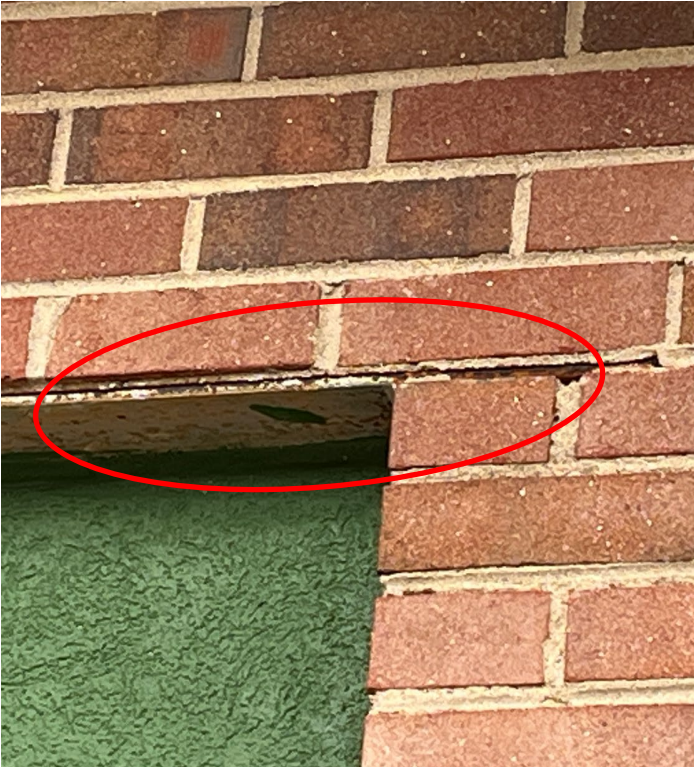
PHOTO AE.04
EXPOSED/RUSTED STEEL LINTELS

Condition: Fair
Quantity: Approx. 440 LF

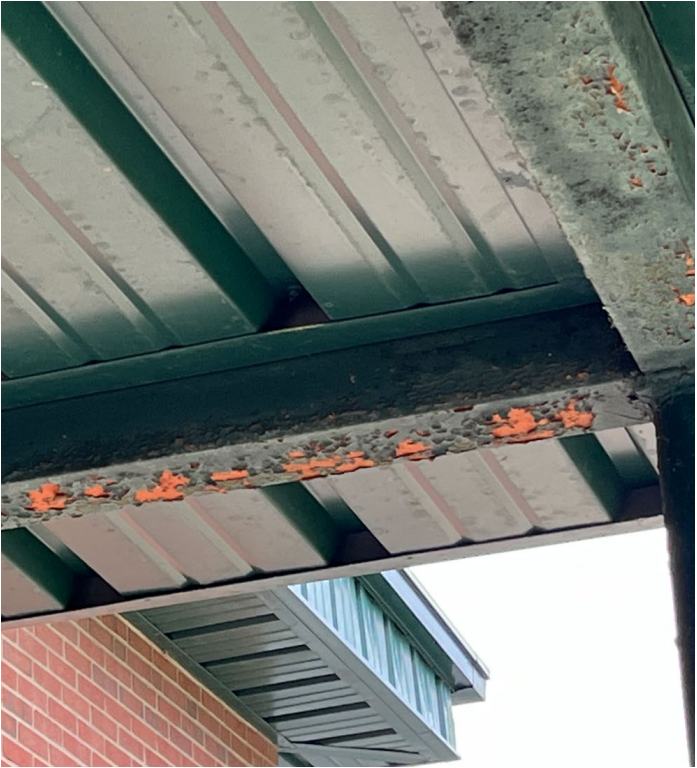
PHOTO AE.05
EXTERIOR CANOPY FRAME/DECK PAINT
(PEELING)

Condition: Poor / Fair
Quantity: Approx. 450 SF (5 Canopies)

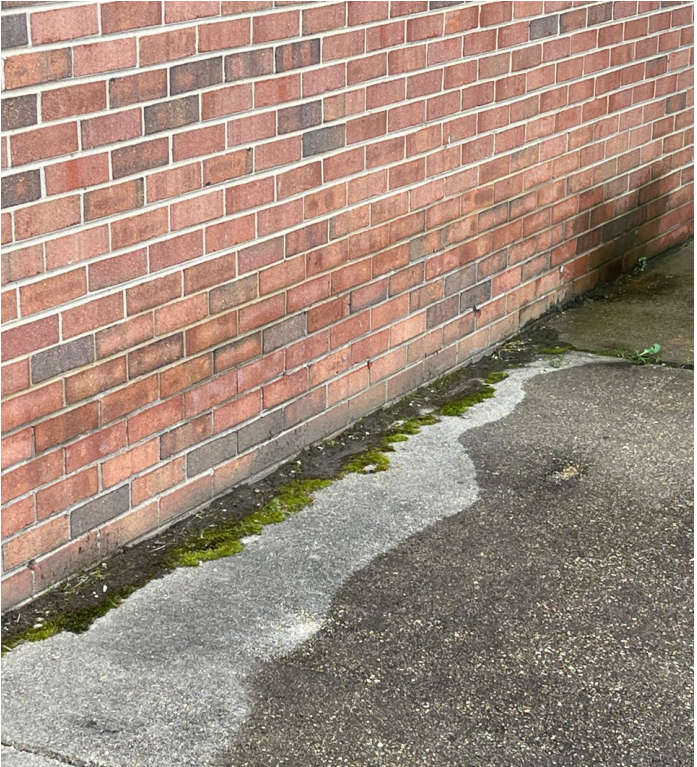
PHOTO AE.06
EXTERIOR DIRT / ALGAE GROWTH

Condition: Fair
Quantity: Approx. 63,026 SF

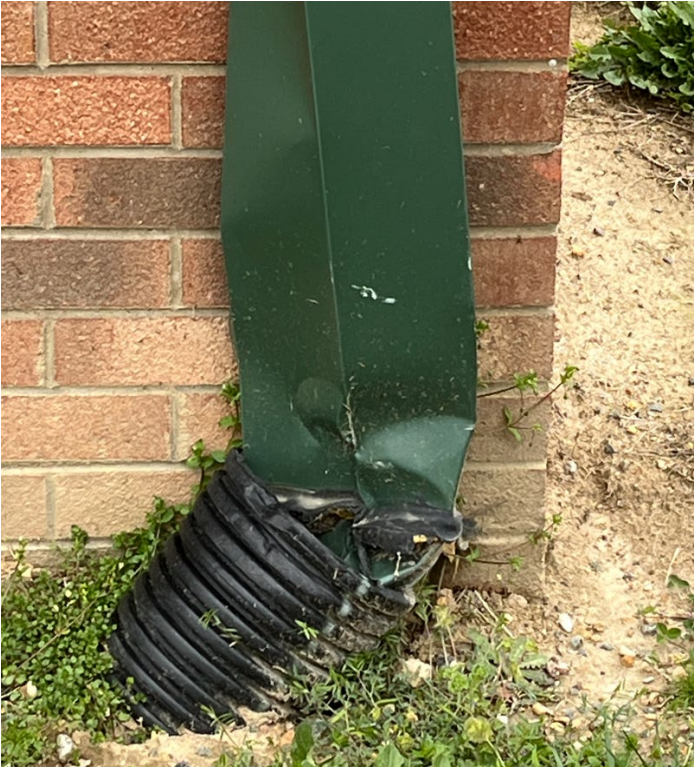
**PHOTO AE.07
DAMAGED DOWNSPOUTS**

*Condition: Poor
Quantity: Approx. 180 LF*

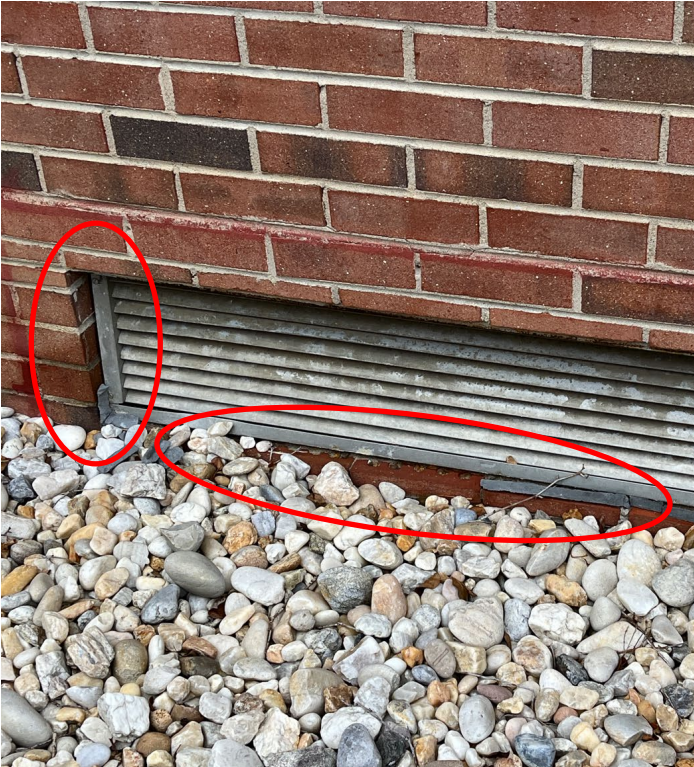
**PHOTO AE.08
CAULKING FAILURE @ LOUVER**

*Condition: Very Poor
Quantity: Approx. 20 LF*

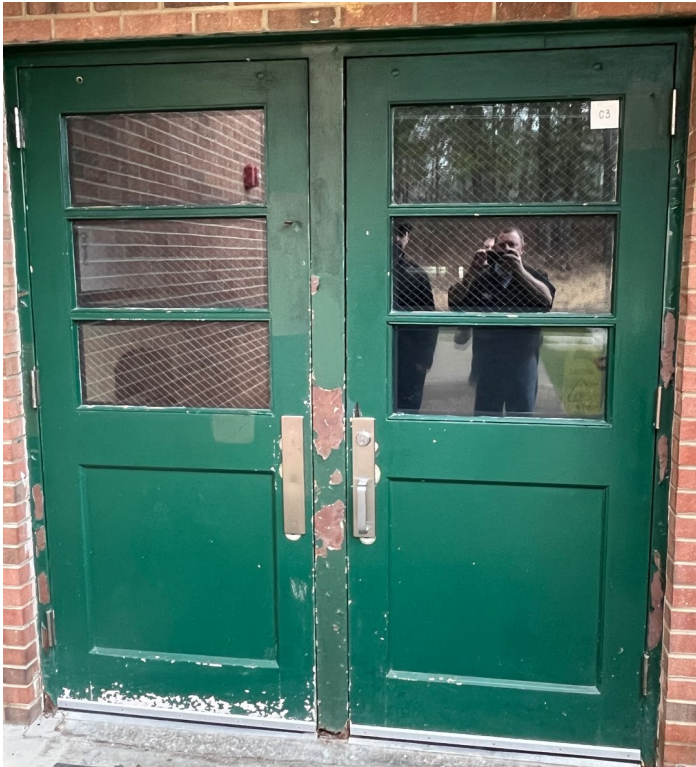
**PHOTO AE.10
EXTERIOR DOOR PAINT (PEELING)**

*Condition: Poor / Fair
Quantity: (12) Exterior Doors*

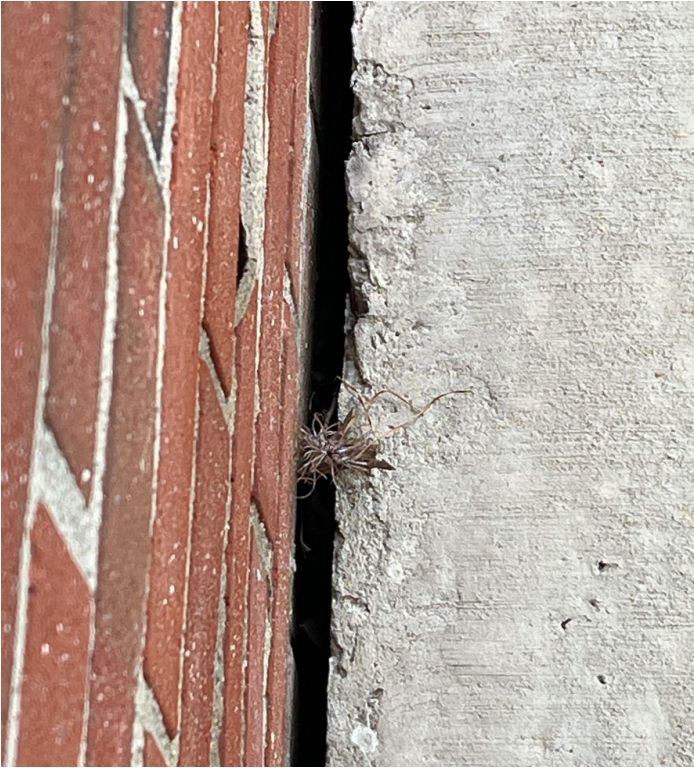
PHOTO AE.11
EXTERIOR JOINT FAILURE
(SIDEWALK TO EXTERIOR WALL)

Condition: Poor
Quantity: Approx. 100 LF

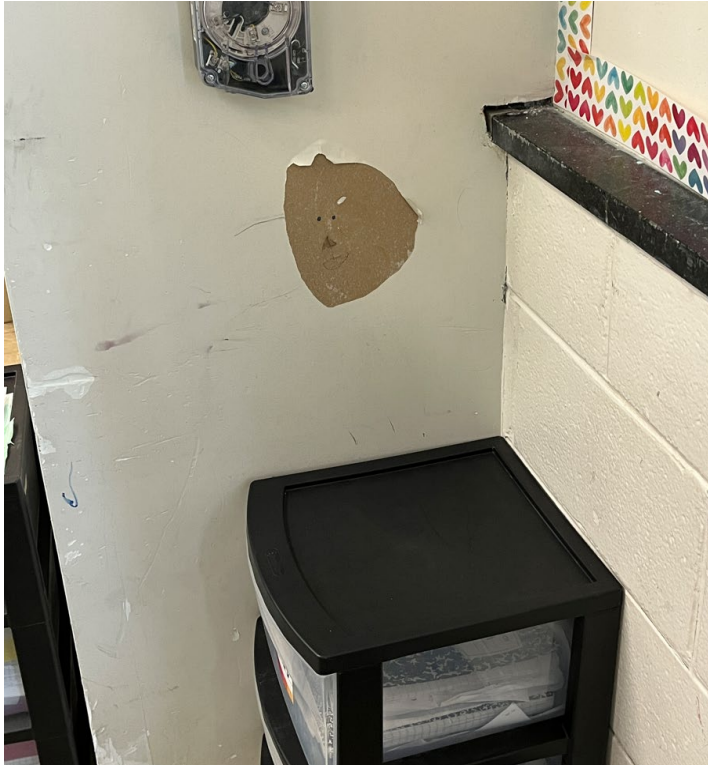
**PHOTO AI.05
DAMAGED GYPSUM WALL AND PAINT PEELING**

Condition: Poor
Quantity: Approx. 17,180 SF

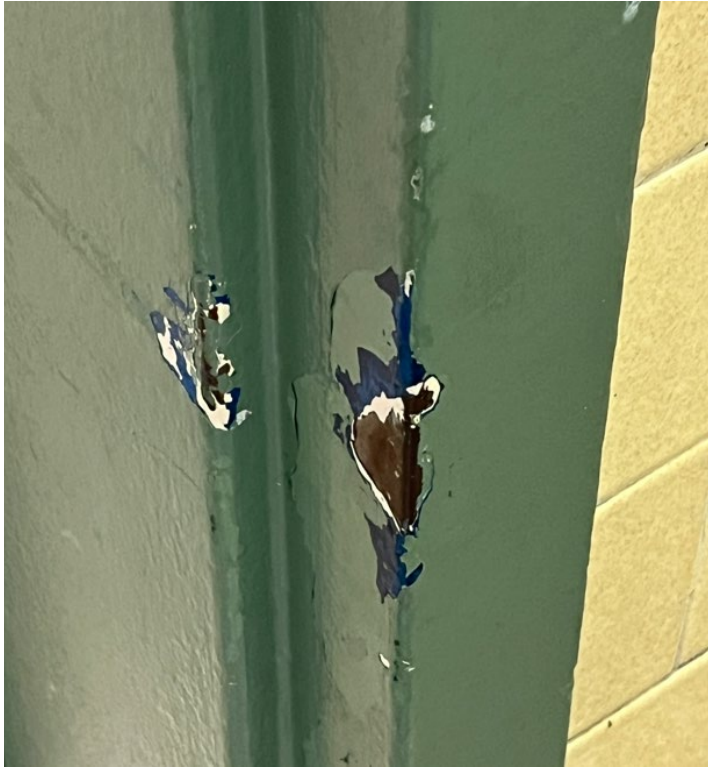
PHOTO AI.06
DOOR FRAME PAINT PEELING

Condition: Fair
Quantity: Approx. (75) Doors

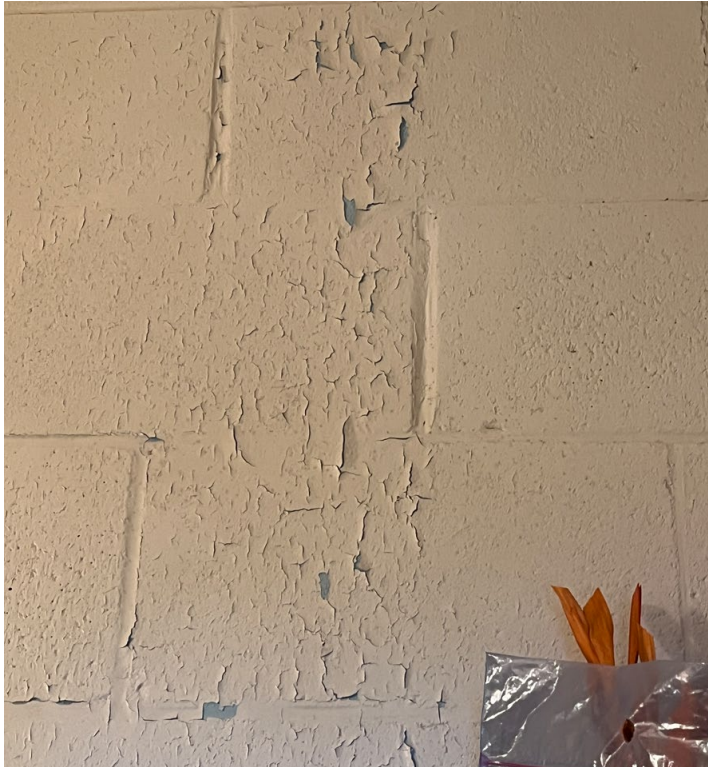
PHOTO AI.07
WALL PAINT PEELING

Condition: Fair
Quantity: Approx. 800 SF

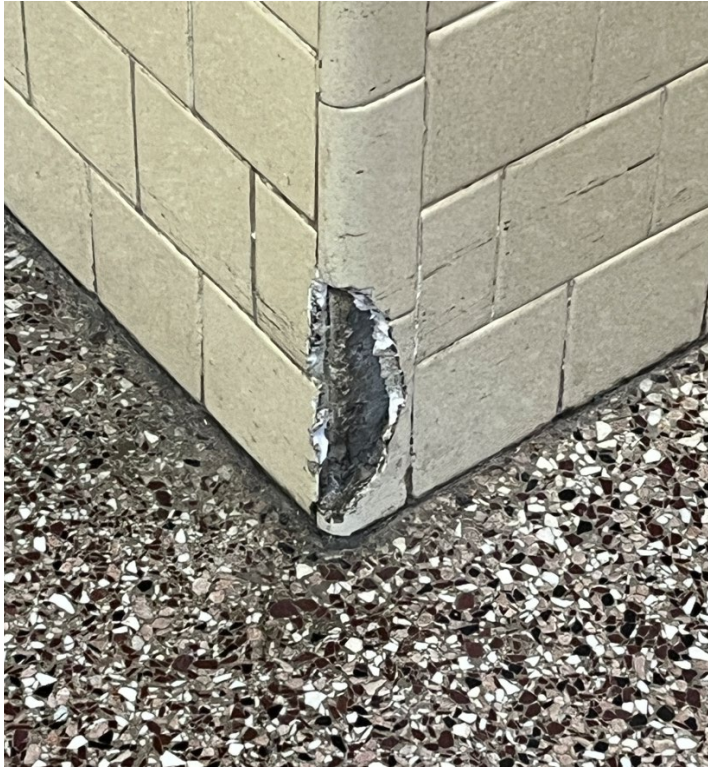
PHOTO AI.08
DAMAGED TILE WAINSCOTING

Condition: Poor / Fair
Quantity: Approx. 5,014 SF

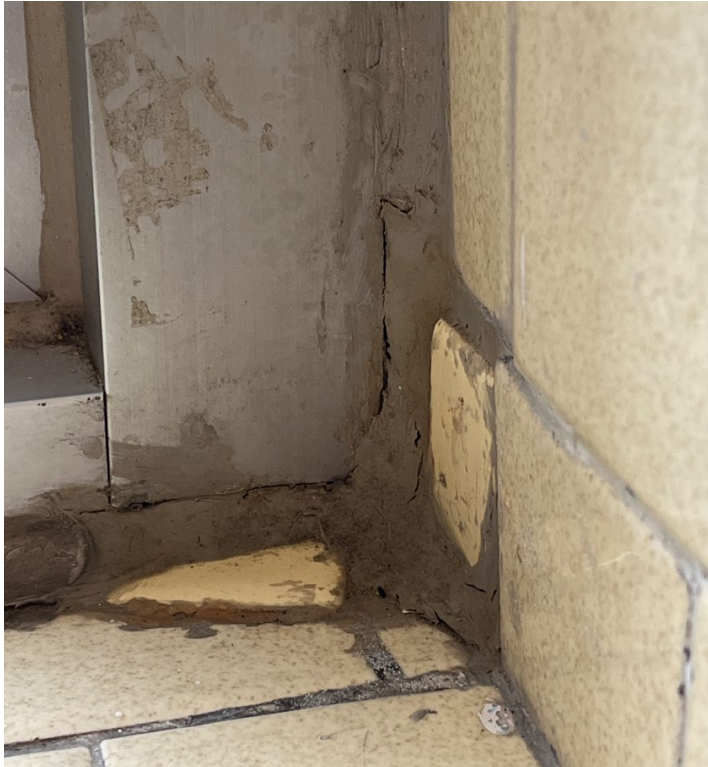
PHOTO AI.09
WINDOW SILL CAULK DETERIORATION

Condition: Poor / Fair
Quantity: Approx. 280 LF

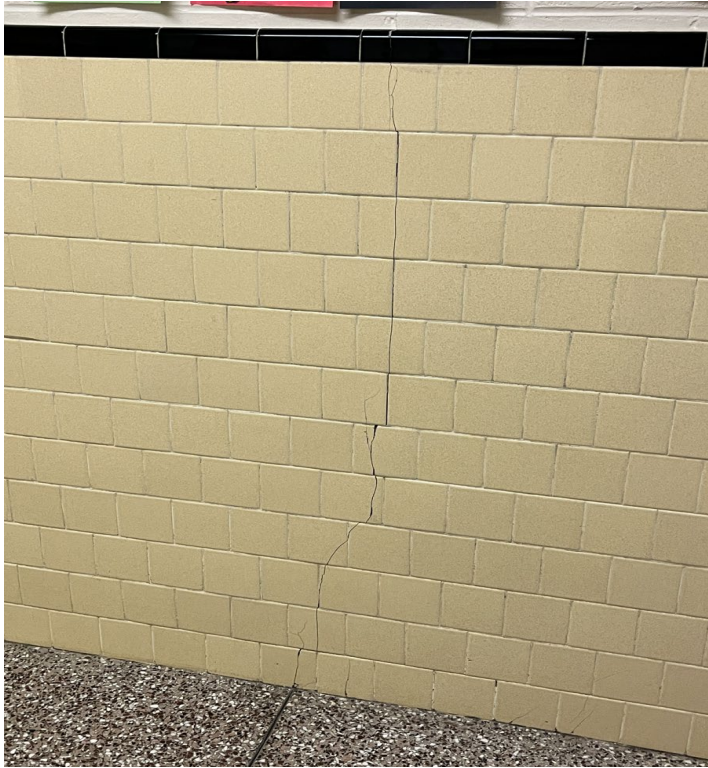
PHOTO AI.10
TILE WAINSCOT CRACKING
(INSTALL CONTROL JOINT)

Condition: Fair
Quantity: Approx. 20 LF

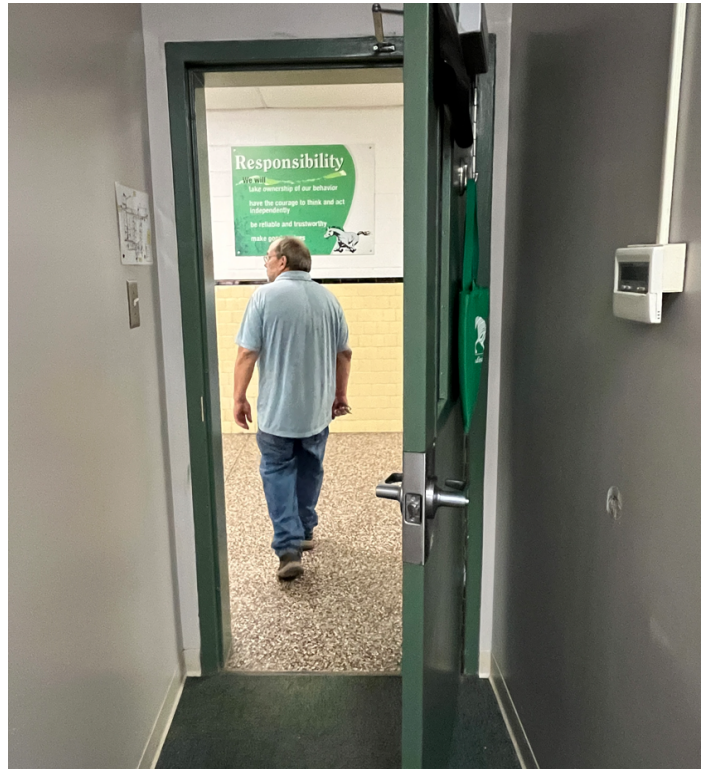
**PHOTO AA.02
MANUEVERING CLEARANCES -
CLASSROOMS AND WORKROOMS
(ADAAG 404.2.4.1)**

*Condition: Fair
Quantity: Approx. (6) Locations*

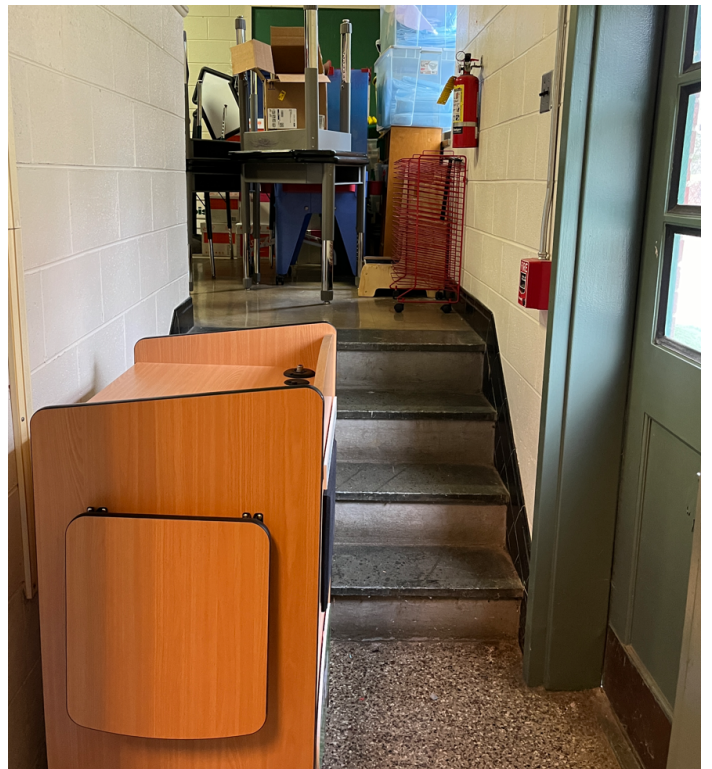
**PHOTO AA.03
STAGE STAIRS - ACCESSIBLE EGRESS,
HANDRAILS EXTENSIONS
(ADAAG 402, 505.10.2, 505.10.3)**

*Condition: Fair
Quantity: (1) Location*

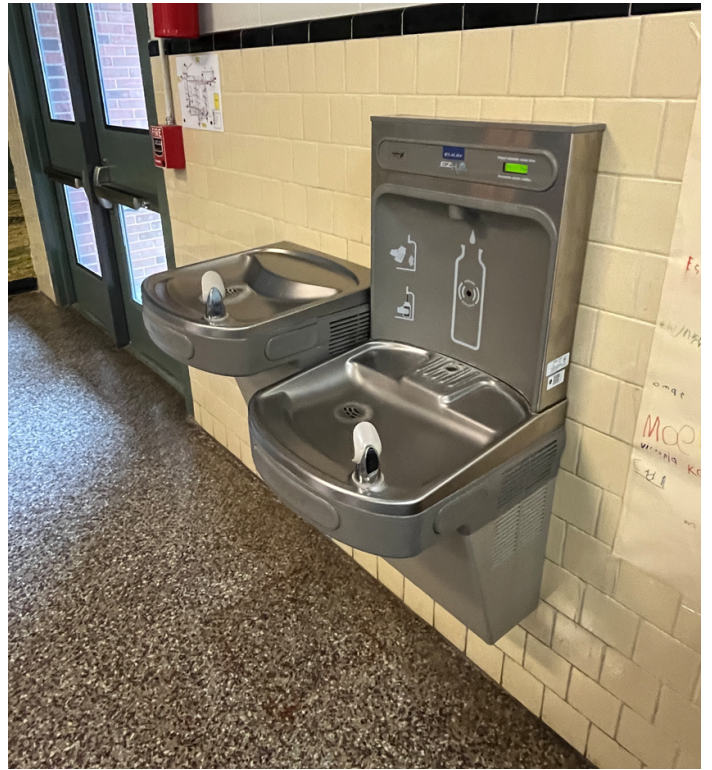
**PHOTO AA.04
DRINKING FOUNTAINS - PROTRUSION LIMITS
(ADAAG 307.2)**

*Condition: Fair
Quantity: (6) Locations*

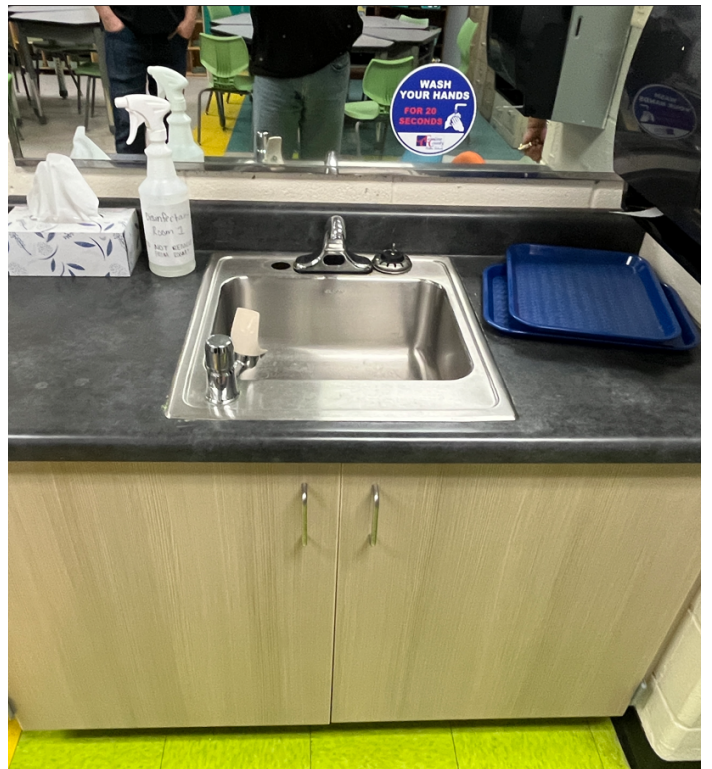
**PHOTO AA.05
CLASSROOM CASEWORK SINKS-
CLEAR FLOOR SPACE (ADAAG 606.2)**

*Condition: Fair / Good
Quantity: (5) Locations*

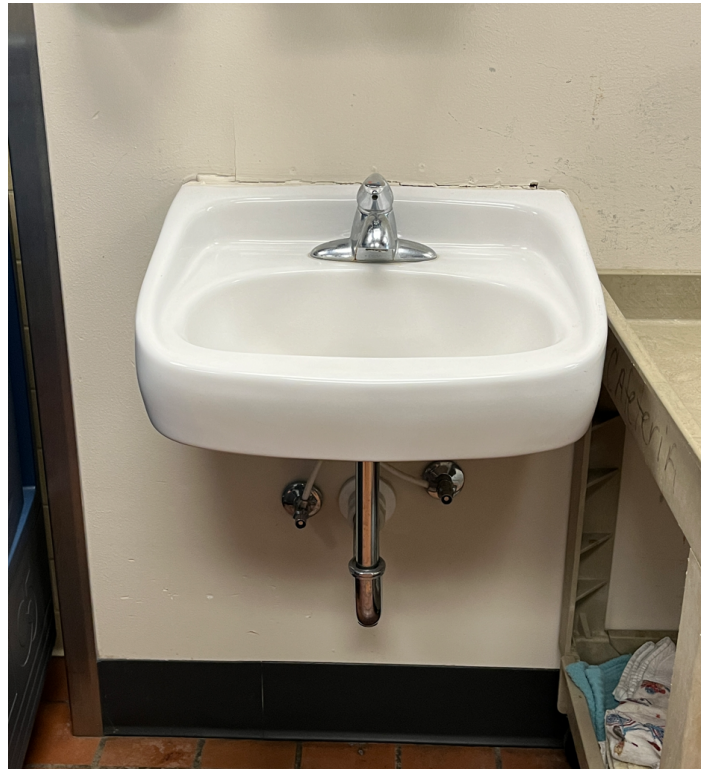
PHOTO AA.06
LAVATORIES & SINKS - EXPOSED PIPES
(ADAAG 606.5)

Condition: Poor / Fair
Quantity: Approx. (8) Sinks

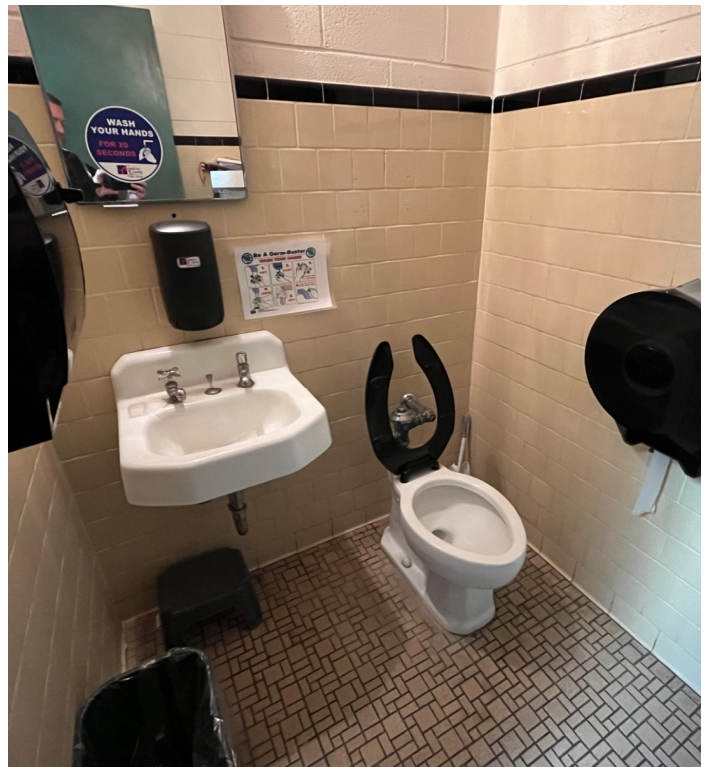
PHOTO AA.07
TOILET ROOM(S) - FIXTURE CLEARANCES,
GRAB BAR SPACE & EXPOSED PIPES
(ADAAG 604.3.1, 604.5, 606.5 & 609.3)

Condition: Fair / Good
Quantity: Approx. 700 SF (Individual); Approx.
497 SF (Group)

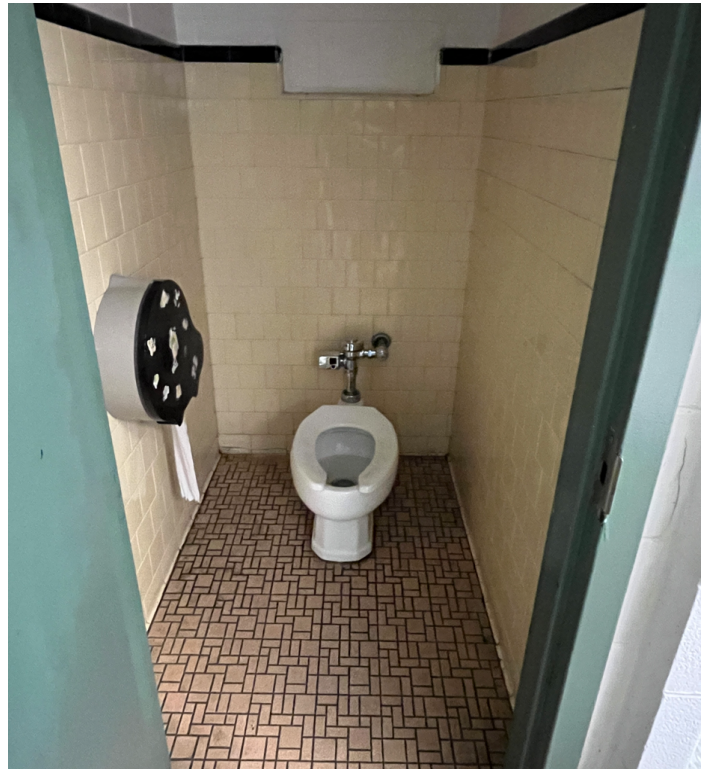
PHOTO AA.08
TOILET ROOM(S) - DOOR CLEAR WIDTH,
GRAB BAR SPACE
(ADAAG 404.2, 604.5, 606.5 & 609.3)

Condition: Fair

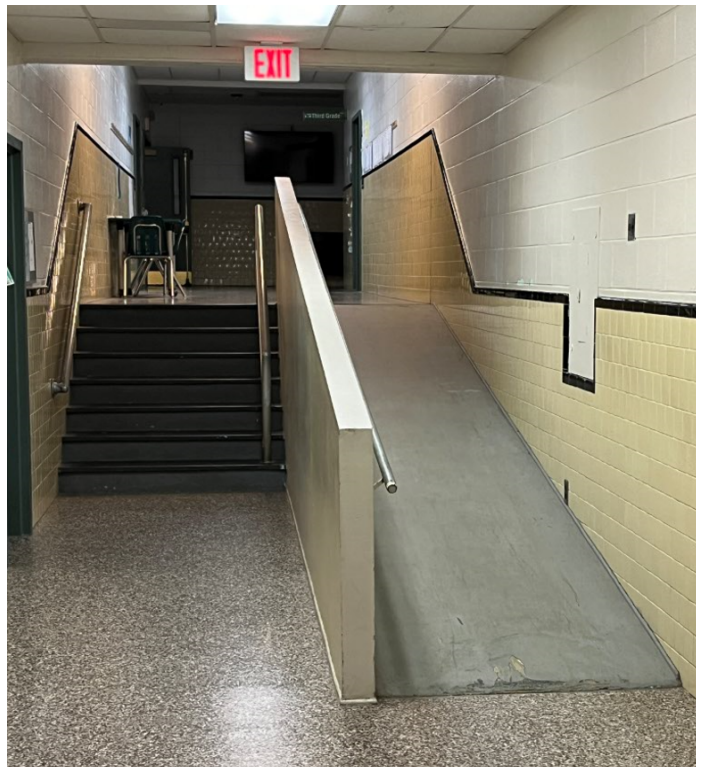
PHOTO AA.09
STAIRS AND RAMPS - HANDRAILS
EXTENSIONS
(ADAAG 505.10)

Condition: Fair

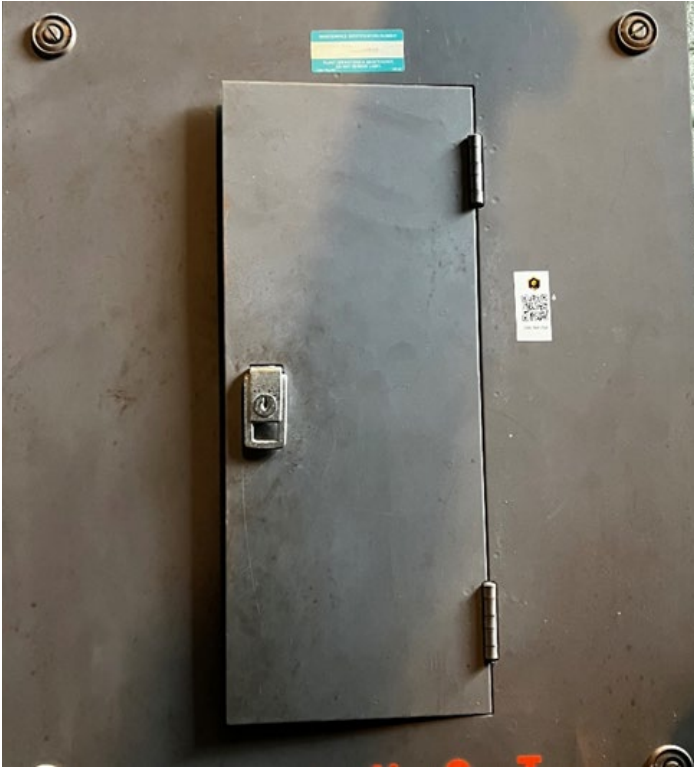
The remaining electrical equipment in the facility falls into three categories: original to the building, replaced, or added during renovations. The original equipment is in poor condition, and finding replacement parts will be challenging. There is also a lack of consistency in terms of brand, age, and condition, with equipment dating back to the 60s, early 90s, and the 2016 renovation. Additionally, some areas have unique one-off pieces of equipment. It is recommended to replace both the original equipment and the 90s installations, along with all associated wiring.

PHOTO E.02A
EXISTING 480V PANELS

Condition: Poor
Quantity: Approx. 44,073 SF

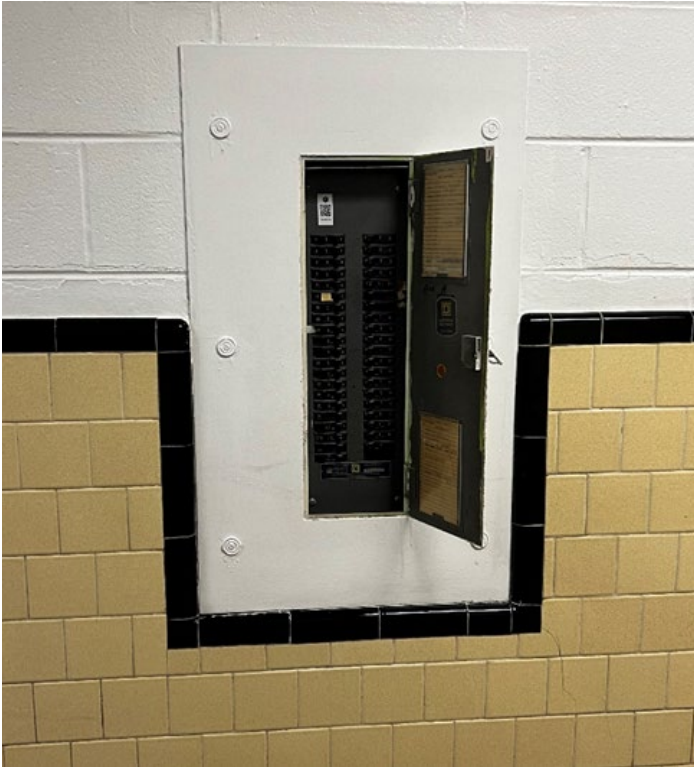
PHOTO E.02B
EXISTING 480V PANELS

Condition: Poor
Quantity: Approx. 44,073 SF

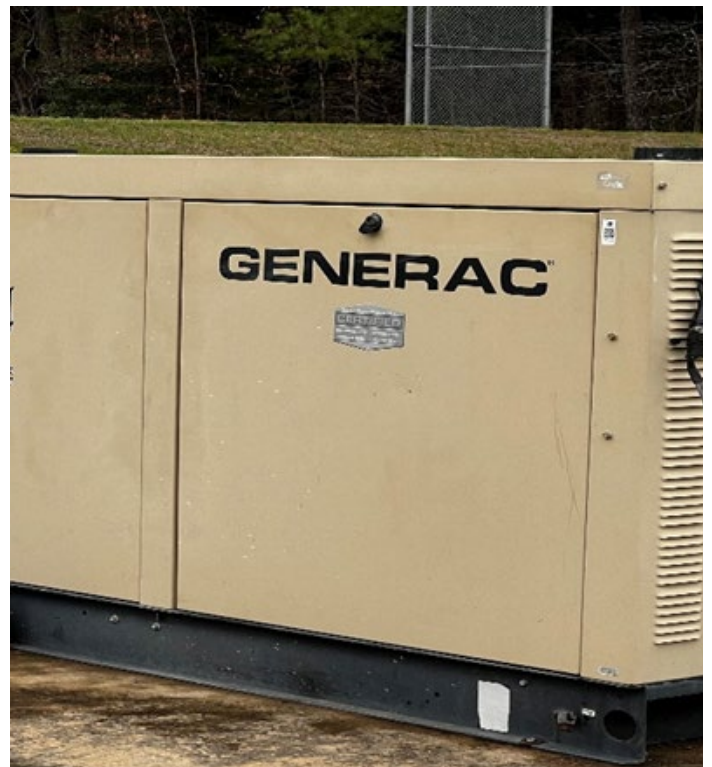
The facility currently has a standby emergency generator. The generator was installed within the last 30 years and seems to be getting close to the expiration of its anticipated service life of 25 years. There is only one transfer switch, and that is the “Life Safety” switch feeding emergency loads such as Emergency lighting. It does not appear that this generator is feeding any other loads, however the panel schedule was incorrect/incomplete and if there are standby loads that are Fed from the same transfer switch, these loads should be separated, and another transfer switch should be added to comply with code.

**PHOTO E.03
GENERATOR**

*Condition: Poor
Quantity: (1)*

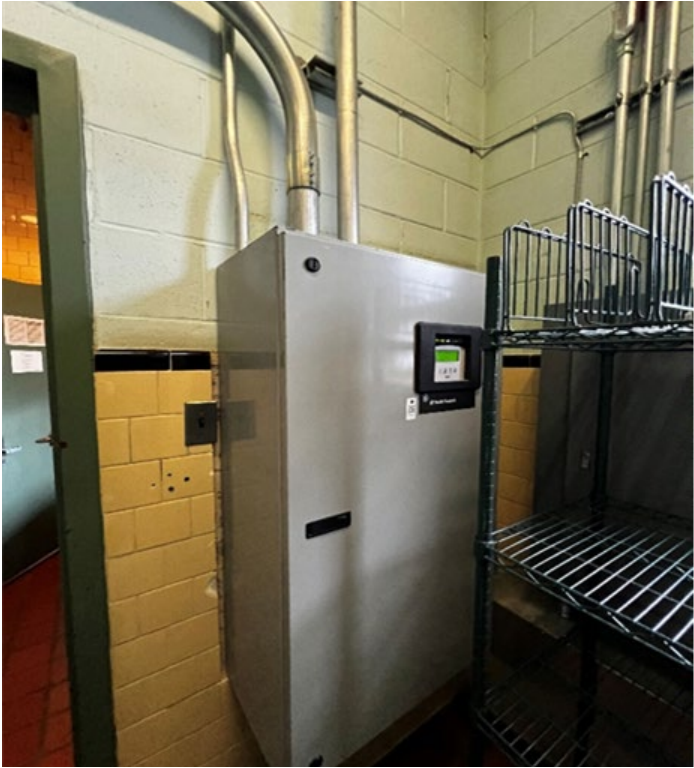
**PHOTO E.04
GENERATOR ATS**

*Condition: Poor
Quantity: (1)*

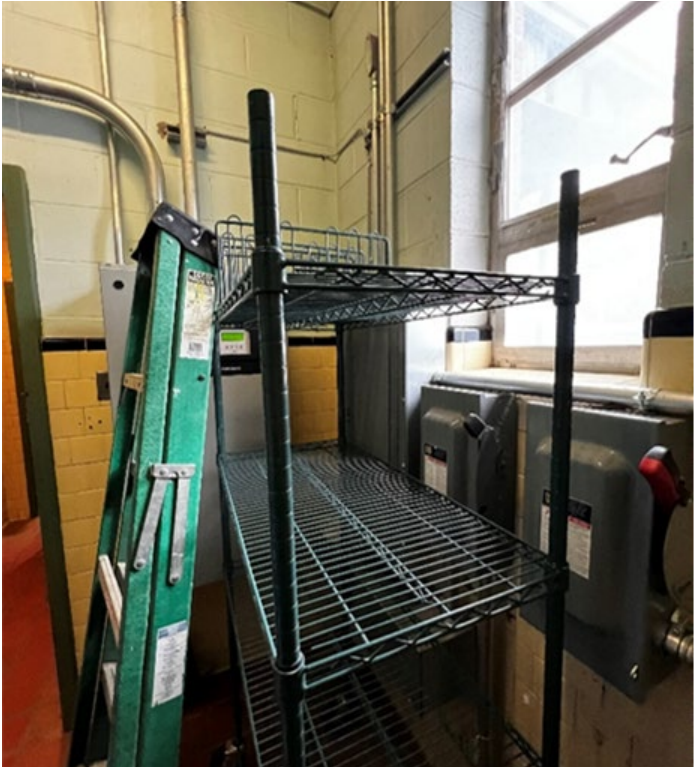
**PHOTO E.05
EQUIPMENT CLEARANCE**

*Condition: Poor
Quantity: See Code Compliance*

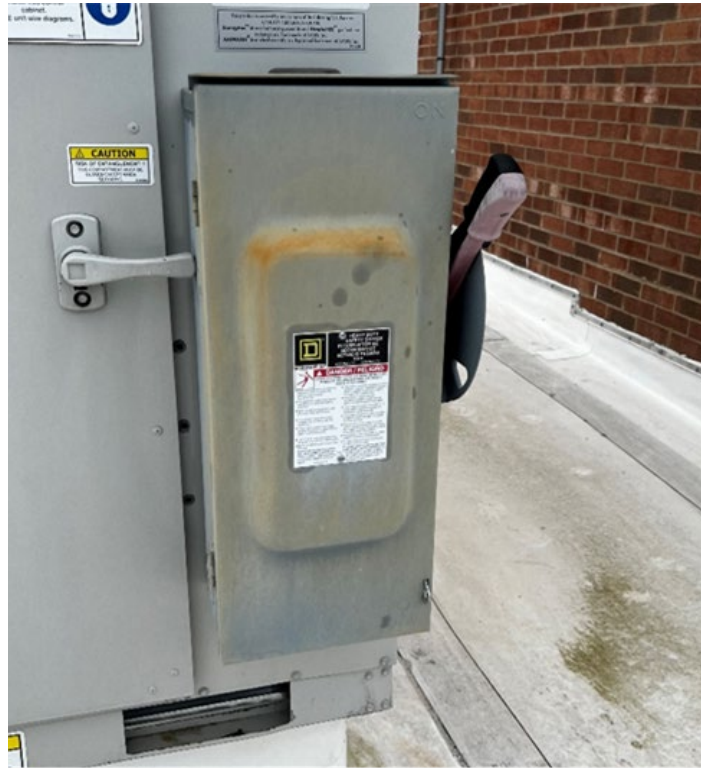
Local means of disconnects appear to be original to installation of equipment. Most of the mechanical equipment has been replaced, along with the associated disconnect. However there are several disconnects and pieces of equipment that should be replaced as they are way past their life expectancy.

**PHOTO E.10
DISCONNECT**

*Condition: Poor
Quantity: (2) Outlets*

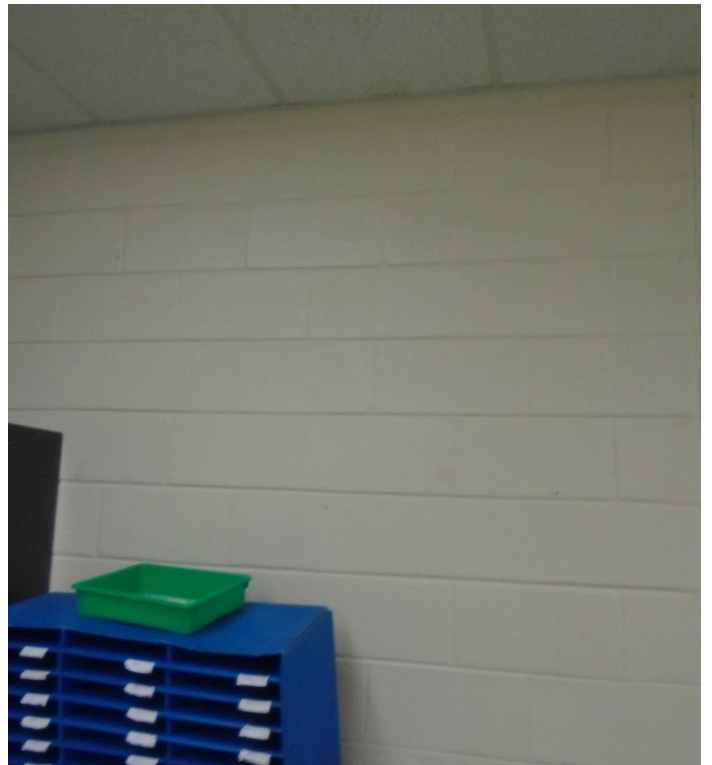
PHOTO S.02
CRACKS IN CMU DUE TO HORIZONTAL EXPANSION

Condition: Fair
Quantity: 48 LF

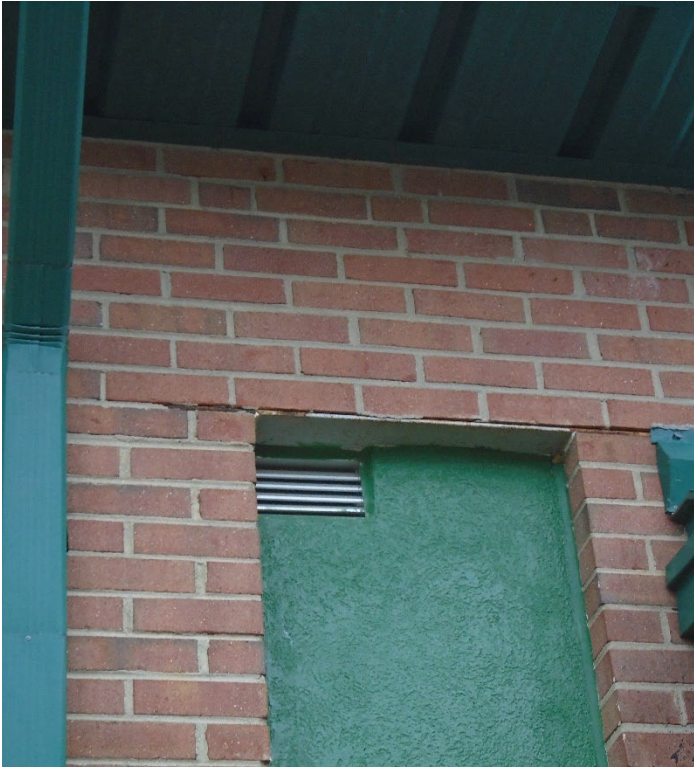
PHOTO S.03
MASONRY STEEL LINTEL CORROSION

Condition: Fair
Quantity: See Architectural - Exterior

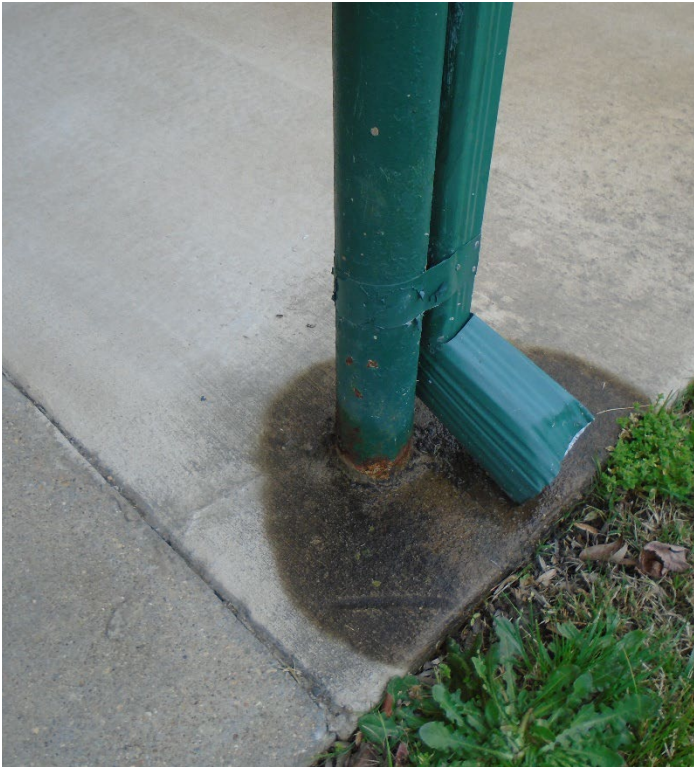
PHOTO S.04
HSS CORROSION (PIPE COLUMN)

Condition: Fair
Quantity: Approx. 108 LF

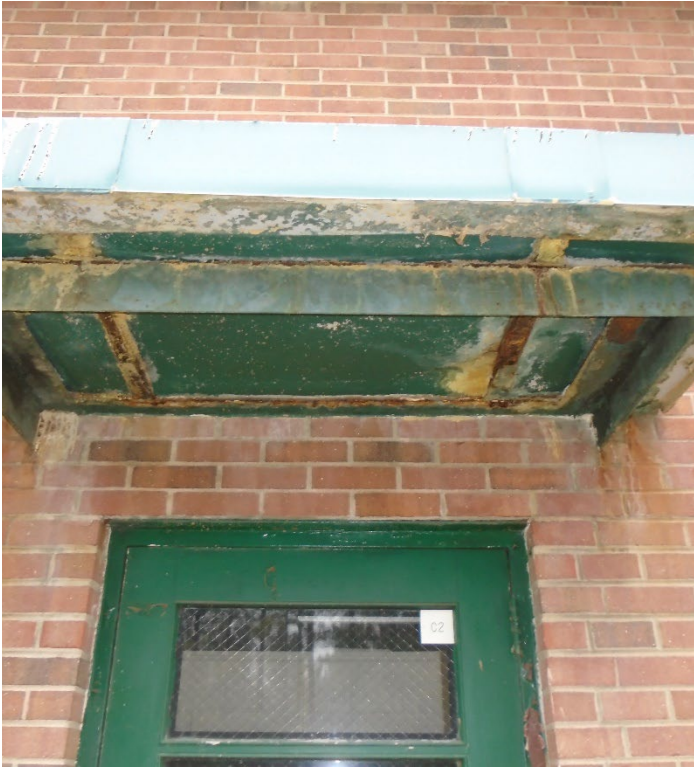
PHOTO S.05
STEEL CORROSION

Condition: Fair
Quantity: 40 LF

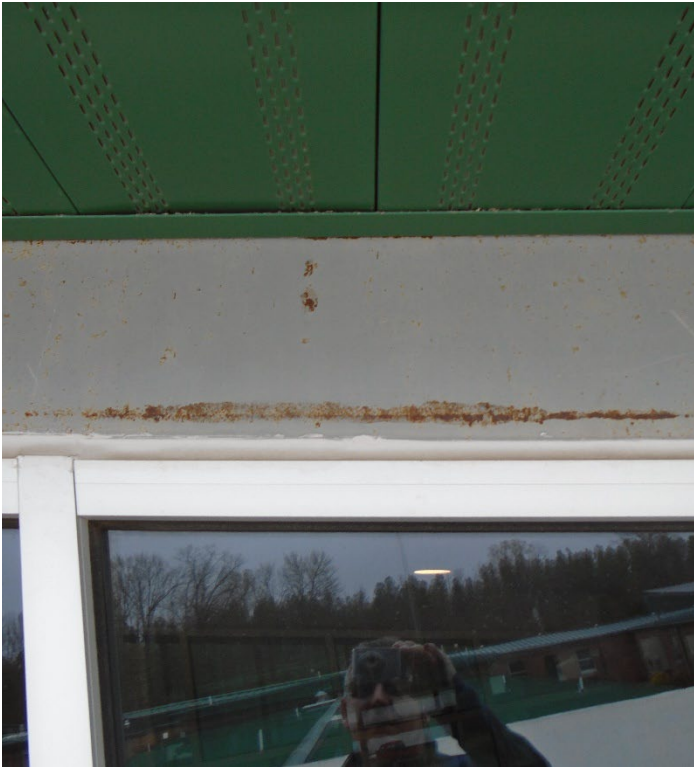
PHOTO S.06
HSS CORROSION

Condition: Fair
Quantity: Approx. 100 LF

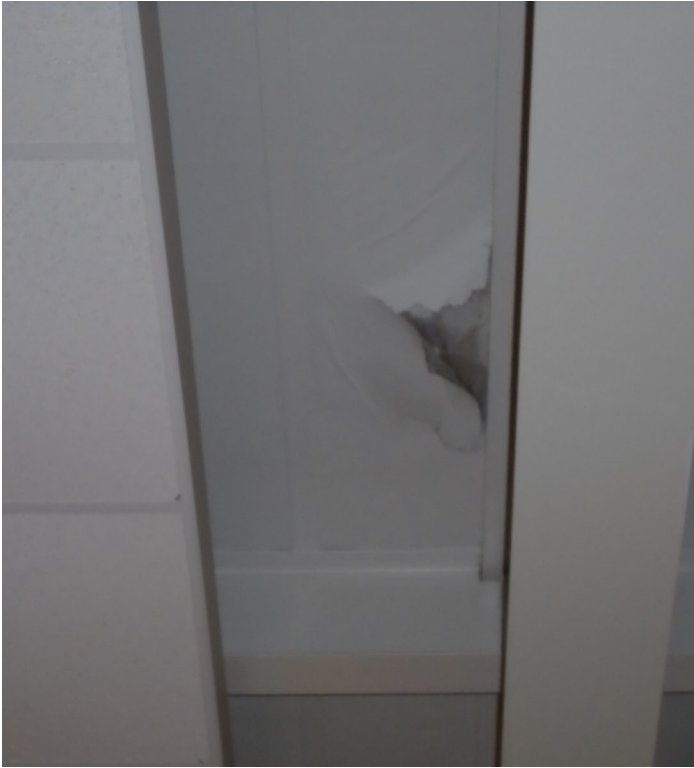
PHOTO S.07
GYPSUM DECK DAMAGE

Condition: Fair
Quantity: 6 SF

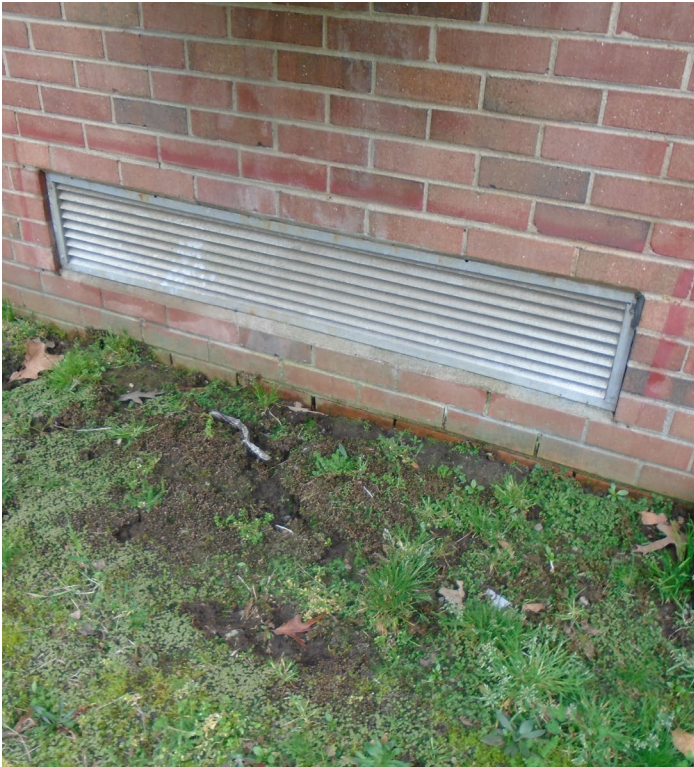
PHOTO S.08
MASONRY VENEER WEEPS COVERED

Condition: Fair
Quantity: Approx. 64 LF
