OLD LADYSMITH ELEMENTARY SCHOOL (LOTUS ACADEMY)

7278 Ladysmith Road, Ruther Glen, Virginia 22546

Facility Condition Assessment

April 2, 2024

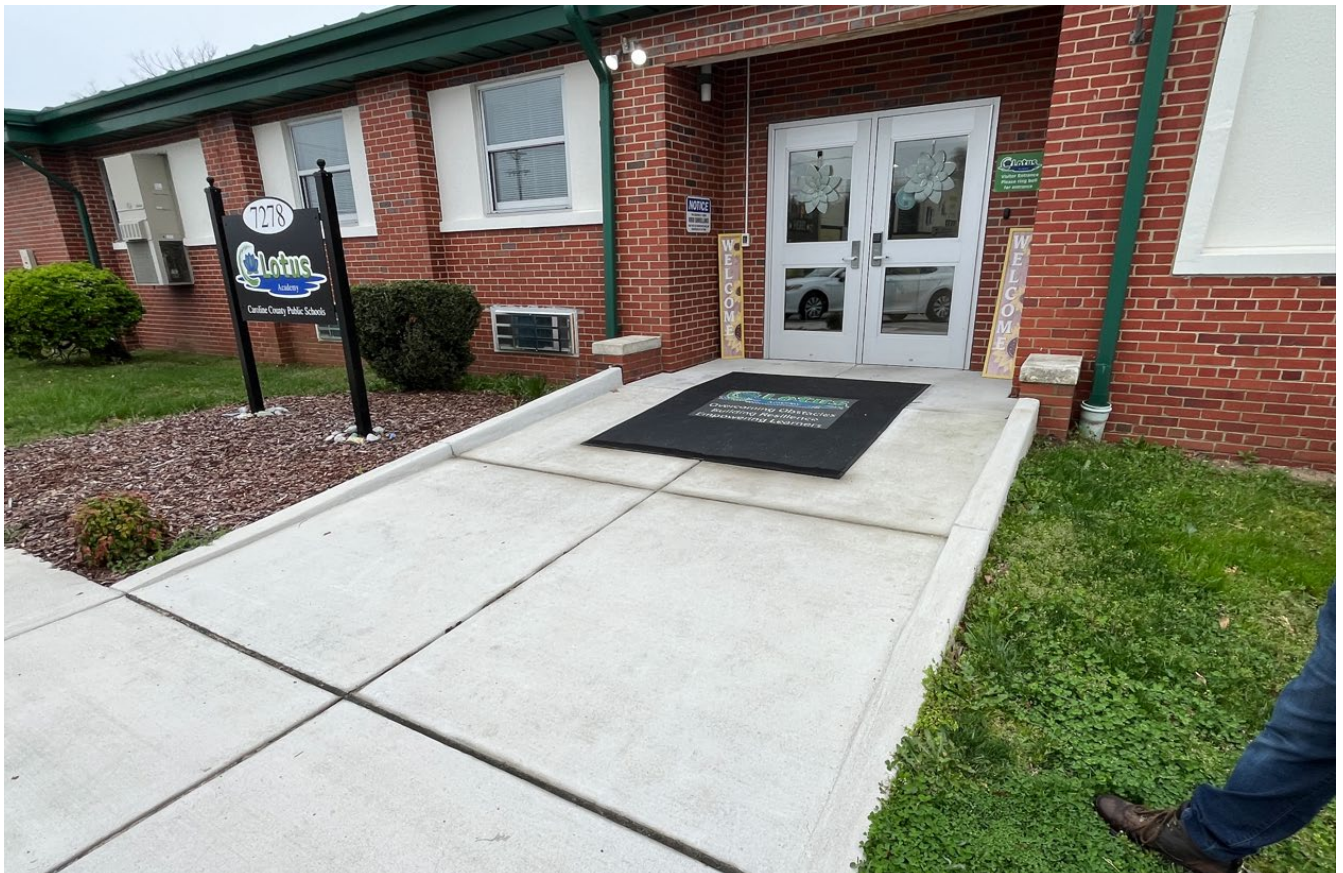
PHOTO AE.01
BRICK DELAMINATION

Condition: Fair / Good
Quantity: Approx. 80 SF

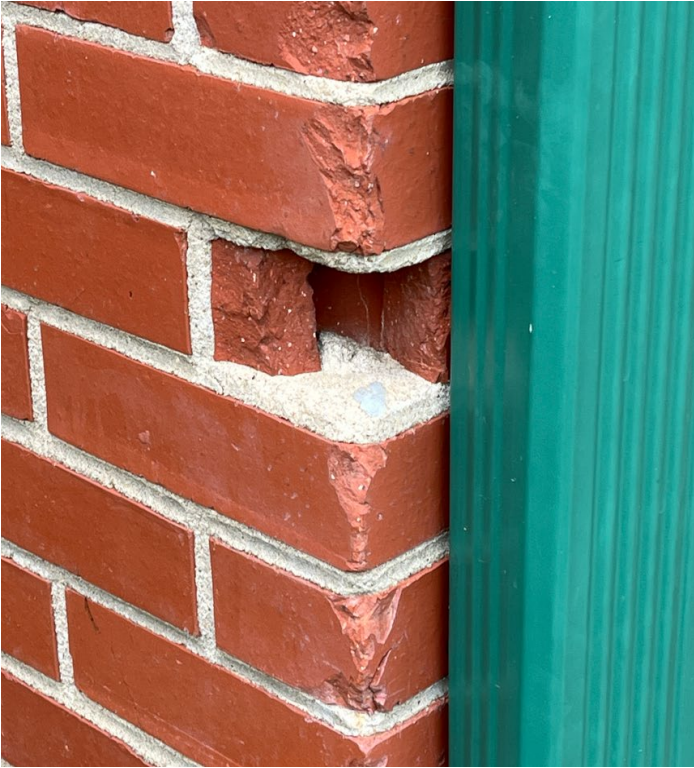
PHOTO AE.02
MASONRY CRACKS

Condition: Fair / Good
Quantity: Approx. 125 SF

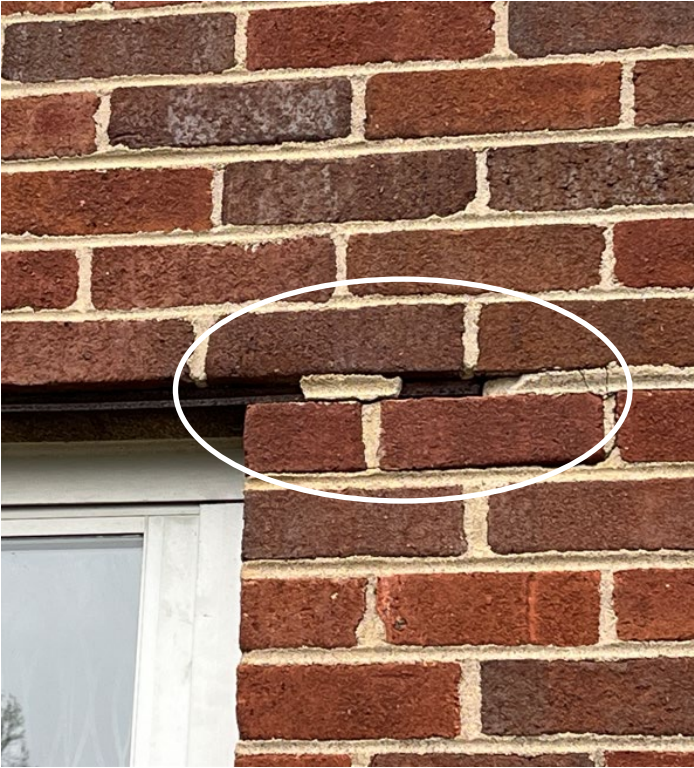
PHOTO AE.03B
MORTAR DETERIORATION

Condition: Poor / Fair
Quantity: Approx. 2,250 LF

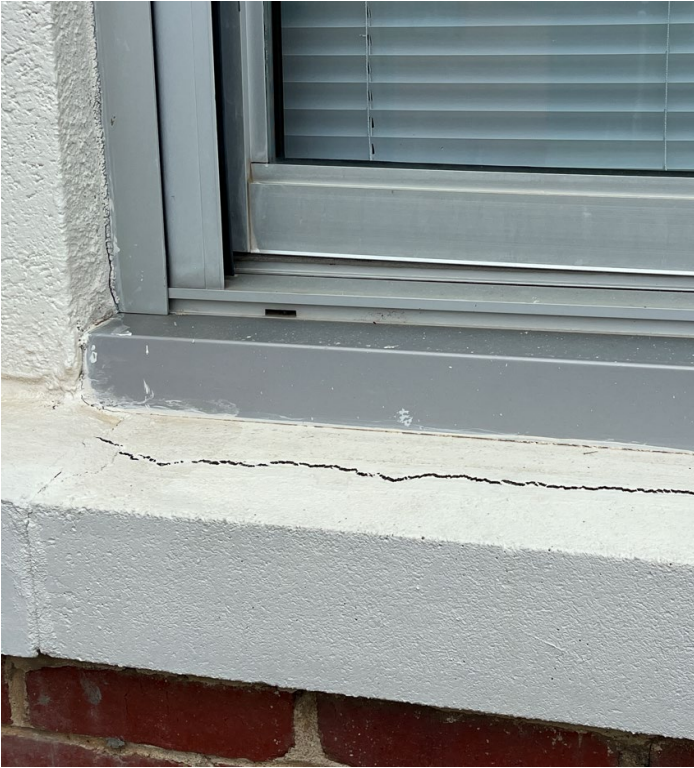
PHOTO AE.04B
PRECAST WINDOW SURROUNDS (CRACKED)

Condition: Poor / Fair
Quantity: Approx. 32 LF

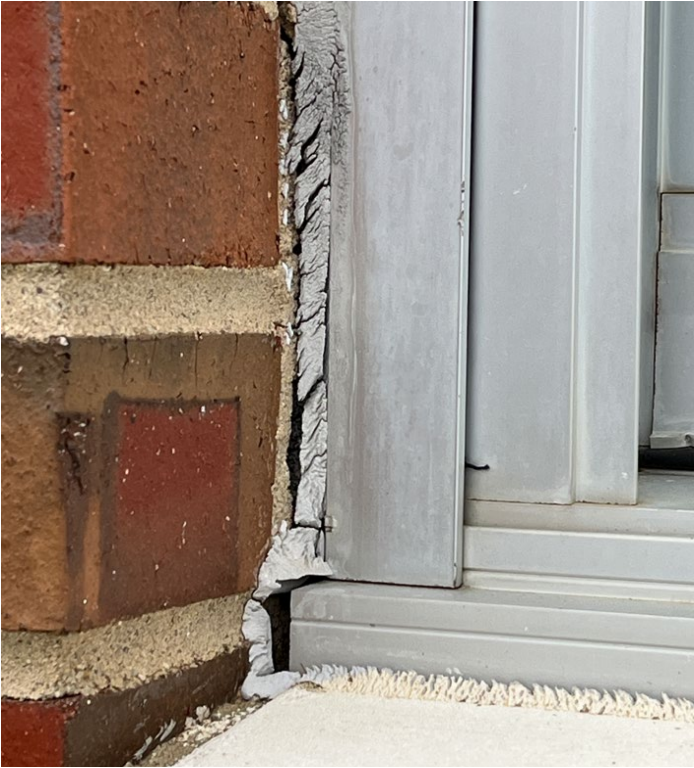
**PHOTO AE.05B
EXTERIOR CAULKING FAILURE (WINDOWS)**

*Condition: Poor
Quantity: Approx. 1,272 LF*

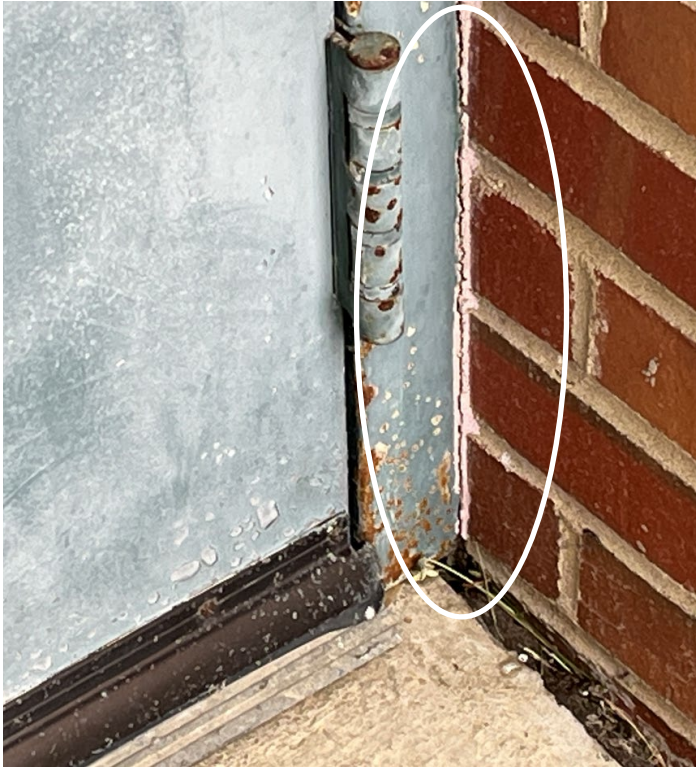
PHOTO AE.07
EXTERIOR CAULKING FAILURE (SILLS)

Condition: Poor
Quantity: Approx. 420 LF

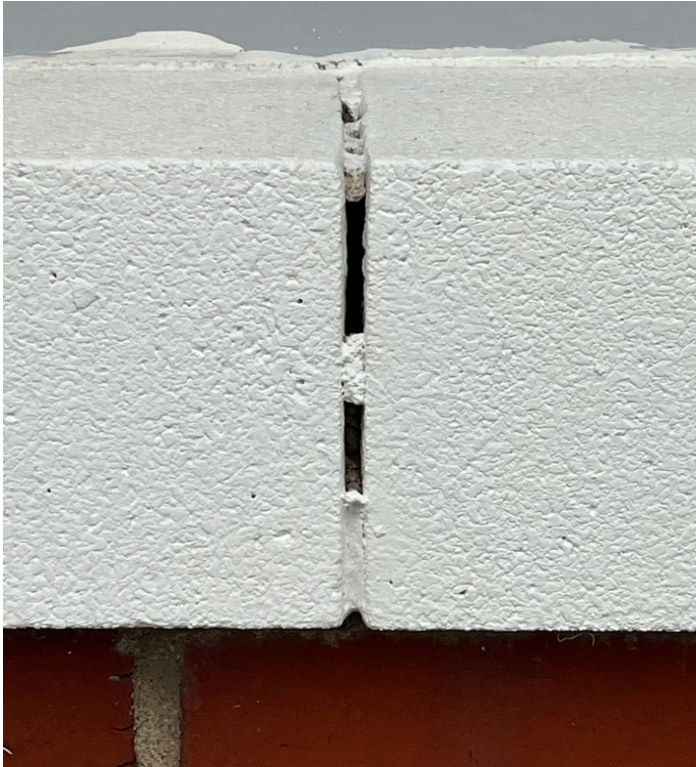
**PHOTO AE.08A
EXTERIOR CAULKING FAILURE
(CONTROL JOINTS)**

*Condition: Poor
Quantity: Approx. 140 LF*

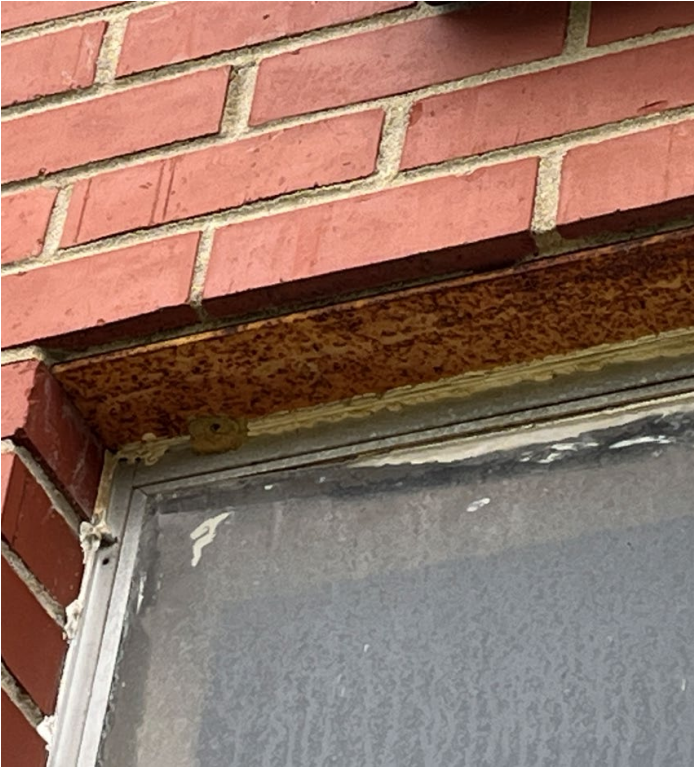
PHOTO AE.09B
EXPOSED/RUSTED STEEL LINTELS

Condition: Poor
Quantity: Approx. 442 LF

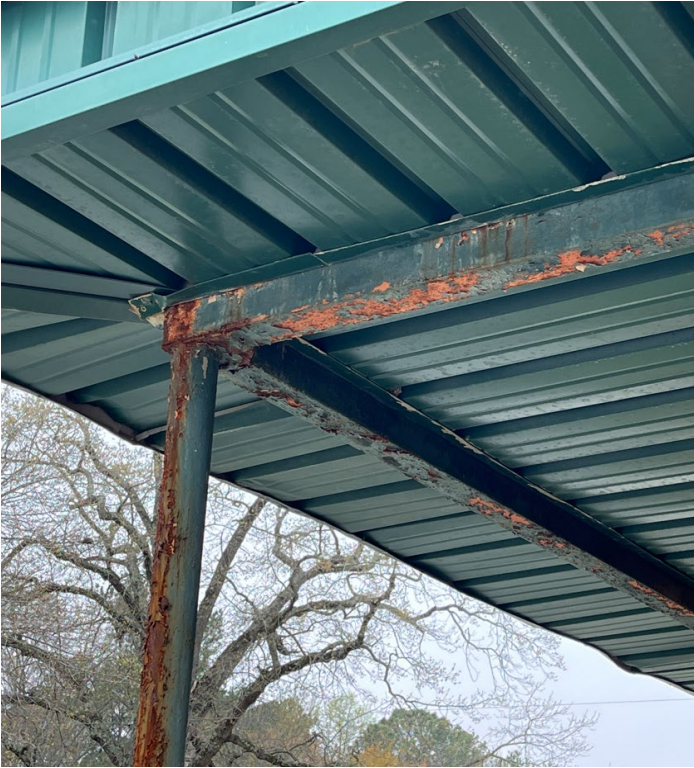
**PHOTO AE.10B
EXTERIOR CANOPY DETERIORATION
(SPALLING CONCRETE & EXPOSED REBAR)**

*Condition: Poor
Quantity: Approx. (7) Canopies*

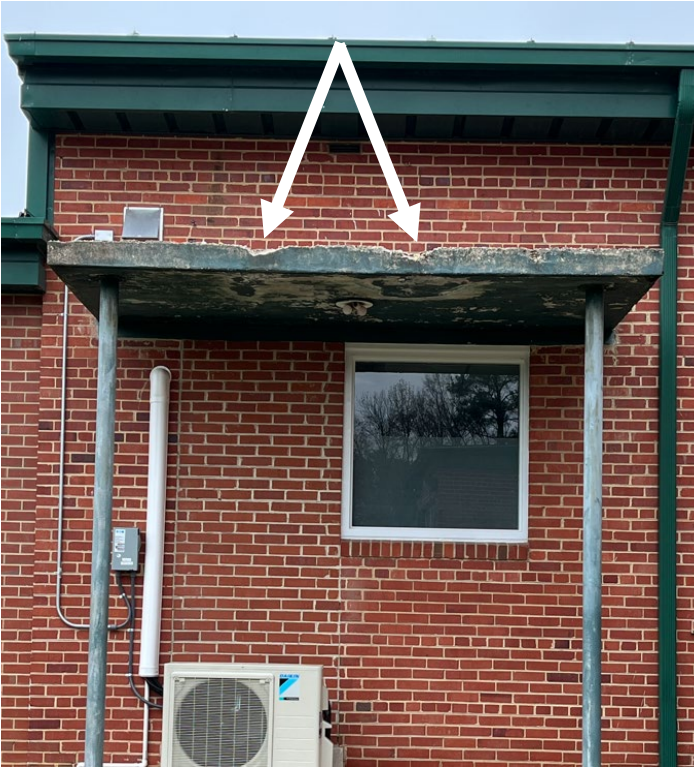
**PHOTO AE.10D
EXTERIOR CANOPY DETERIORATION**

*Condition: Poor
Quantity: Approx. (7) Canopies*

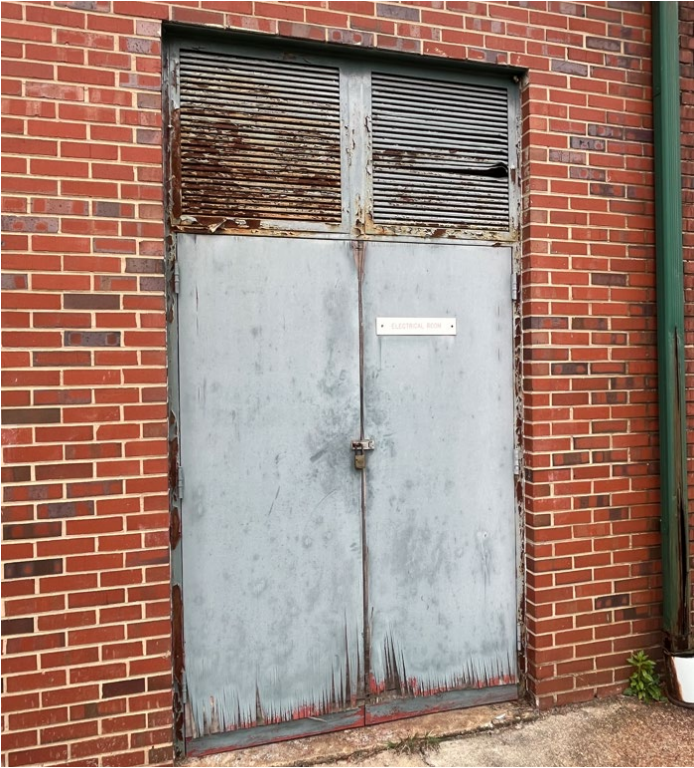
**PHOTO AE.11B
EXTERIOR DOORS & FRAMES
(DETERIORATED)**

*Condition: Poor
Quantity: Approx. (26) Doors & Frames*

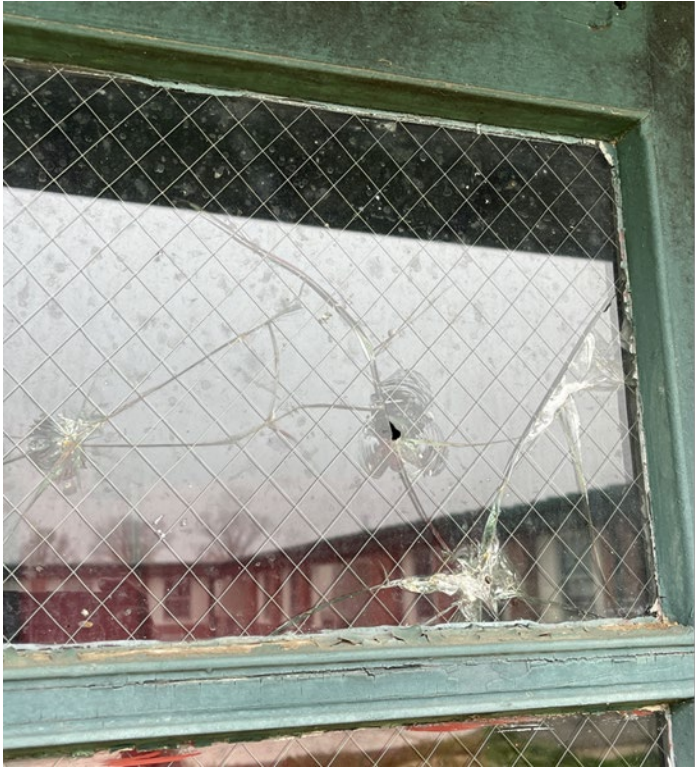
**PHOTO AE.11D
EXTERIOR DOORS & FRAMES
(RUSTED FRAMES)**

*Condition: Poor
Quantity: Approx. (26) Doors & Frames*

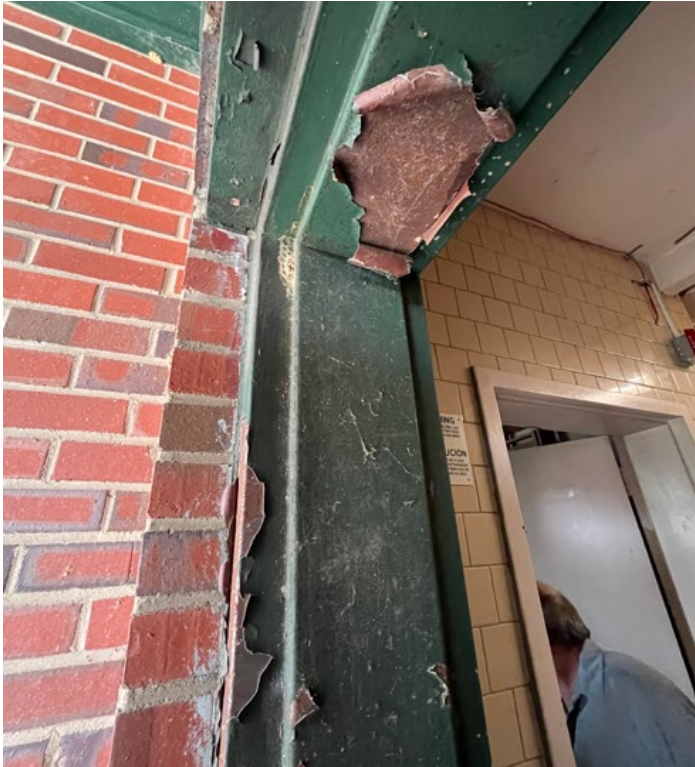
**PHOTO AE.12A
EXTERIOR WINDOWS & FRAMES
(RUSTED FRAMES)**

*Condition: Poor
Quantity: Approx. 2,070 SF*

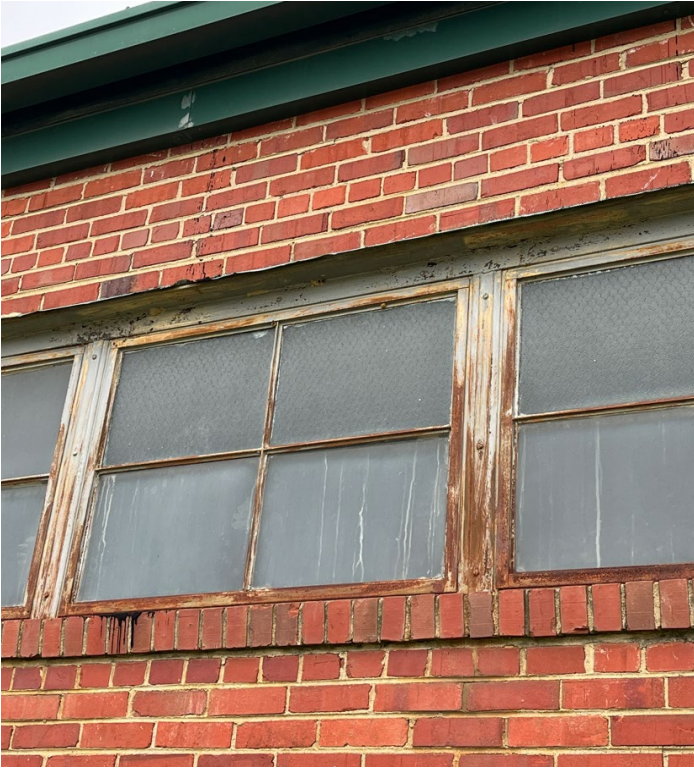
**PHOTO AE.12B
EXTERIOR WINDOWS & FRAMES
(BROKEN WINDOW GLASS)**

*Condition: Poor
Quantity: Approx. 2,070 SF*

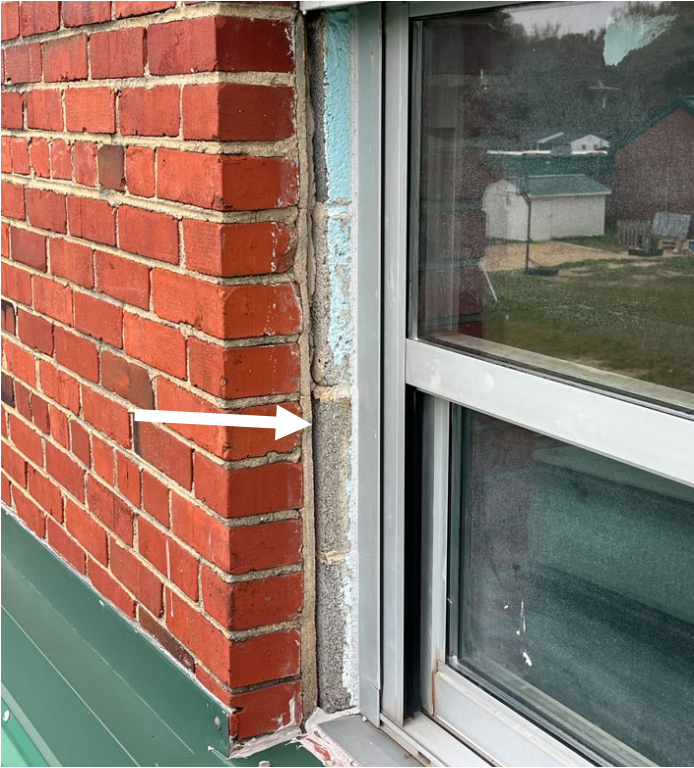
**PHOTO AE.12D
EXTERIOR WINDOWS & FRAMES
(MISSING MULLION / TRIM)**

*Condition: Poor
Quantity: Approx. 2,070 SF*

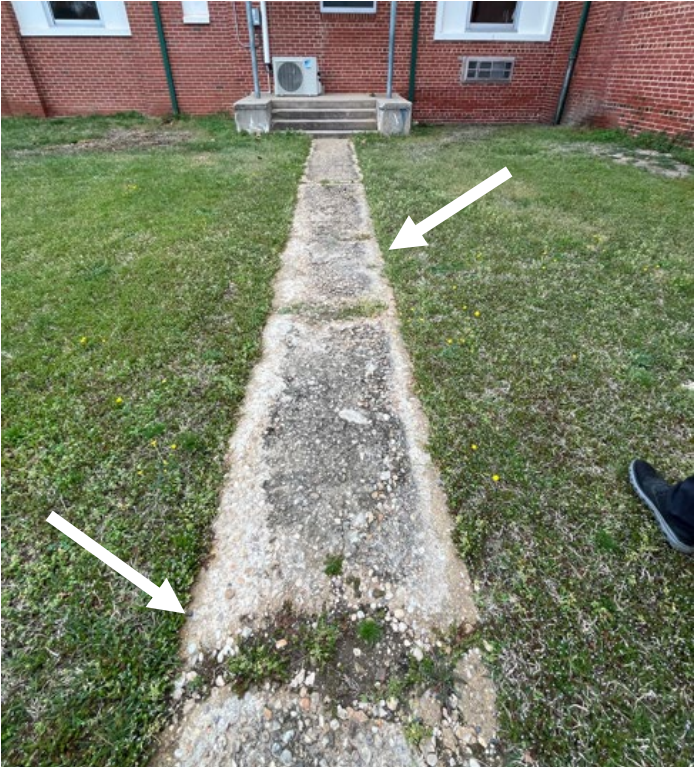
PHOTO AE.13B
CONCRETE SIDEWALK / STAIR REPAIRS

Condition: Poor / Fair
Quantity: Approx. 4,085 SF

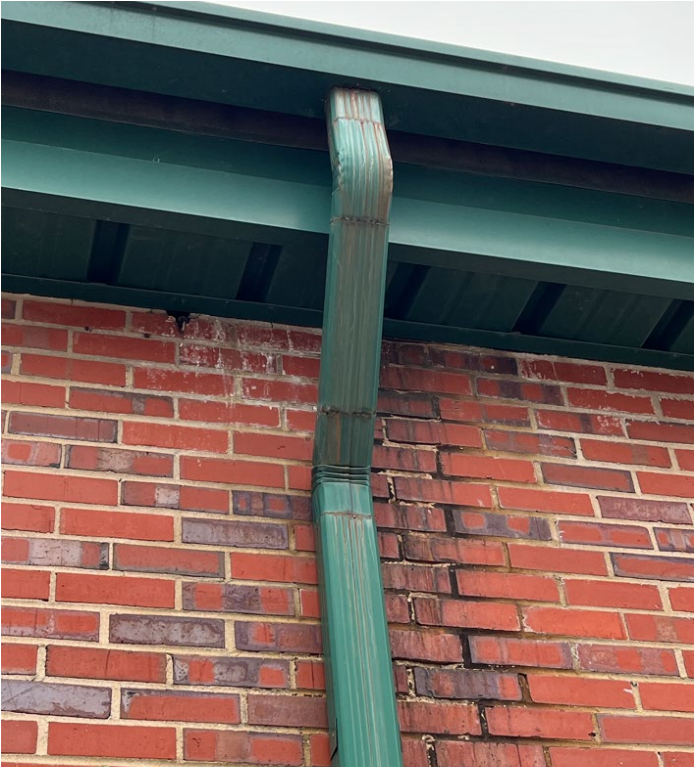
PHOTO AE.14B
DOWNSPOUTS (RUSTED & LEAKING)

Condition: Poor
Quantity: See Roof Section

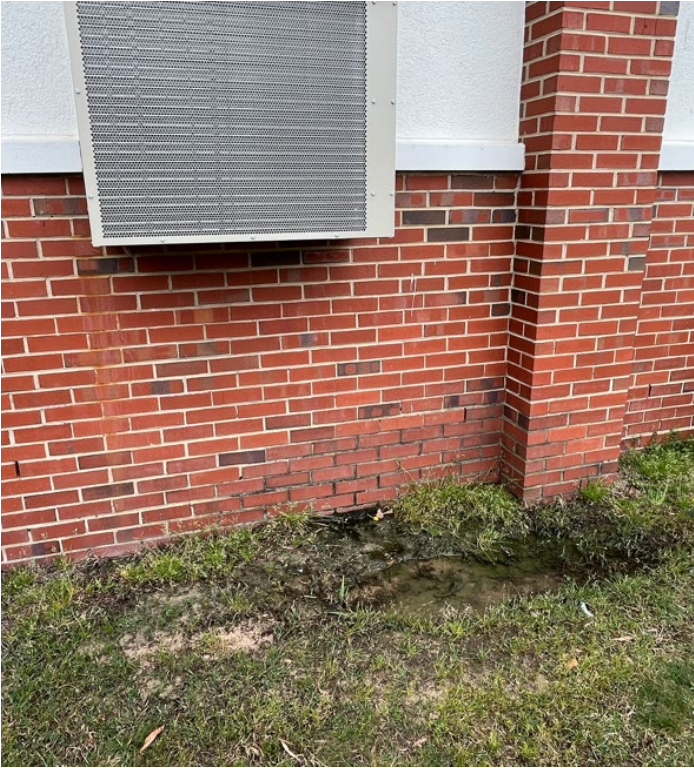
PHOTO AE.18
SEAL EXPOSED BUILDING ENVELOPE

Condition: Fair
Quantity: (1) Location

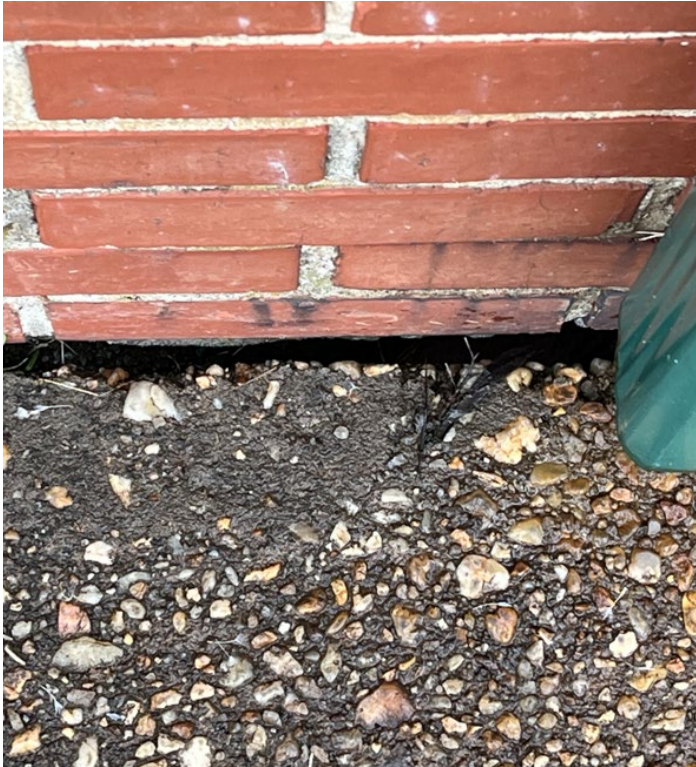
PHOTO AE.21A
EXTERIOR BUILDING CLEANING

Condition: Poor / Fair
Quantity: Approx. 43,763 SF

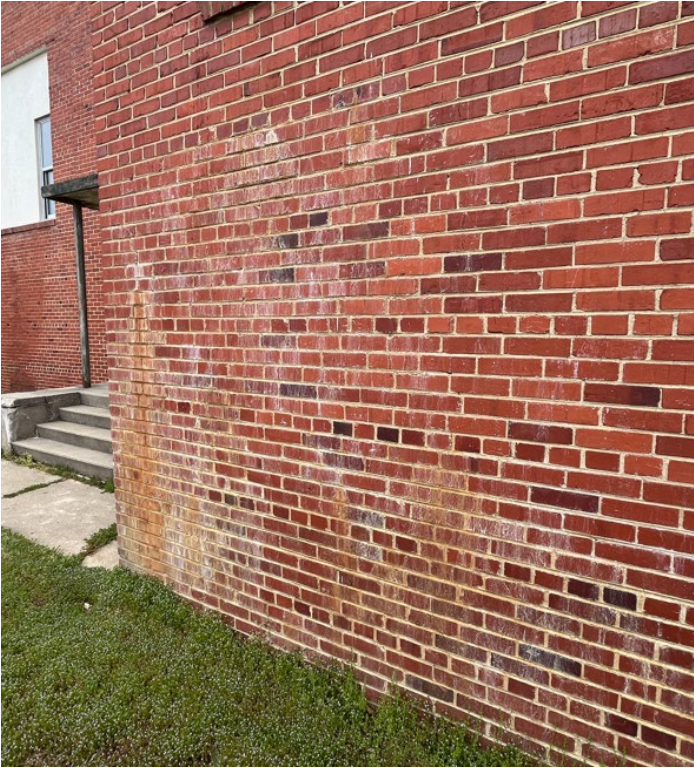
PHOTO AE.21B
EXTERIOR BUILDING CLEANING

Condition: Poor / Fair
Quantity: Approx. 43,763 SF

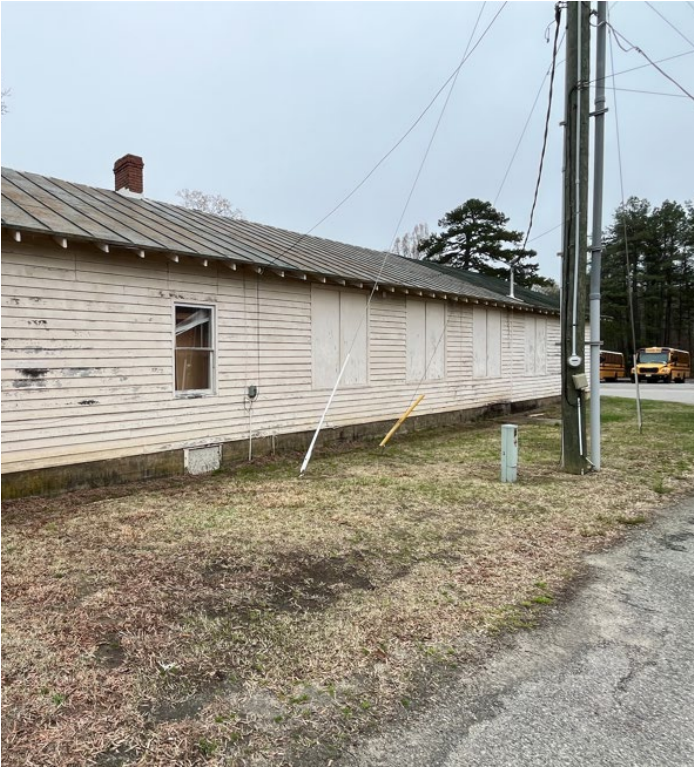
PHOTO AE.22B
STAND-ALONE STORAGE BUILDING

Condition: Poor / Fair
Quantity: Approx. 4,000 SF

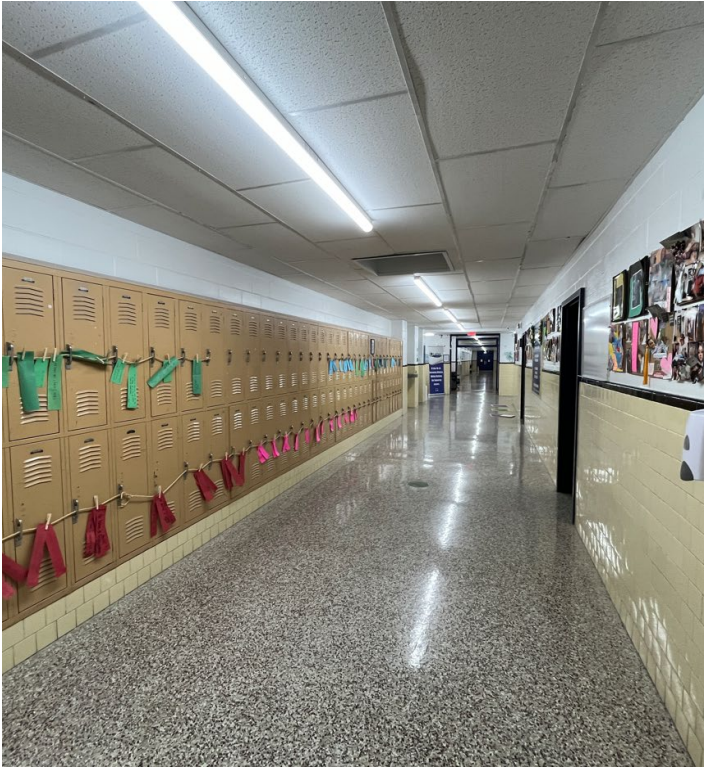
**PHOTO AI.02B
TYPICAL CORRIDOR FLOORING
(CRACKING TERRAZZO)**

*Condition: Fair
Quantity: Approx. 2,509 SF*

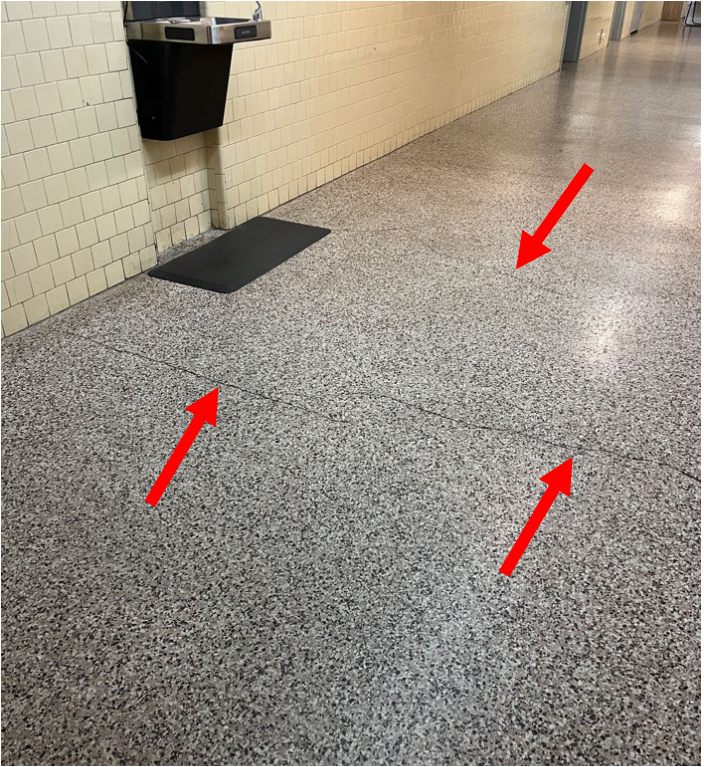
**PHOTO AI.03
TYPICAL CORRIDOR FLOORING (VCT)**

*Condition: Fair
Quantity: Approx. 3,671 SF*

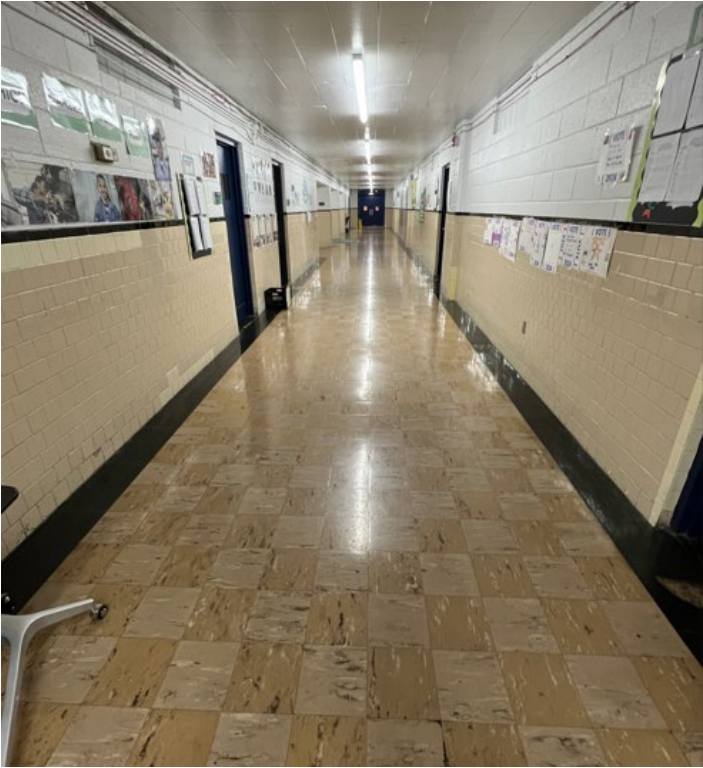
**PHOTO AI.04A
TYPICAL CLASSROOM FLOORING (VCT)
(TILE CORNERS CUPPING)**

*Condition: Poor / Fair
Quantity: Approx. 34,005 SF*

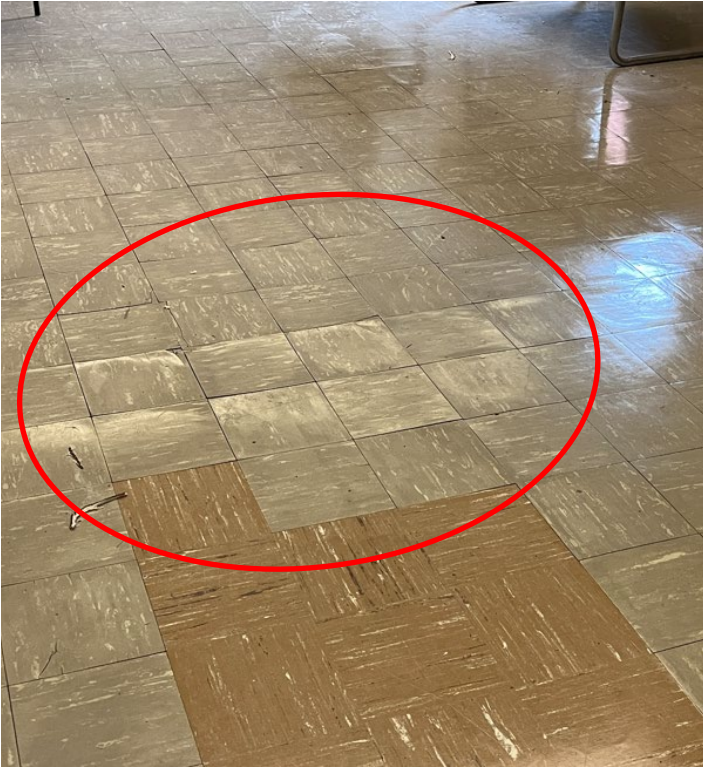
PHOTO AI.04B
TYPICAL CLASSROOM FLOORING (VCT)
(TILE CORNERS CUPPING)

Condition: Poor / Fair
Quantity: Approx. 34,005 SF

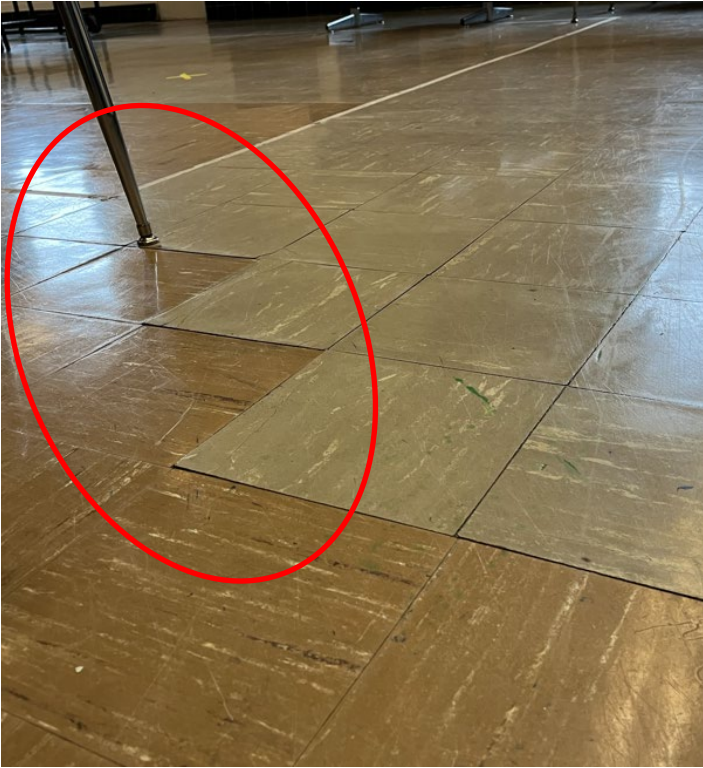
PHOTO AI.04C
TYPICAL CLASSROOM FLOORING (VCT)
(DAMAGED TILE)

Condition: Poor / Fair
Quantity: Approx. 34,005 SF

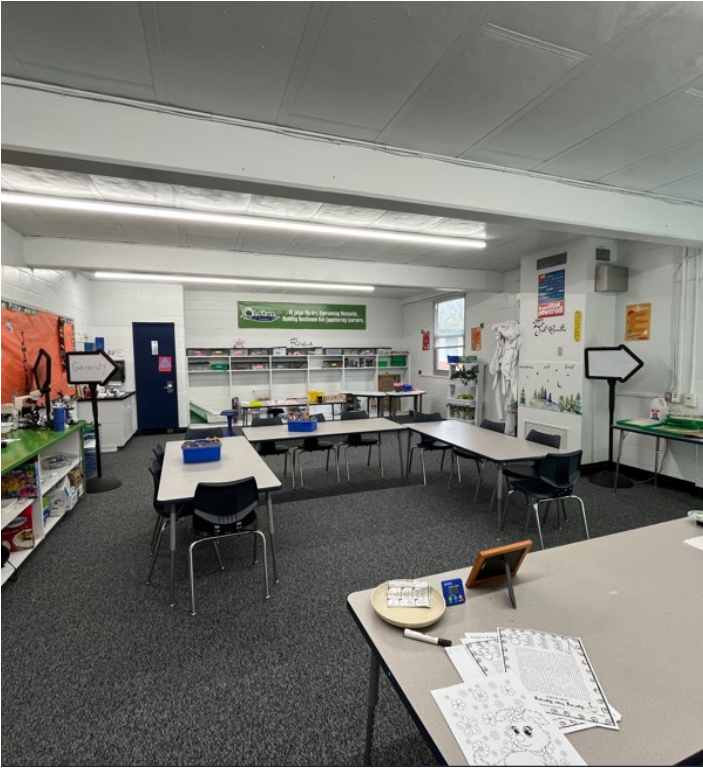
**PHOTO AI.06A
TYPICAL ACOUSTICAL CEILINGS (GYPSUM)
(DAMAGED W/ MOLD GROWTH)**

*Condition: Poor / Fair
Quantity: Approx. 20,494 SF*

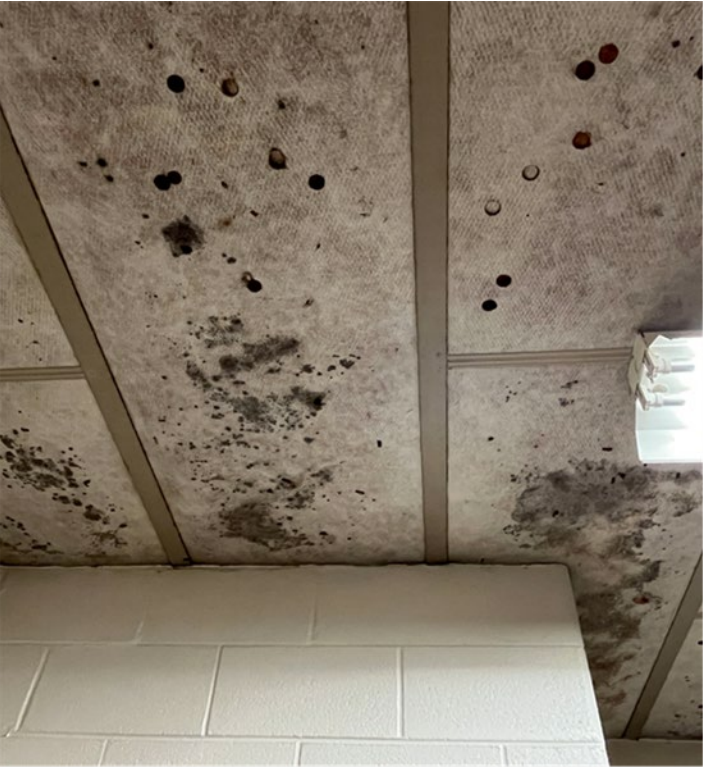
**PHOTO AI.06B
TYPICAL ACOUSTICAL TILE CEILINGS (ACT)
(SAGGING TILES)**

*Condition: Poor / Fair
Quantity: Approx. 23,269 SF*

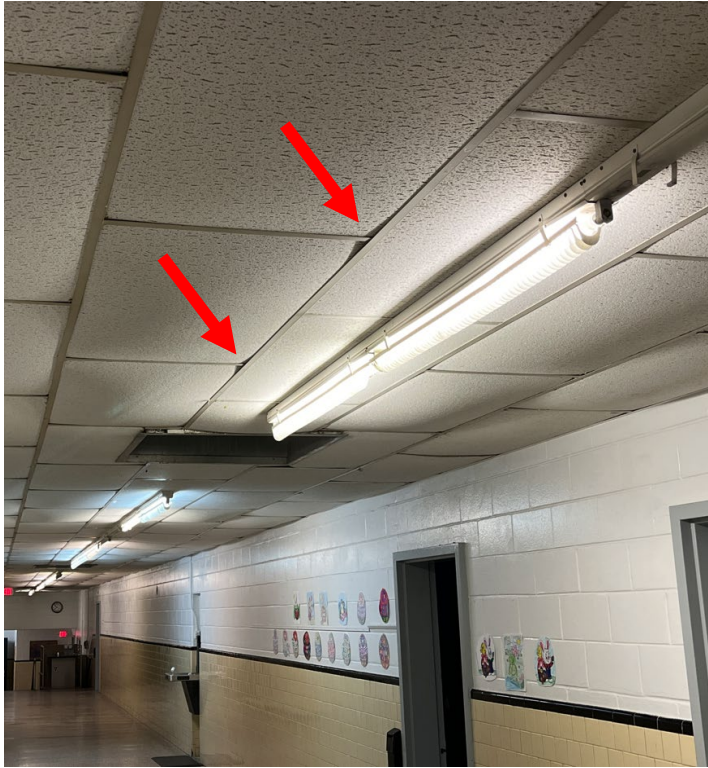
**PHOTO AI.06C
WATER INFILTRATION & MOLD GROWTH
(ACT CEILINGS)**

*Condition: Poor / Fair
Quantity: Approx. 23,269 SF*

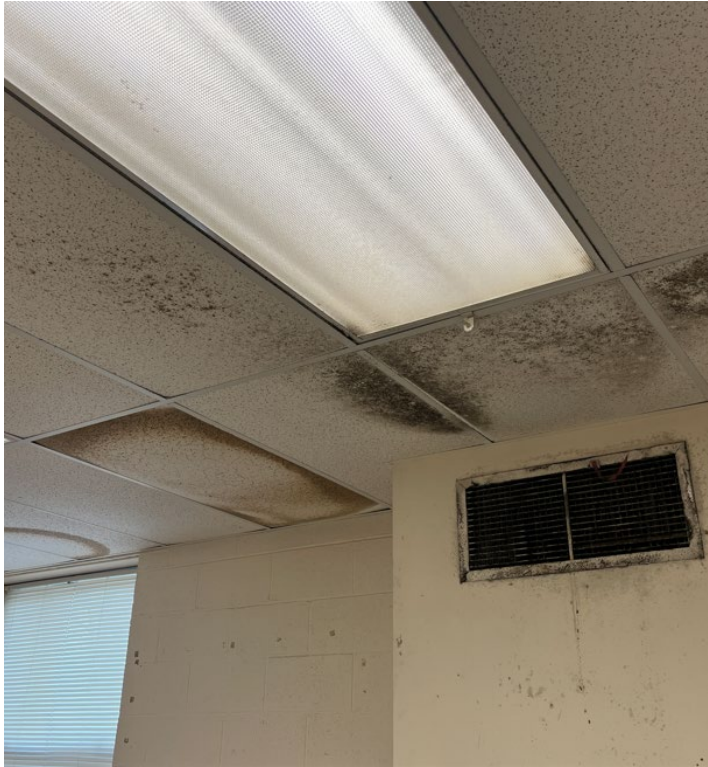
PHOTO AI.06D
WATER INFILTRATION (ACT CEILINGS)

Condition: Poor / Fair
Quantity: Approx. 23,269 SF

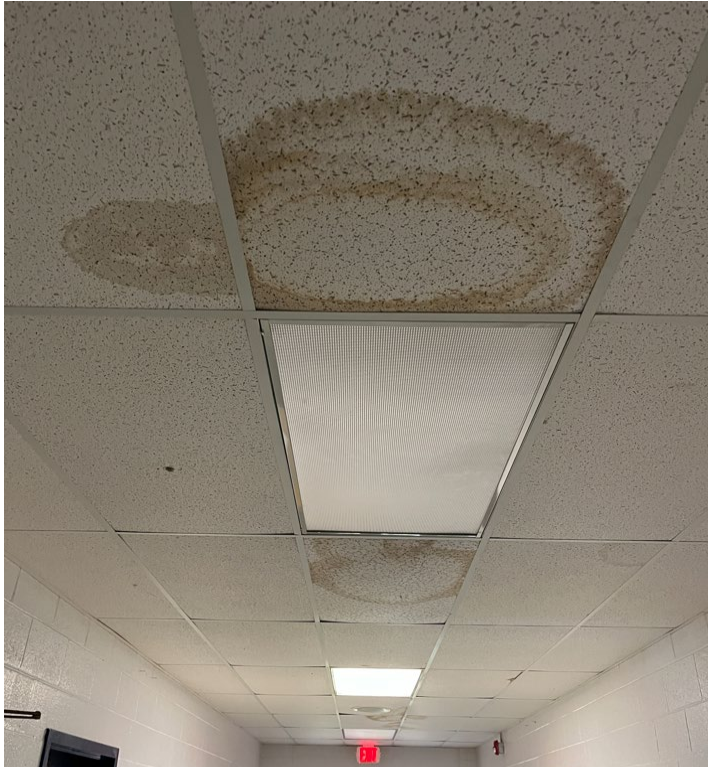
PHOTO AI.06E
WATER INFILTRATION (ACT CEILINGS)

Condition: Poor / Fair
Quantity: Approx. 23,269 SF

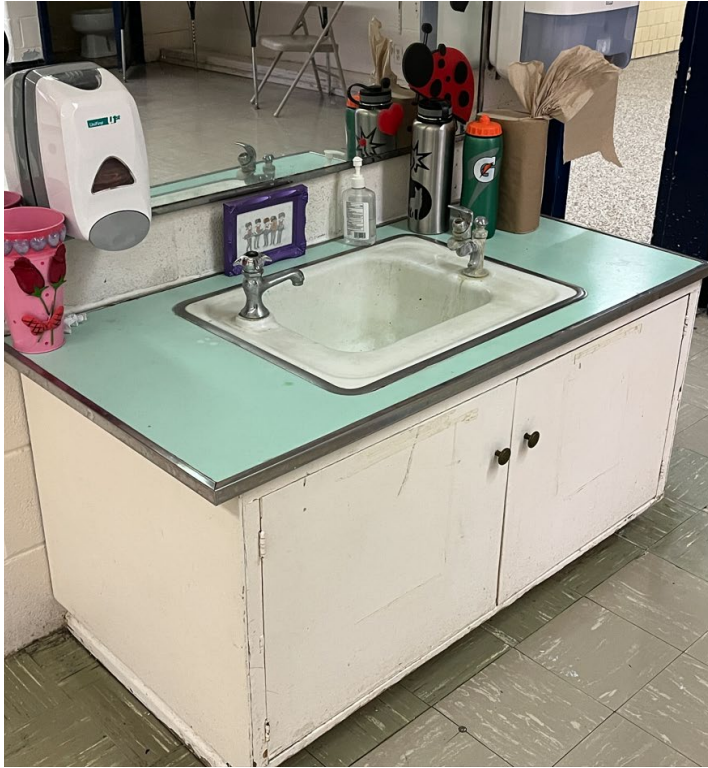
**PHOTO AI.08A
PAINTED WALL FINISHES (INTERIOR)**

*Condition: Poor / Fair
Quantity: Approx. 40,673 SF*

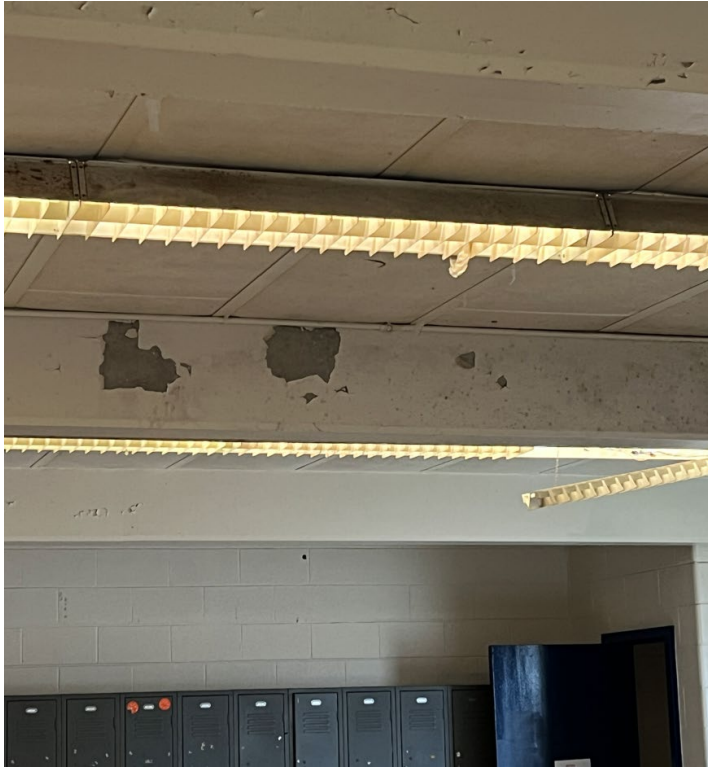
**PHOTO AI.08B
PAINTED WALL FINISHES (INTERIOR)**

*Condition: Poor / Fair
Quantity: Approx. 40,673 SF*

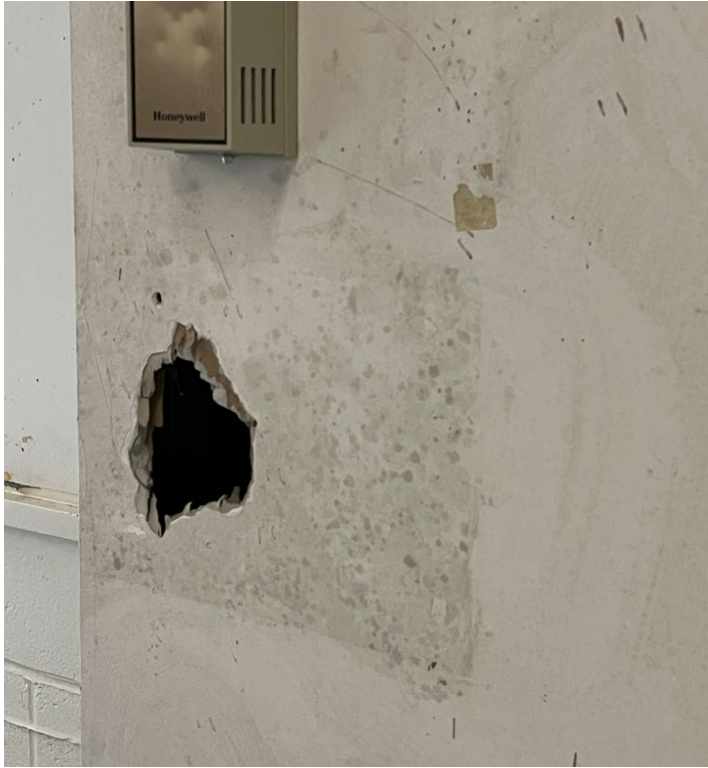
**PHOTO AI.08C
PAINTED WALL FINISHES (INTERIOR)**

*Condition: Poor / Fair
Quantity: Approx. 40,673 SF*

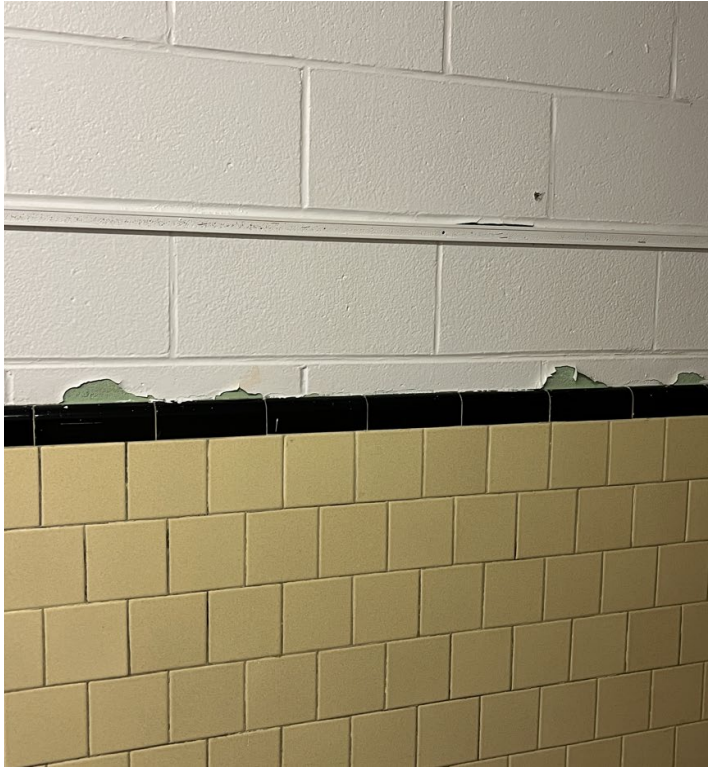
PHOTO AI.09A
CERAMIC TILE WAINSCOTTING
(CORRIDORS)

Condition: Poor / Fair
Quantity: Approx. 3,090 SF

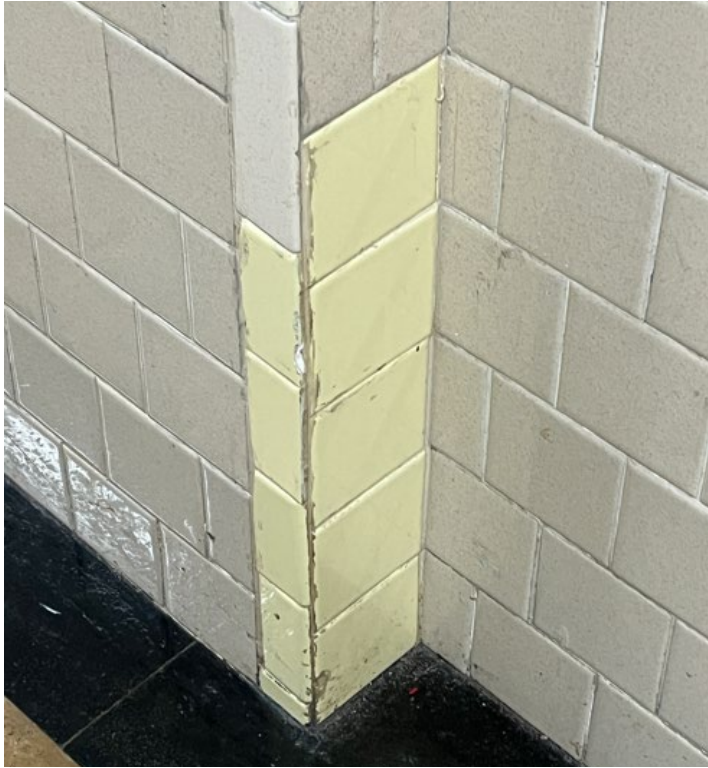
PHOTO AI.09B
CERAMIC TILE WAINSCOTTING
(CORRIDORS)

Condition: Poor / Fair
Quantity: Approx. 3,090 SF

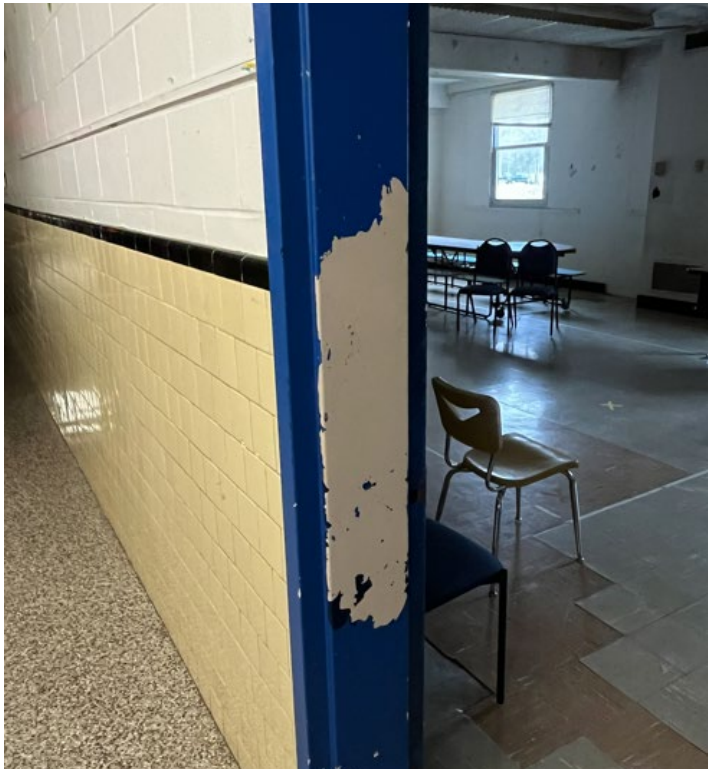
PHOTO AI.10B
INTERIOR DOOR FRAMES (RUSTED)

Condition: Poor / Fair
Quantity: Approx. 43,673 SF (84 Frames)

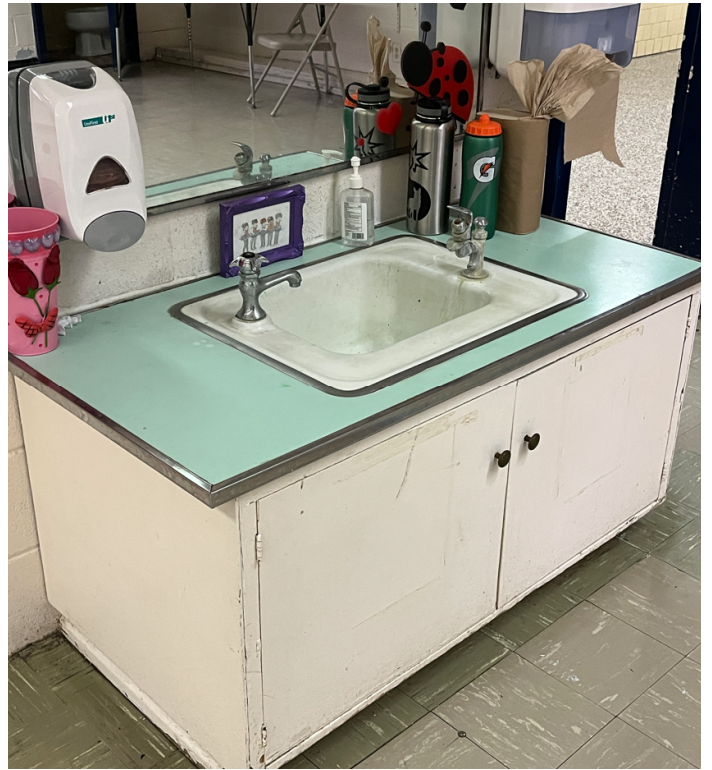
PHOTO AA.09
LAVATORIES & SINKS - EXPOSED PIPES
(ADAAG 606.5)

Condition: Poor
Quantity: Approx. (16) Sinks
