OLD LADYSMITH ELEMENTARY SCHOOL (LOTUS ACADEMY)

7278 Ladysmith Road, Ruther Glen, Virginia 22546

Facility Condition Assessment

April 2, 2024

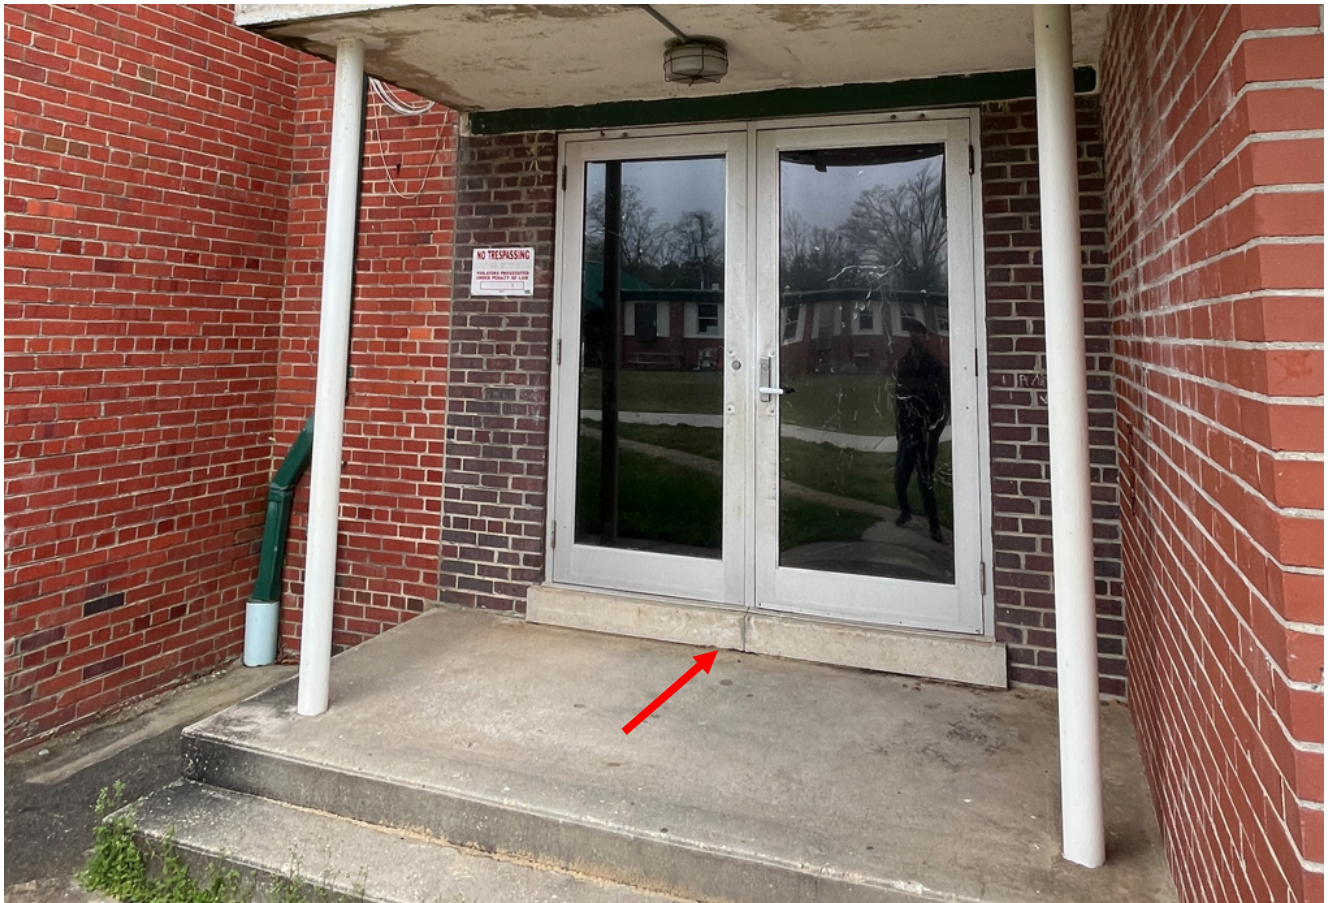
PHOTO AB.01

EXIT DISCHARGE ROUTE REQUIREMENTS (NFPA 101 & OSHA 1910)

Condition: Poor / Fair

Ensure Straight & Level Walkways, Guardrails for Fall Hazards and Adequate Capacity of Exit Route

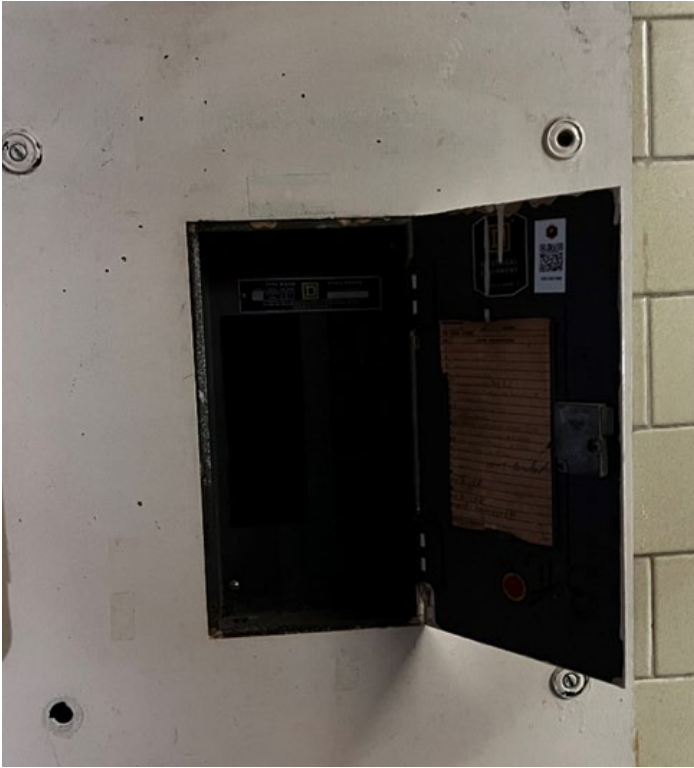
**PHOTO E.02B
EXISTING PANELS**

Condition: Poor
Quantity: Approx. 43,763 SF
