## SCHOOL BOARD OFFICE

### Facility Condition Assessment

Caroline County Public Schools

April 4, 2024

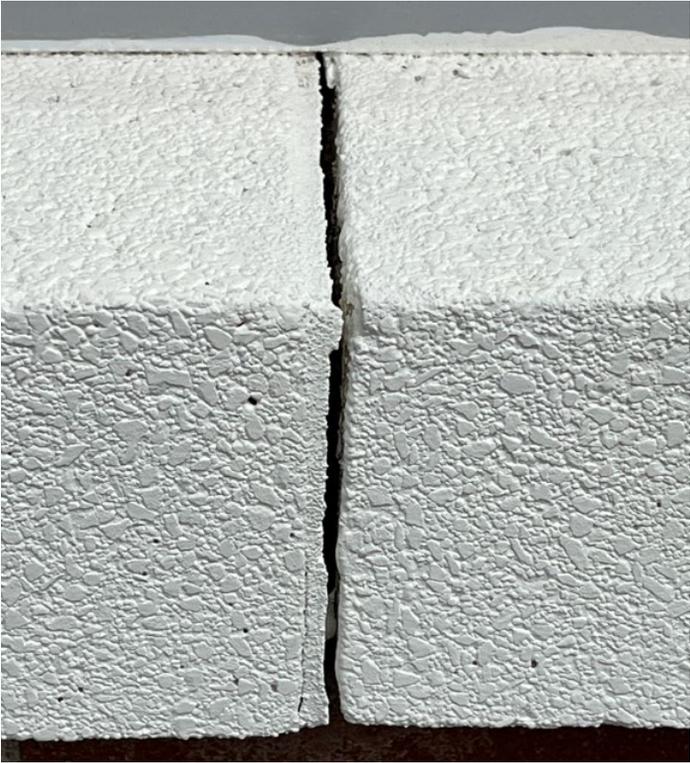
**PHOTO AE.01**  
**MORTAR DETERIORATION @**  
**WINDOW SILLS**

*Condition: Poor*  
*Quantity: Approx. 140 LF*

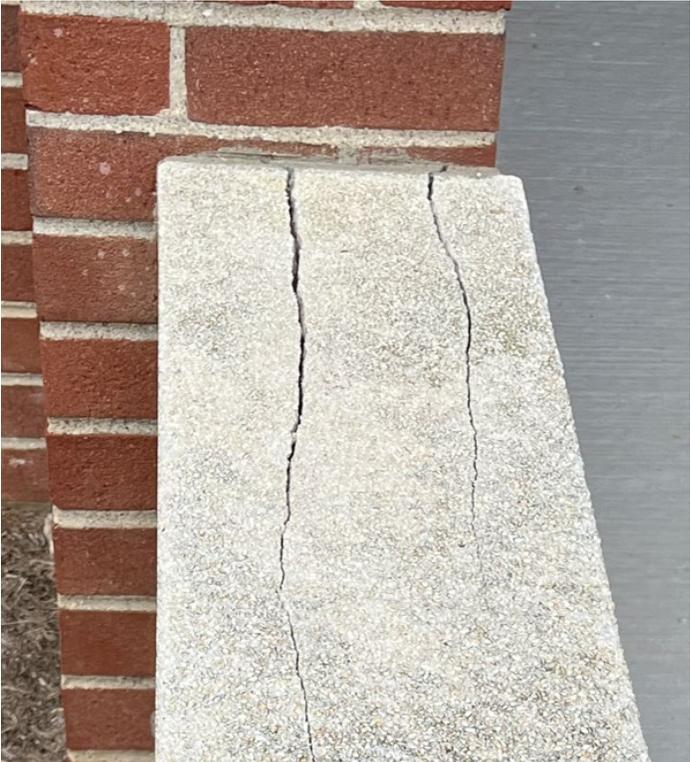
**PHOTO AE.02**  
**DAMAGED CONCRETE SILLS**

*Condition: Poor*  
*Quantity: Approx. 50 LF*

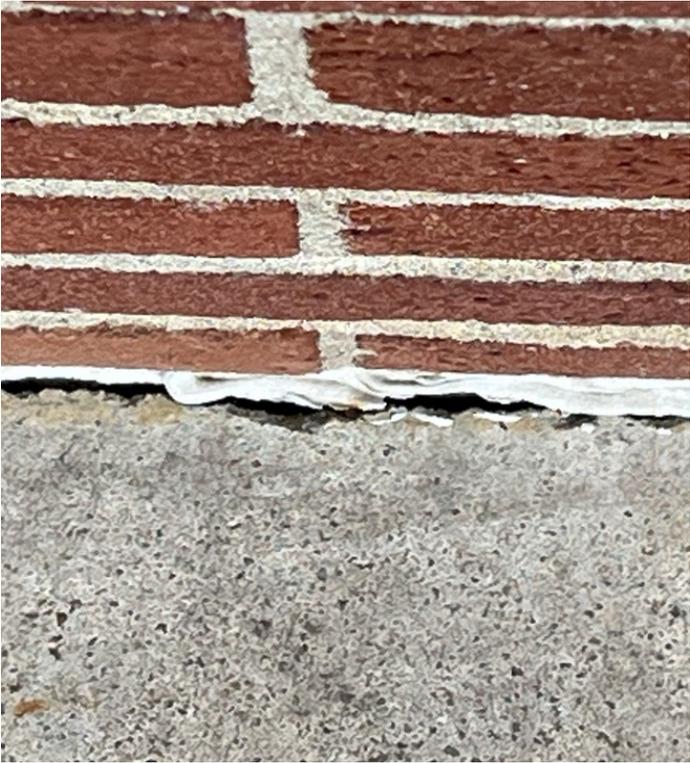
**PHOTO AE.03**  
**EXTERIOR CAULKING FAILURE**  
**(SIDEWALK TO BUILDING)**

*Condition: Poor*  
*Quantity: Approx. 240 LF*

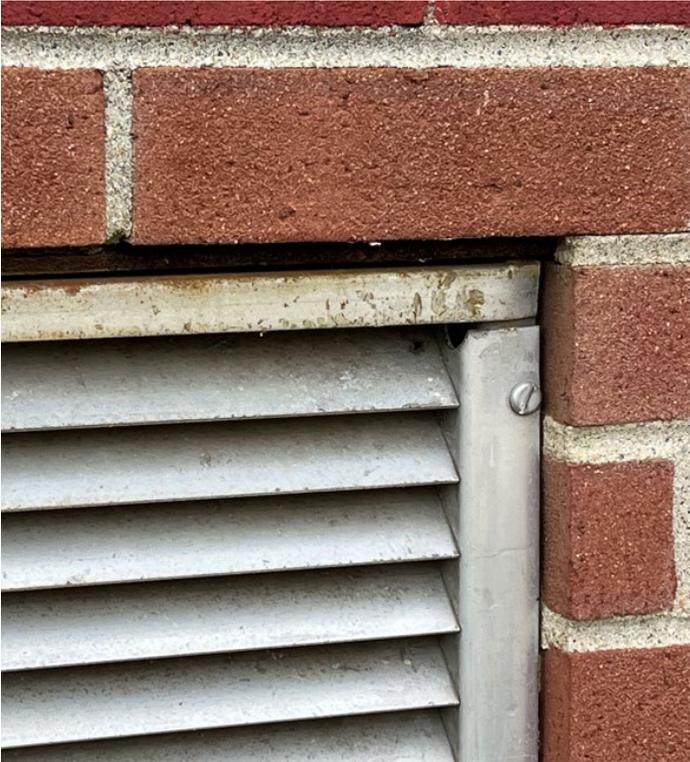
**PHOTO AE.04**  
**EXTERIOR CAULKING FAILURE (LOUVERS)**

*Condition: Poor*  
*Quantity: Approx. 300 LF*

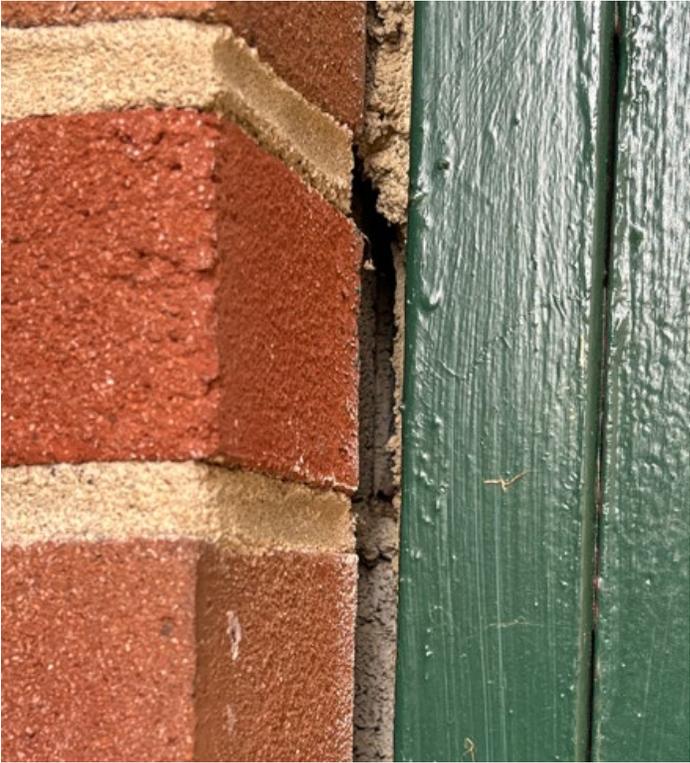
**PHOTO AE.05  
EXTERIOR CAULKING MISSING  
(DOOR FRAMES)**

*Condition: Poor  
Quantity: Approx. 210 LF*

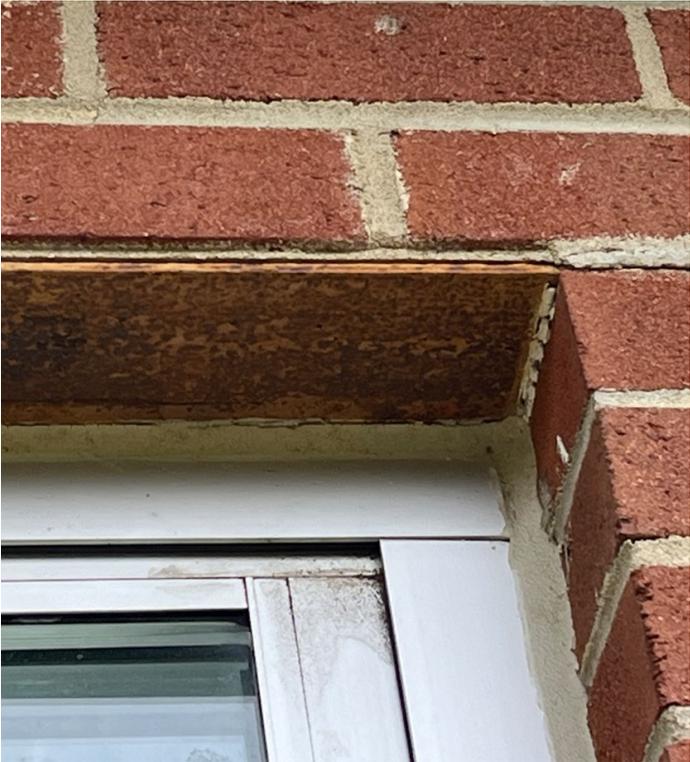
**PHOTO AE.06  
EXPOSED/RUSTED STEEL LINTELS**

*Condition: Poor  
Quantity: See Structural*

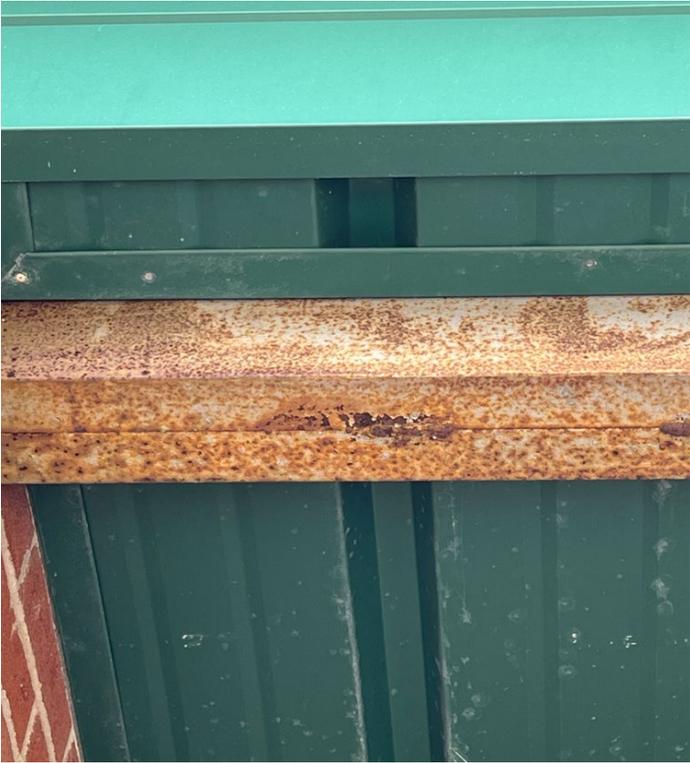
**PHOTO AE.07**  
**EXTERIOR CANOPY/SOFFIT FRAME RUSTED**

*Condition: Fair*  
*Quantity: See Structural*

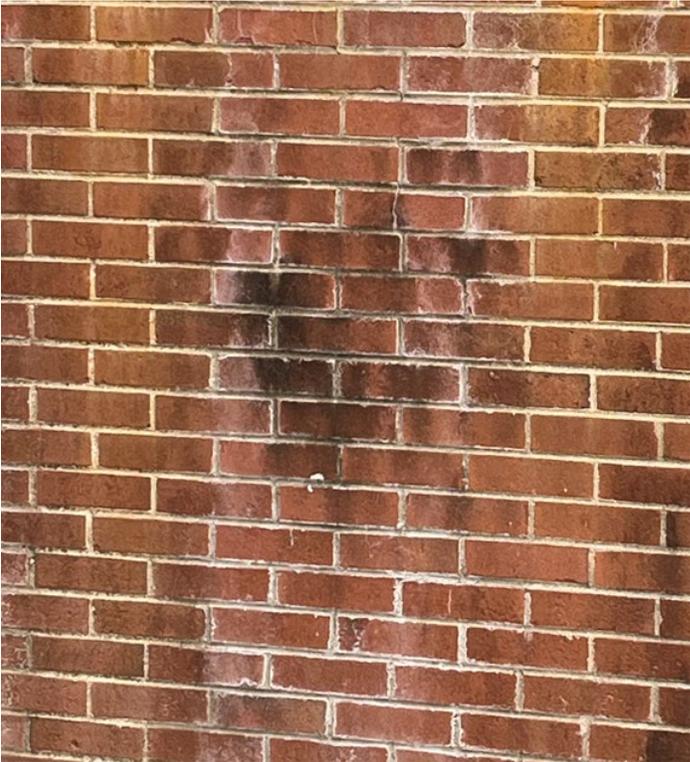
**PHOTO AE.08**  
**EXTERIOR DIRT / ALGAE GROWTH**

*Condition: Fair*  
*Quantity: Approx. 36,235 SF*

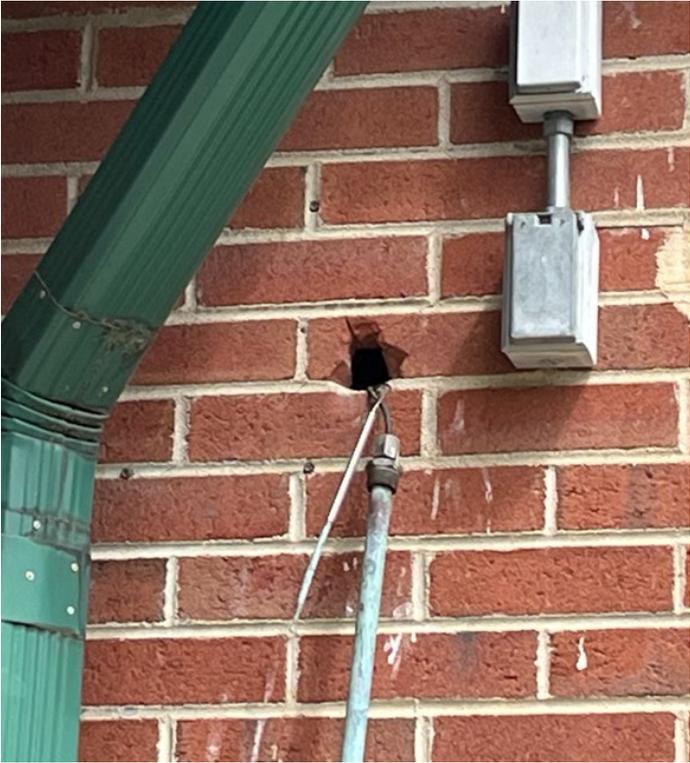
**PHOTO AE.09**  
**BUILDING ENVELOPE OPENINGS AT**  
**PREVIOUS PENETRATIONS**

*Condition: Poor*  
*Quantity: (2) Locations*

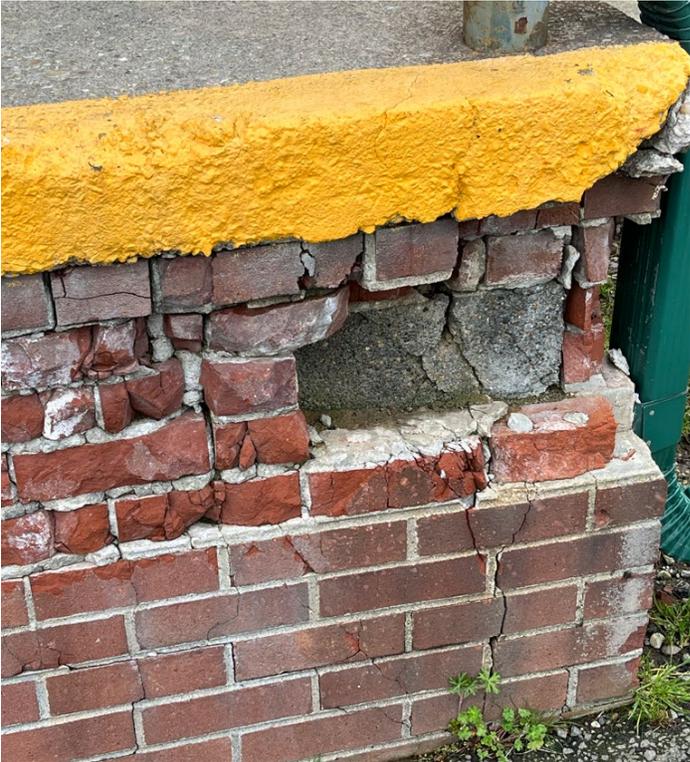
**PHOTO AE.10**  
**DAMAGED MASONRY FACADE**

*Condition: Poor*  
*Quantity: Approx. 185 SF*

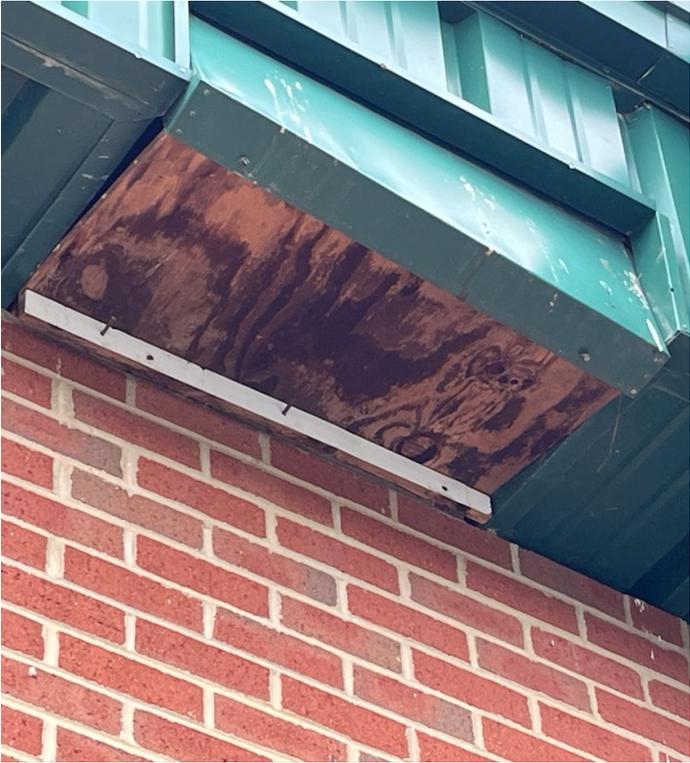
**PHOTO AE.11  
DAMAGED/MISSING METAL SOFFIT  
PANELING**

*Condition: Poor  
Quantity: (2) Locations*

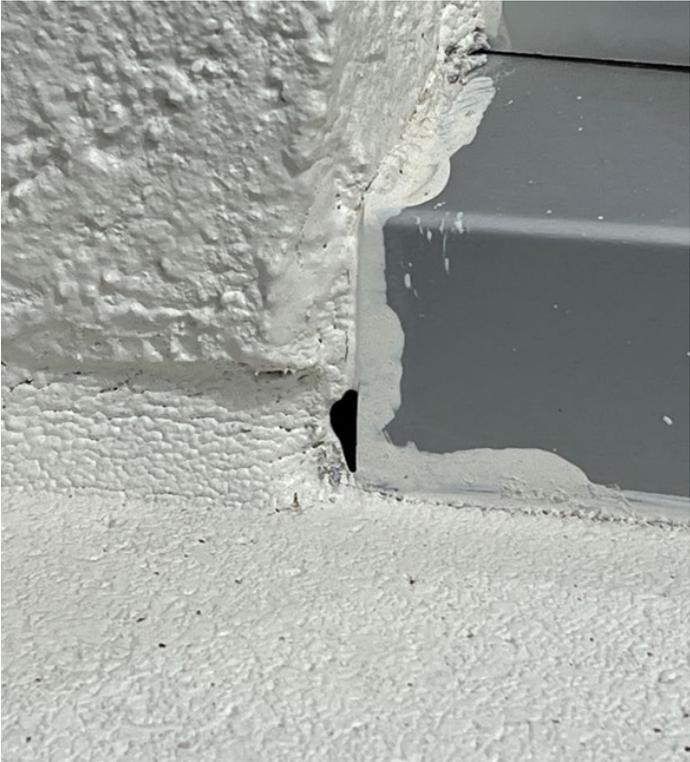
**PHOTO AE.11  
WINDOW CAULKING**

*Condition: Fair  
Quantity: Approx. 1,178 LF*

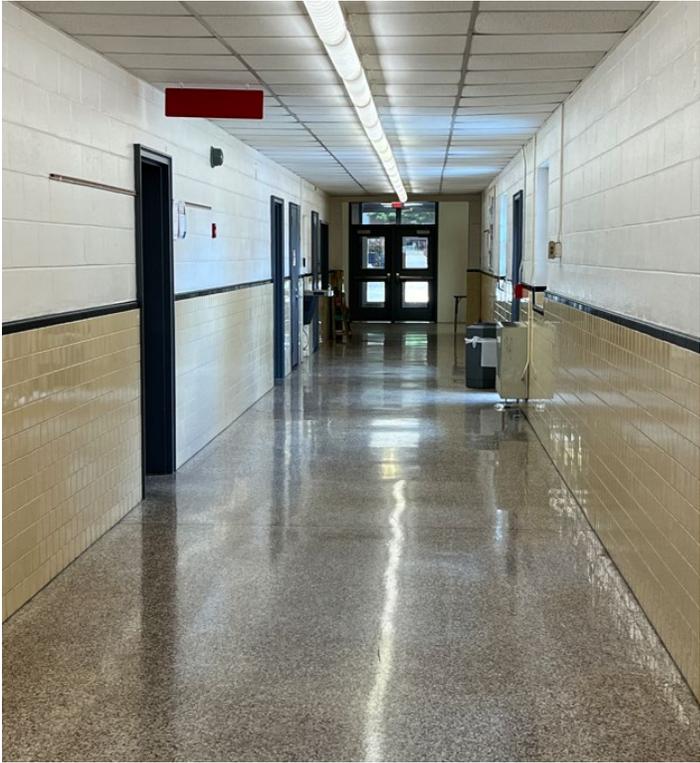
**PHOTO AI.01  
TYPICAL CORRIDOR FLOORING  
(TERRAZZO)**

*Condition: Fair  
Quantity: Approx. 10,900 SF*

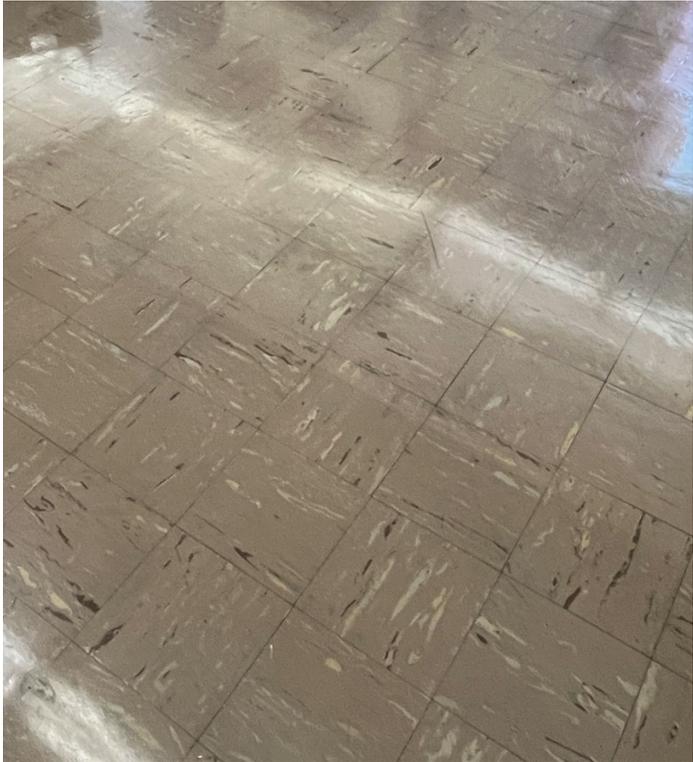
**PHOTO AI.02  
TYPICAL CLASSROOM FLOORING (VCT)**

*Condition: Fair  
Quantity: Approx. 20,240 SF*

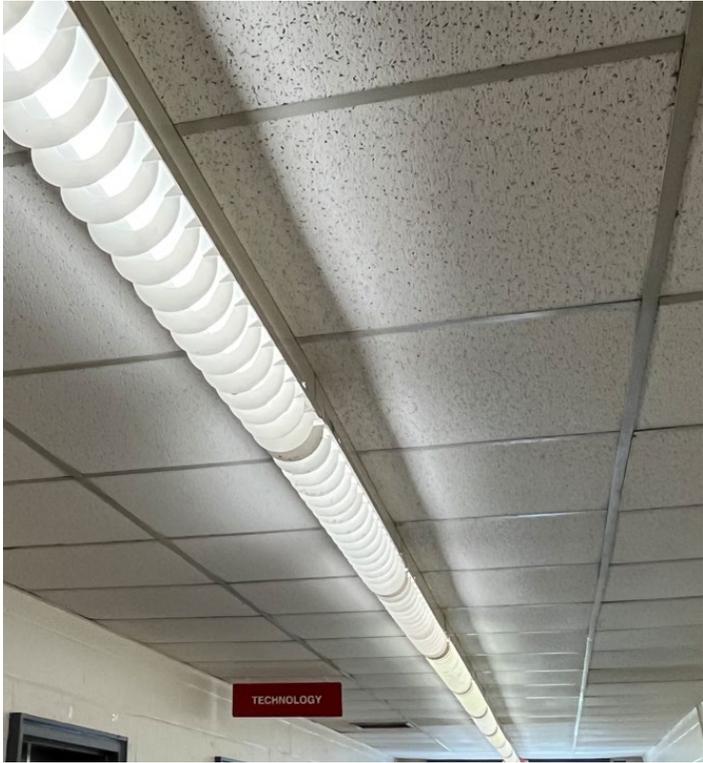
**PHOTO AI.03  
TYPICAL ACOUSTICAL TILE CEILINGS (ACT)  
@ CORRIDOR**

*Condition: Fair  
Quantity: Approx. 10,900 SF*

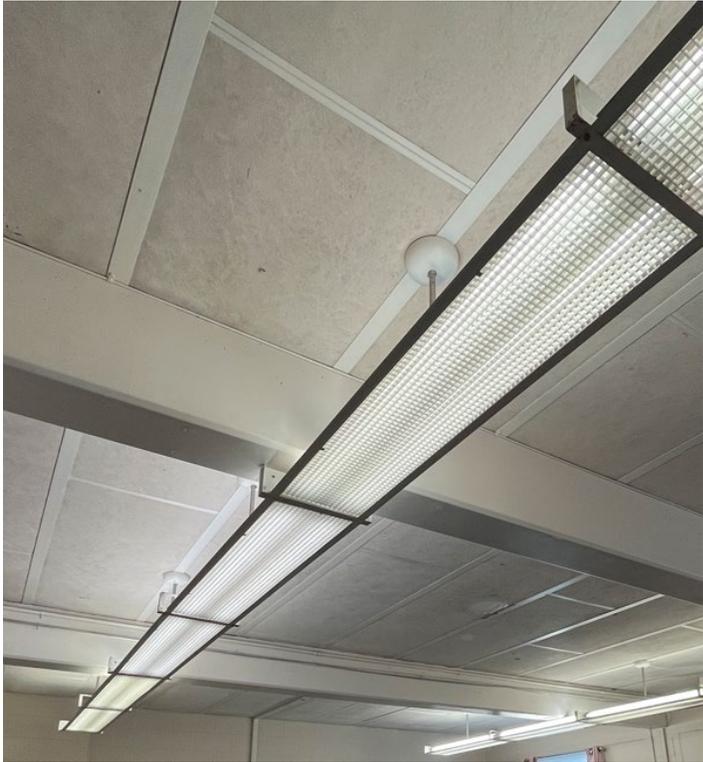
**PHOTO AI.04  
TYPICAL GYPSUM PANEL CEILINGS @  
CLASSROOMS**

*Condition: Fair  
Quantity: Approx. 19,460 SF*

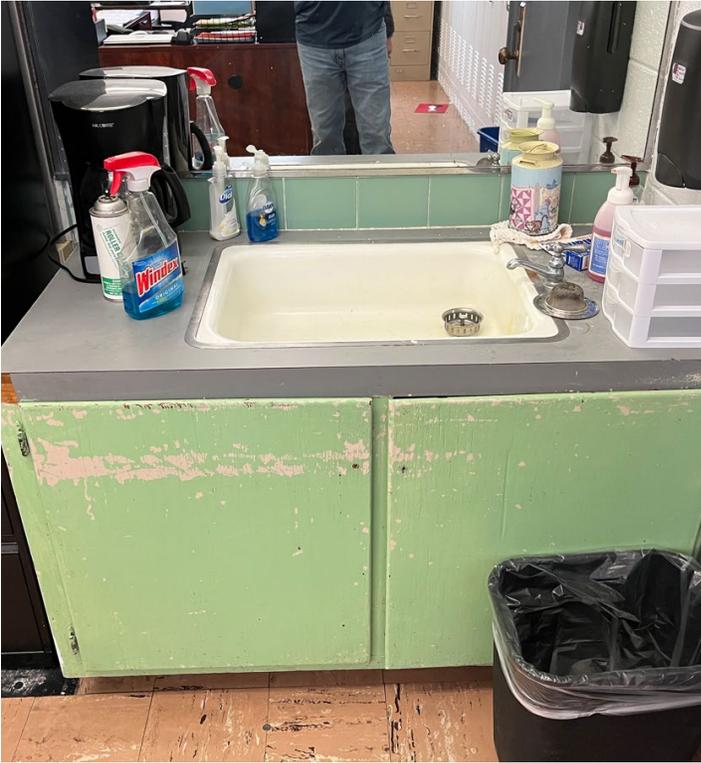
**PHOTO AI.05A  
TYPICAL CLASSROOM CASEWORK**

*Condition: Poor / Fair  
Quantity: (20) Classrooms*

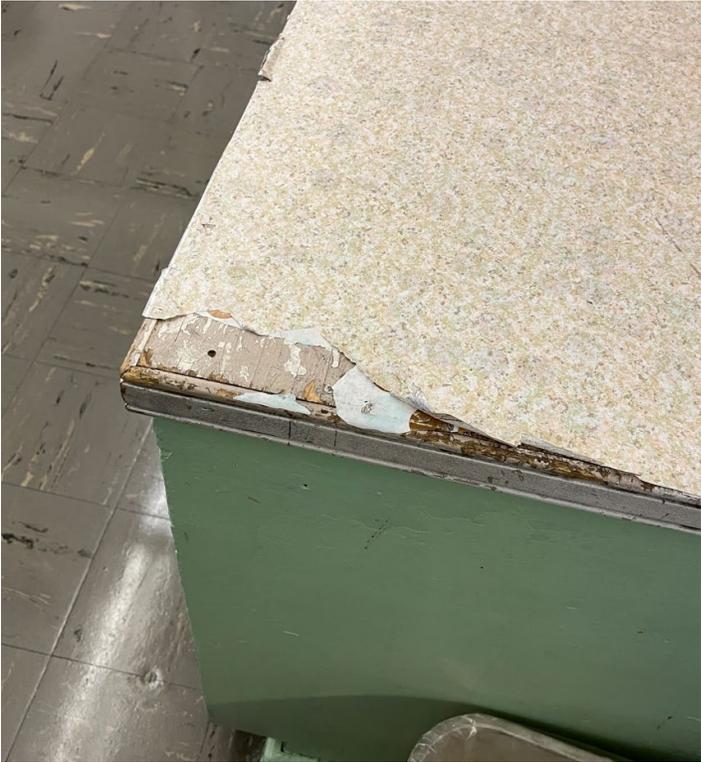
**PHOTO AI.05B  
TYPICAL CLASSROOM CASEWORK**

*Condition: Poor / Fair  
Quantity: (20) Classrooms*

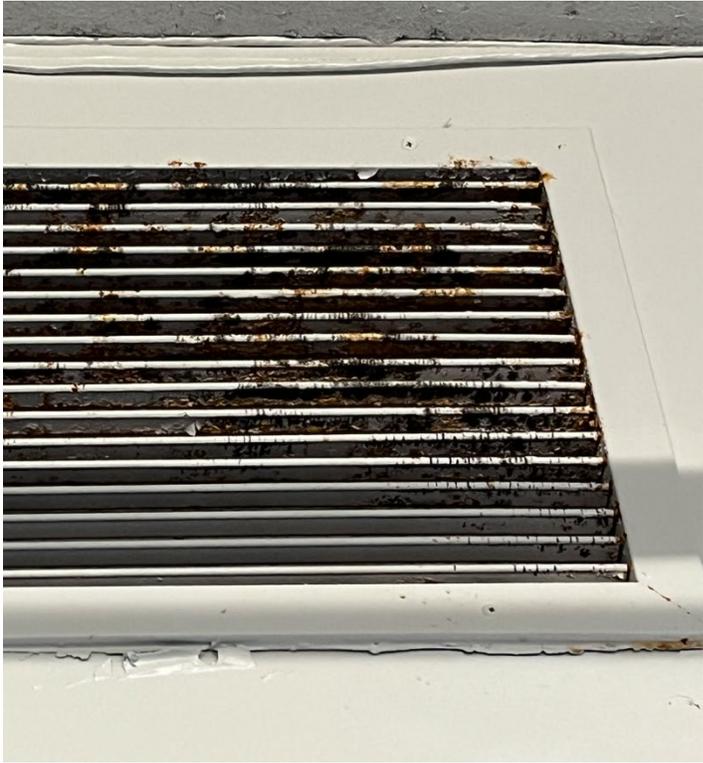
**PHOTO AI.06**  
**RUSTING (PEELING) INTERIOR LOUVERS**

*Condition: Very Poor*  
*Quantity: (108) Locations*

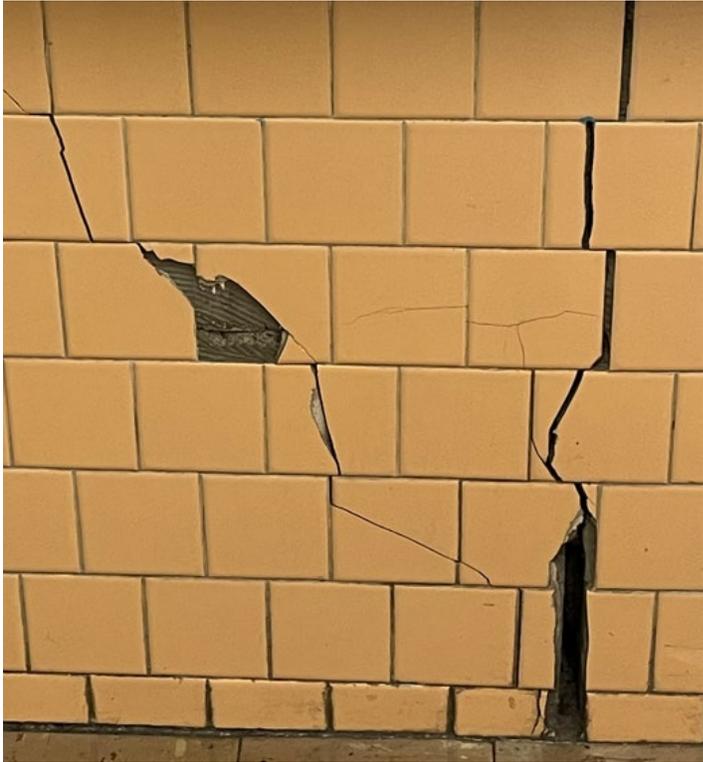
**PHOTO AI.07A**  
**DAMAGED WALL TILE**

*Condition: Poor*  
*Quantity: Approx. 1,560 SF*

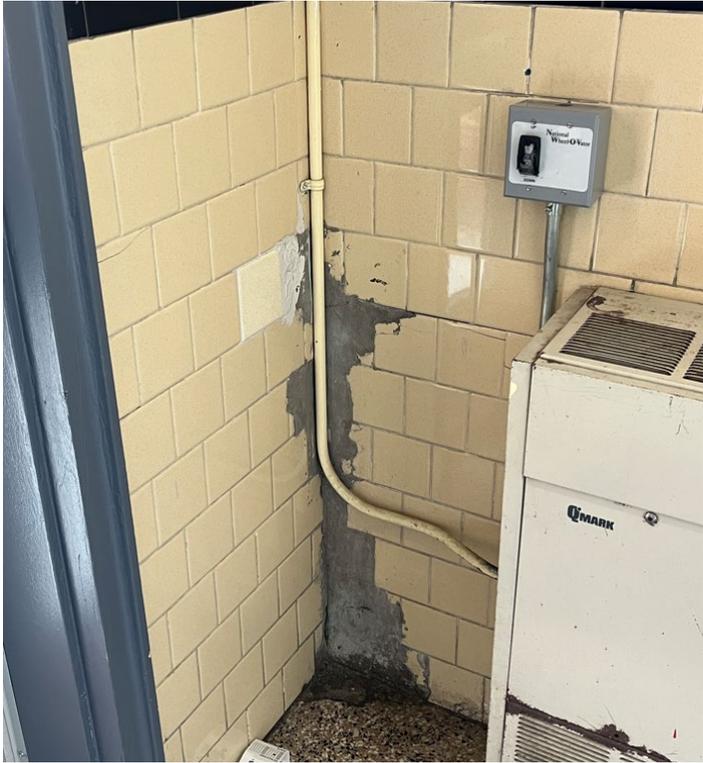
**PHOTO AI.07B  
DAMAGED WALL TILE**

*Condition: Poor  
Quantity: Approx. 1,560 SF*

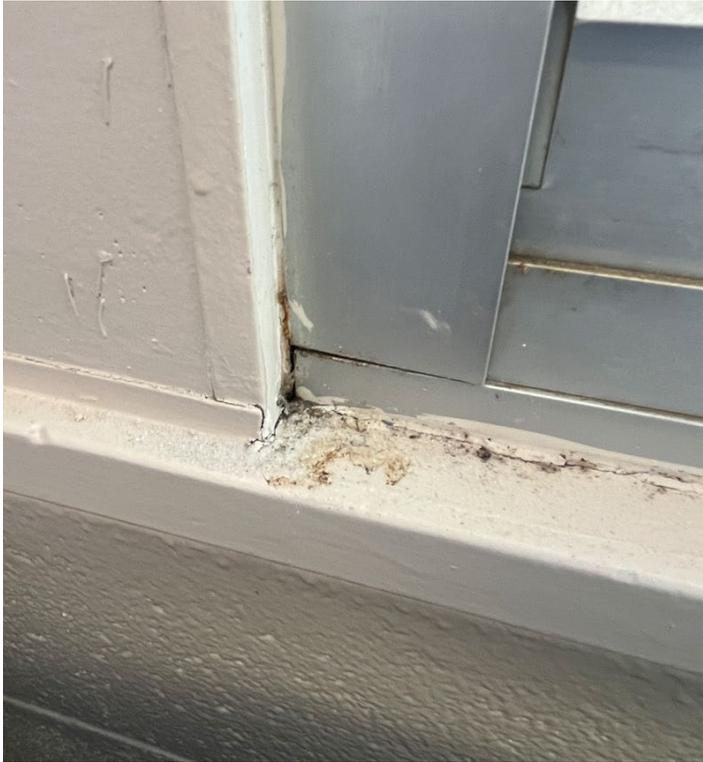
**PHOTO AI.08  
WATER INFILTRATION @ WINDOWS**

*Condition: Poor / Fair  
Quantity: Approx. 270 LF*

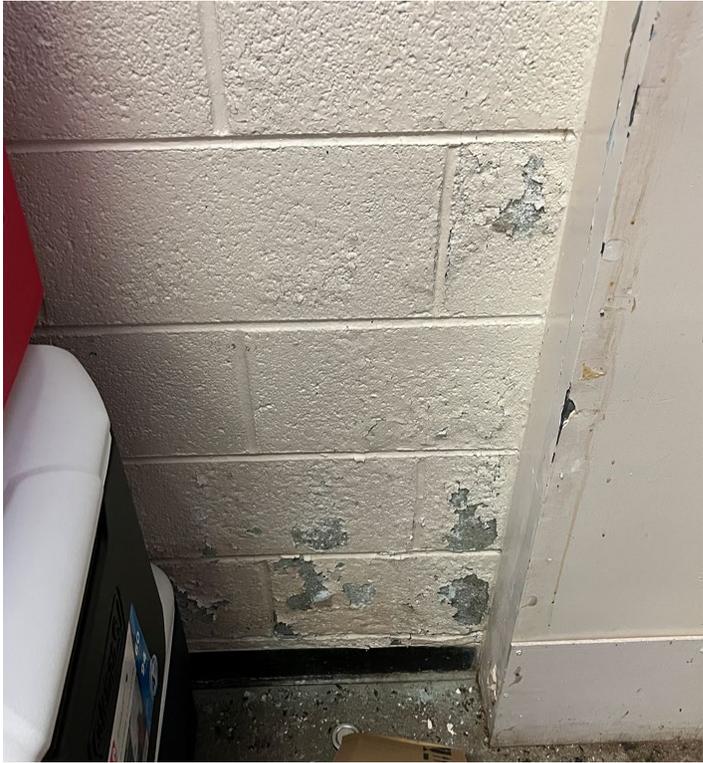
**PHOTO AI.09**  
**WATER INFILTRATION @ EXTERIOR WALLS**

*Condition: Poor / Fair*  
*Quantity: Approx. 350 SF*

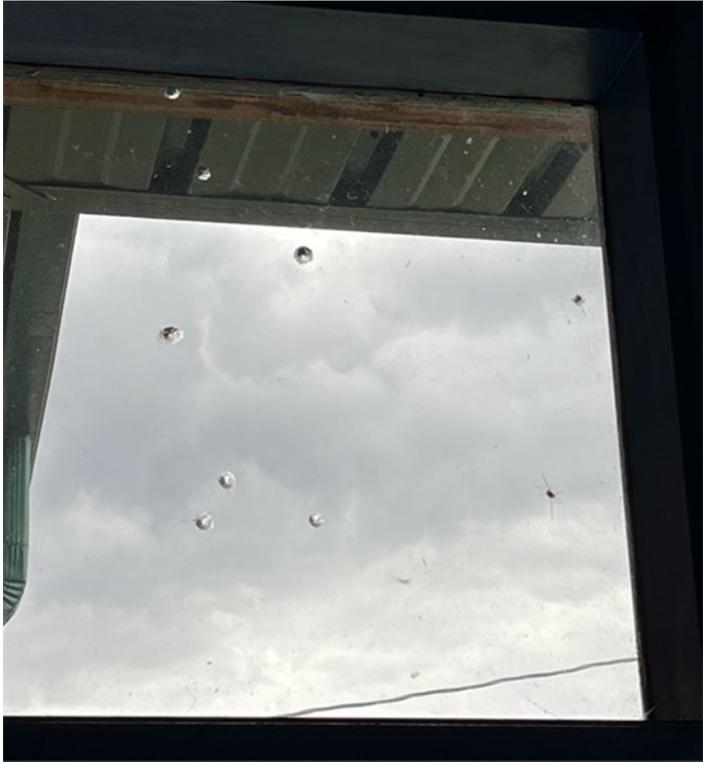
**PHOTO AI.10**  
**DAMAGED WINDOW PANES**

*Condition: Fair*  
*Quantity: (1) Location*

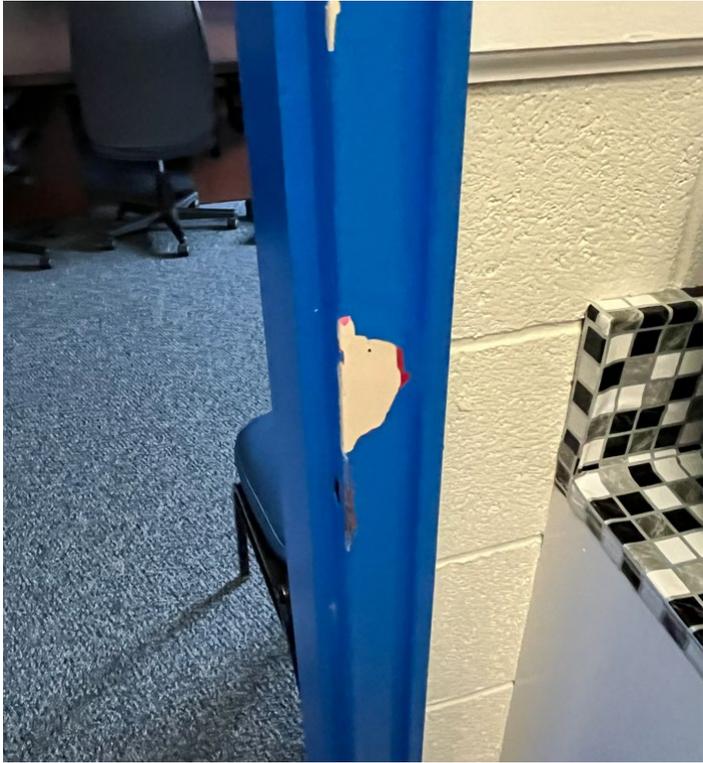
**PHOTO AI.11A**  
**INTERIOR DOOR FRAMES**

*Condition: Fair*  
*Quantity: Approx. 105 Door Frames*

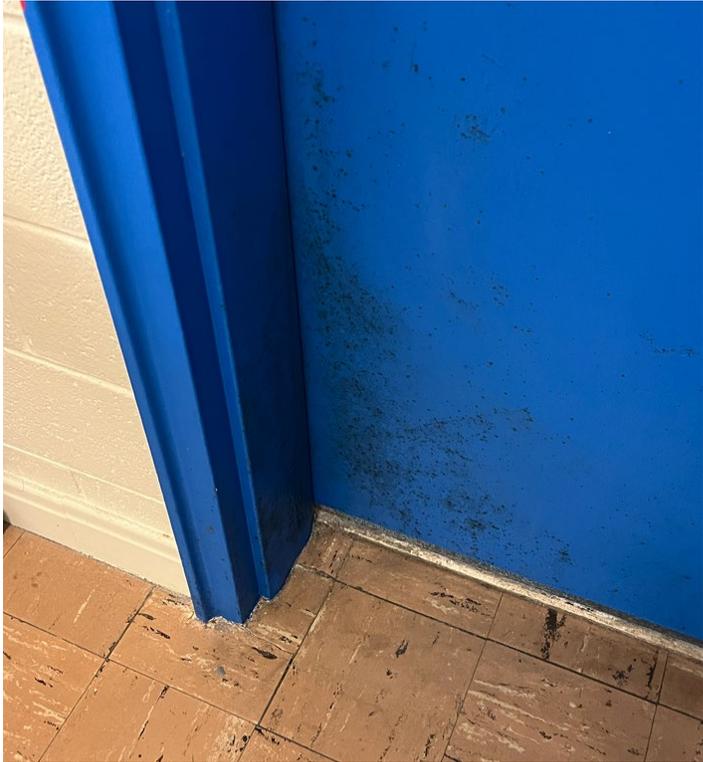
**PHOTO AI.11B**  
**INTERIOR DOORS**

*Condition: Fair*  
*Quantity: Approx. 105 Door Frames*

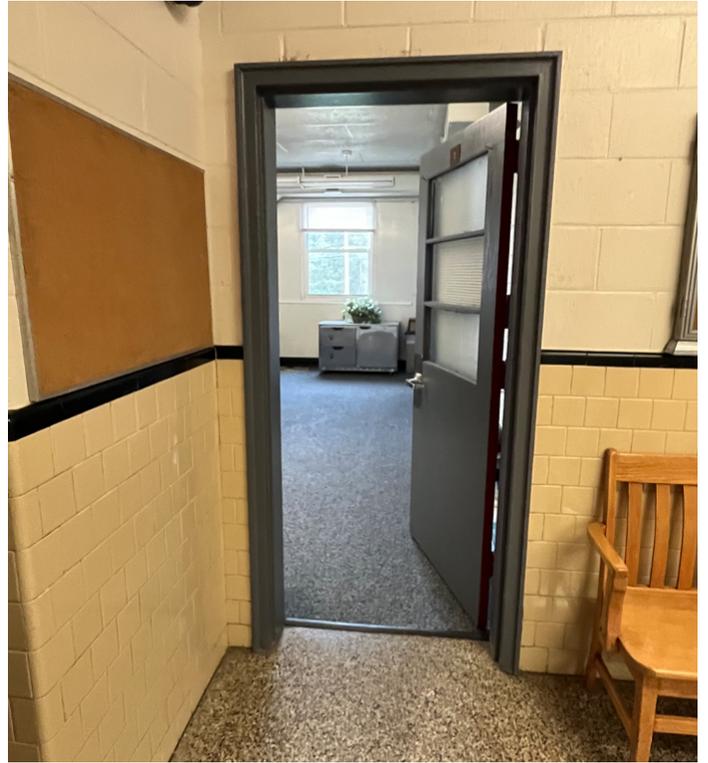
**PHOTO AA.02  
MANUEVERING CLEARANCES -CLASSROOMS  
(ADAAG 404.2.4.1)**

*Condition: Fair  
Quantity: Approx. (20) Locations*

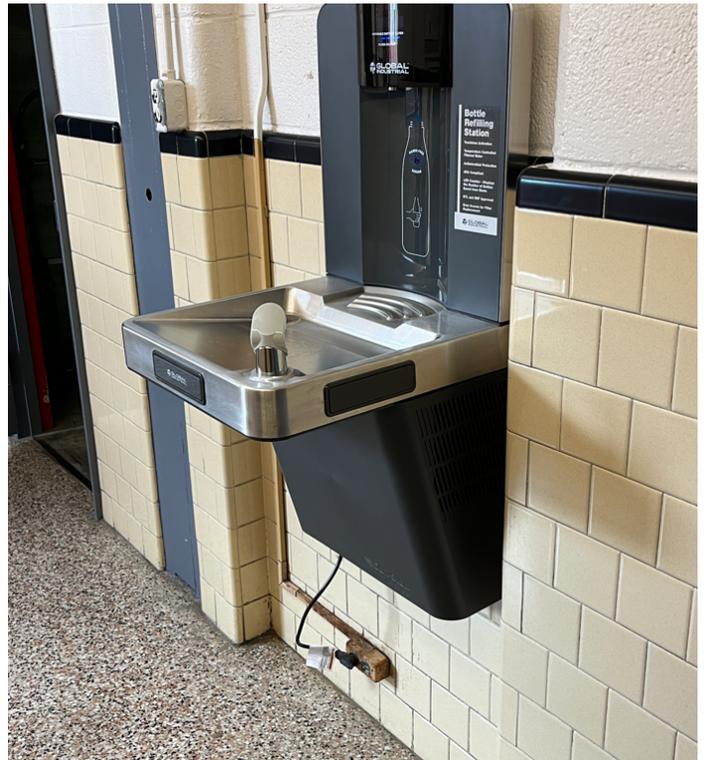
**PHOTO AA.03  
DRINKING FOUNTAINS - PROTRUSION LIMITS  
(ADAAG 307.2)**

*Condition: Fair  
Quantity: (2) Locations*

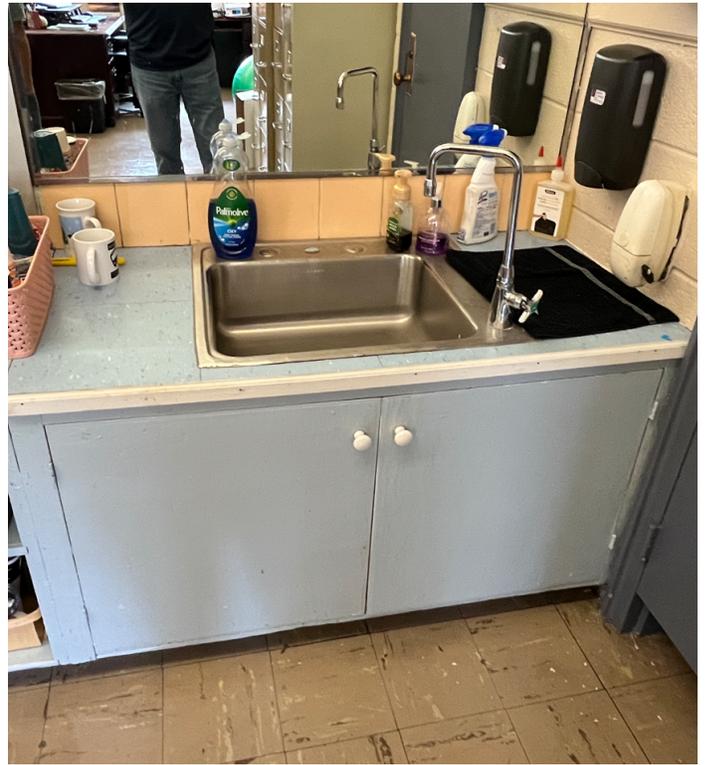
**PHOTO AA.04  
CASEWORK SINKS - CLEAR FLOOR SPACE  
(ADAAG 606.2)**

*Condition: Poor / Fair  
Quantity: Approx. (20) Locations*

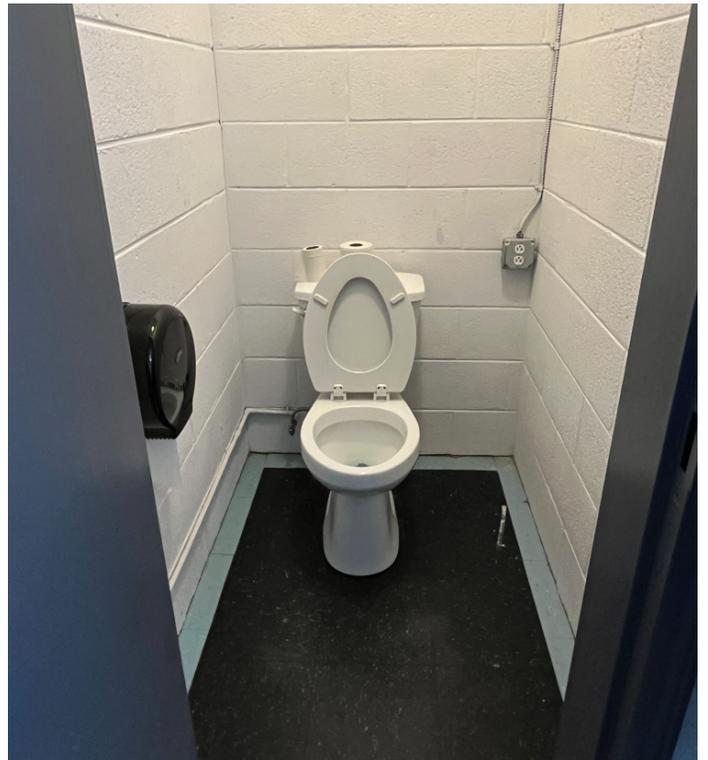
**PHOTO AA.05  
INDIVIDUAL TOILET ROOM(S) - DOOR CLEAR  
WIDTH AND GRAB BARS  
(ADAAG 404.2, 604.5, & 609)**

*Condition: Fair  
Quantity: Approx. 600 SF*

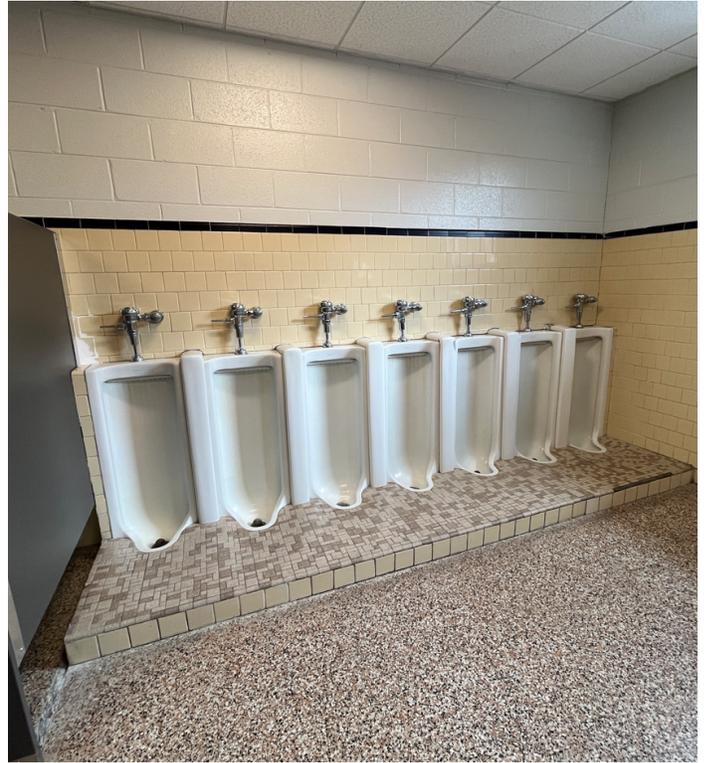
**PHOTO AA.06**  
**GROUP TOILET ROOM(S) - DOOR CLEAR**  
**WIDTH AND GRAB BARS**  
**(ADAAG 404.2, 604.5, & 609)**

*Condition: Fair*

*Quantity: Approx. 555 SF*

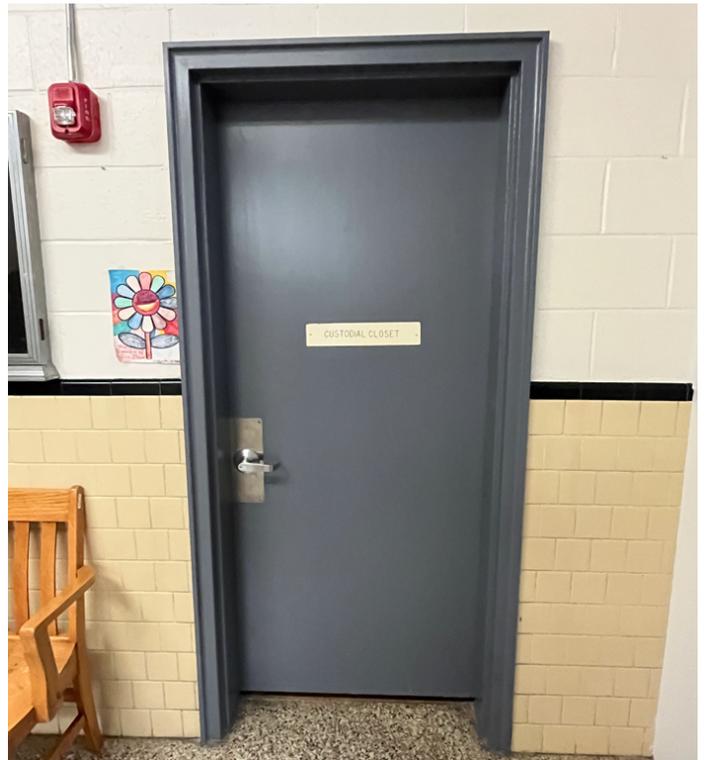
**PHOTO AA.07A**  
**BUILDING SIGNAGE - LOCATION & HEIGHT**  
**(ADAAG 216 & 703)**

*Condition: Poor*

*Quantity: Approx. 105 Signs*

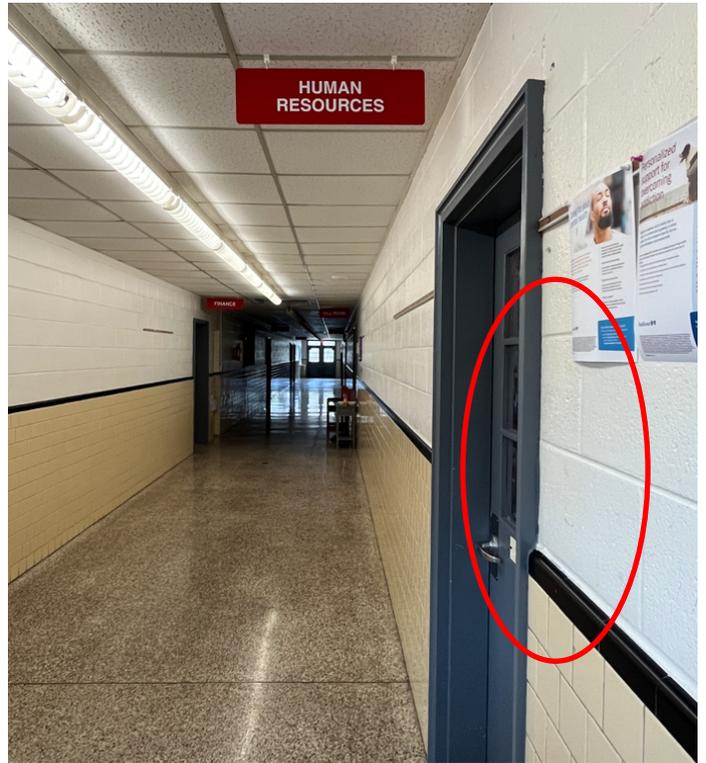
**PHOTO AA.07B**  
**BUILDING SIGNAGE - LOCATION & HEIGHT**  
**(ADAAG 216 & 703)**

*Condition: Poor*  
*Quantity: Approx. 105 Signs*

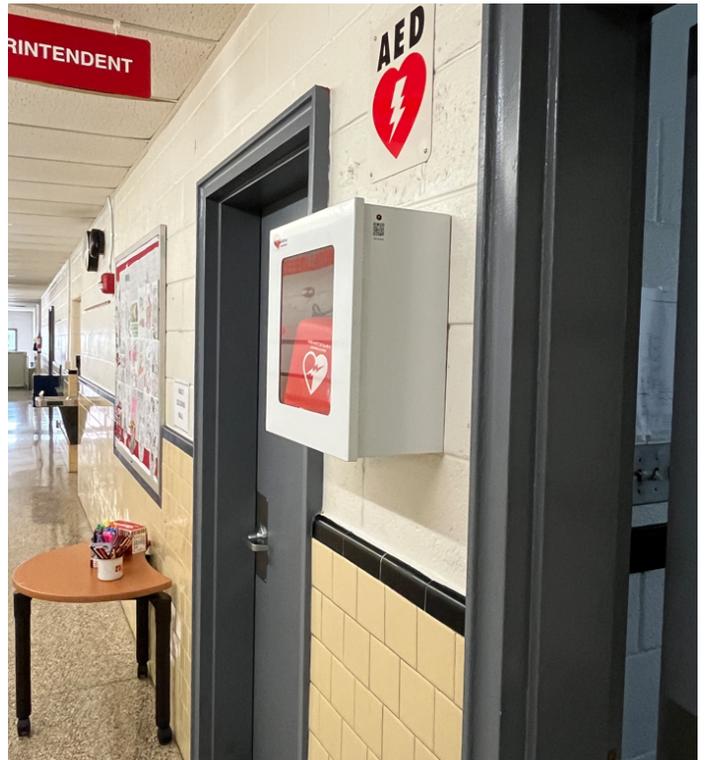
**PHOTO AA.08**  
**ADDITIONAL DEVICES - PROTRUSION LIMITS**  
**(ADAAG 307.2)**

*Condition: Poor*  
*Quantity: (2) Additional Devices*

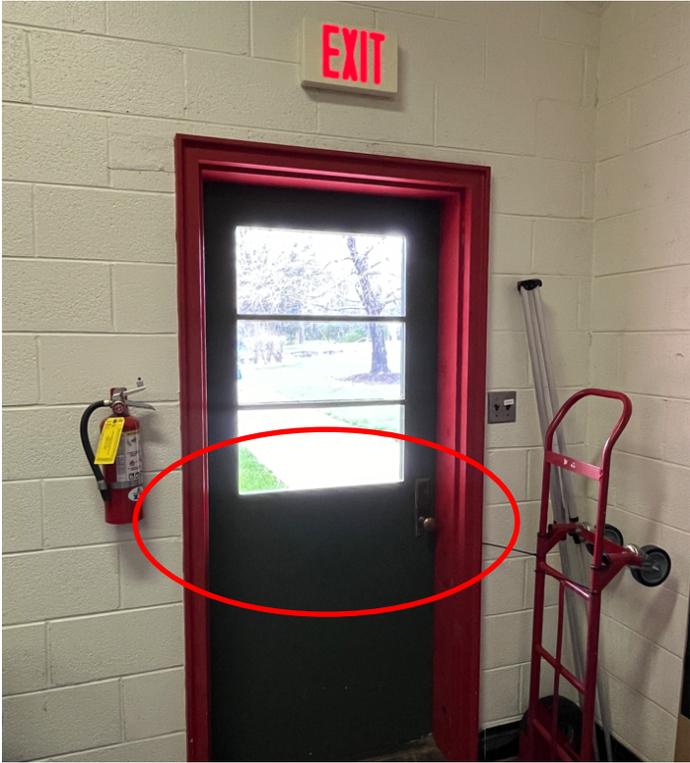
**PHOTO AA.09  
PANIC EXIT DOOR HARDWARE**

*Condition: Poor  
Quantity: Approx. (1) Location*

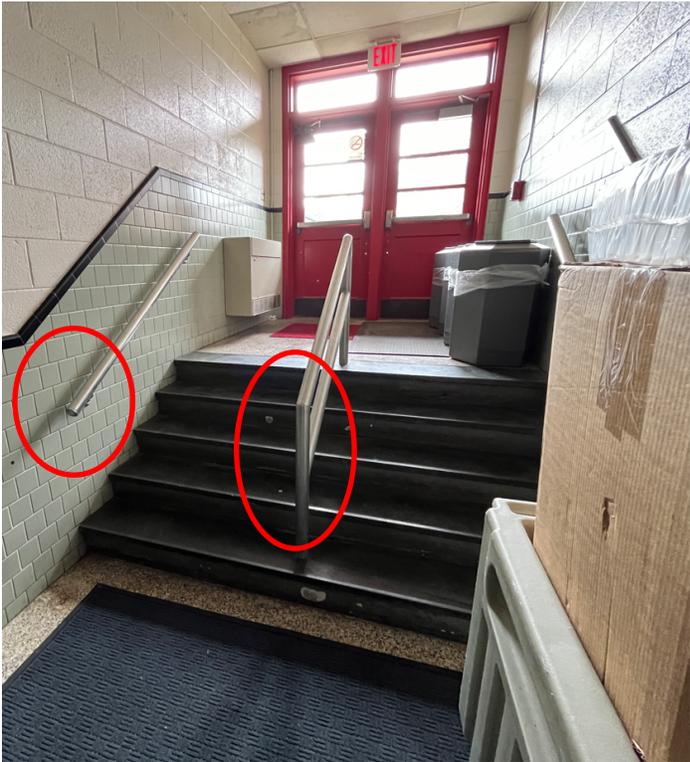
**PHOTO AA.10  
HANDRAILS EXTENSIONS AT INTERIOR  
STAIRS (ADAAG 505.10)**

*Condition: Fair  
Quantity: Approx. 20 LF*

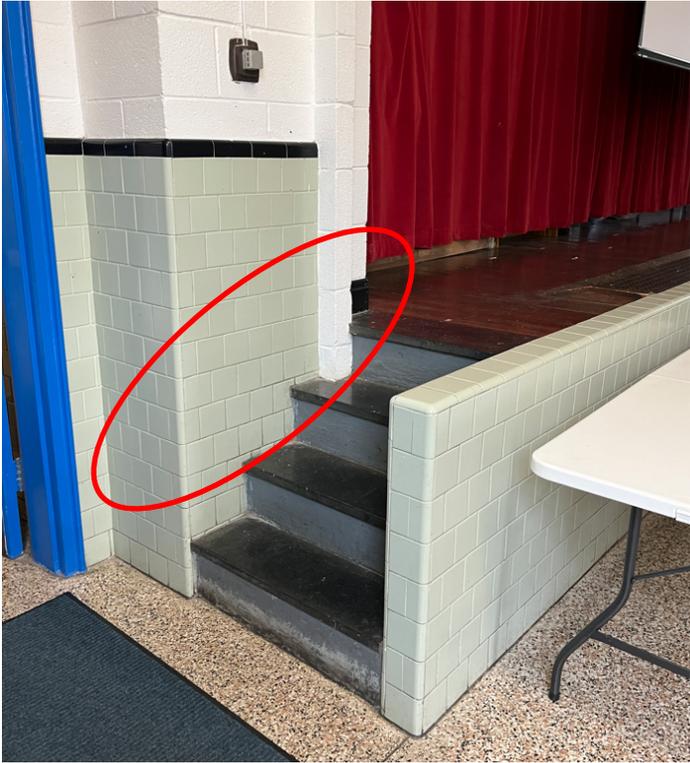
**PHOTO AA.11**  
**HANDRAILS AT INTERIOR STAGE STAIRS**  
**(ADAAG 505.10)**

*Condition: Fair*  
*Quantity: Approx. 48 LF*

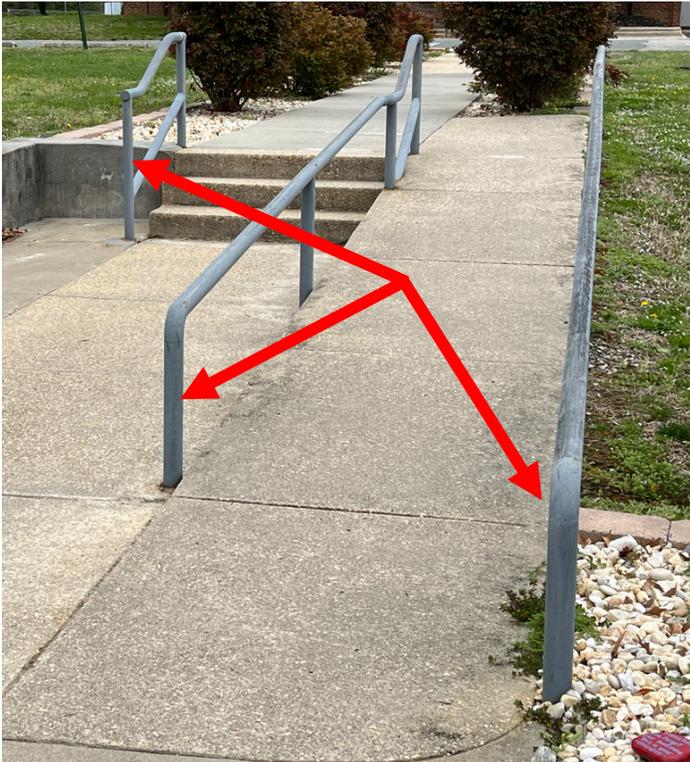
**PHOTO AA.12**  
**HANDRAIL EXTENSIONS AT EXTERIOR STAIR**  
**AND RAMP (ADAAG 505.10)**

*Condition: Fair*  
*Quantity: Approx. 16 LF*

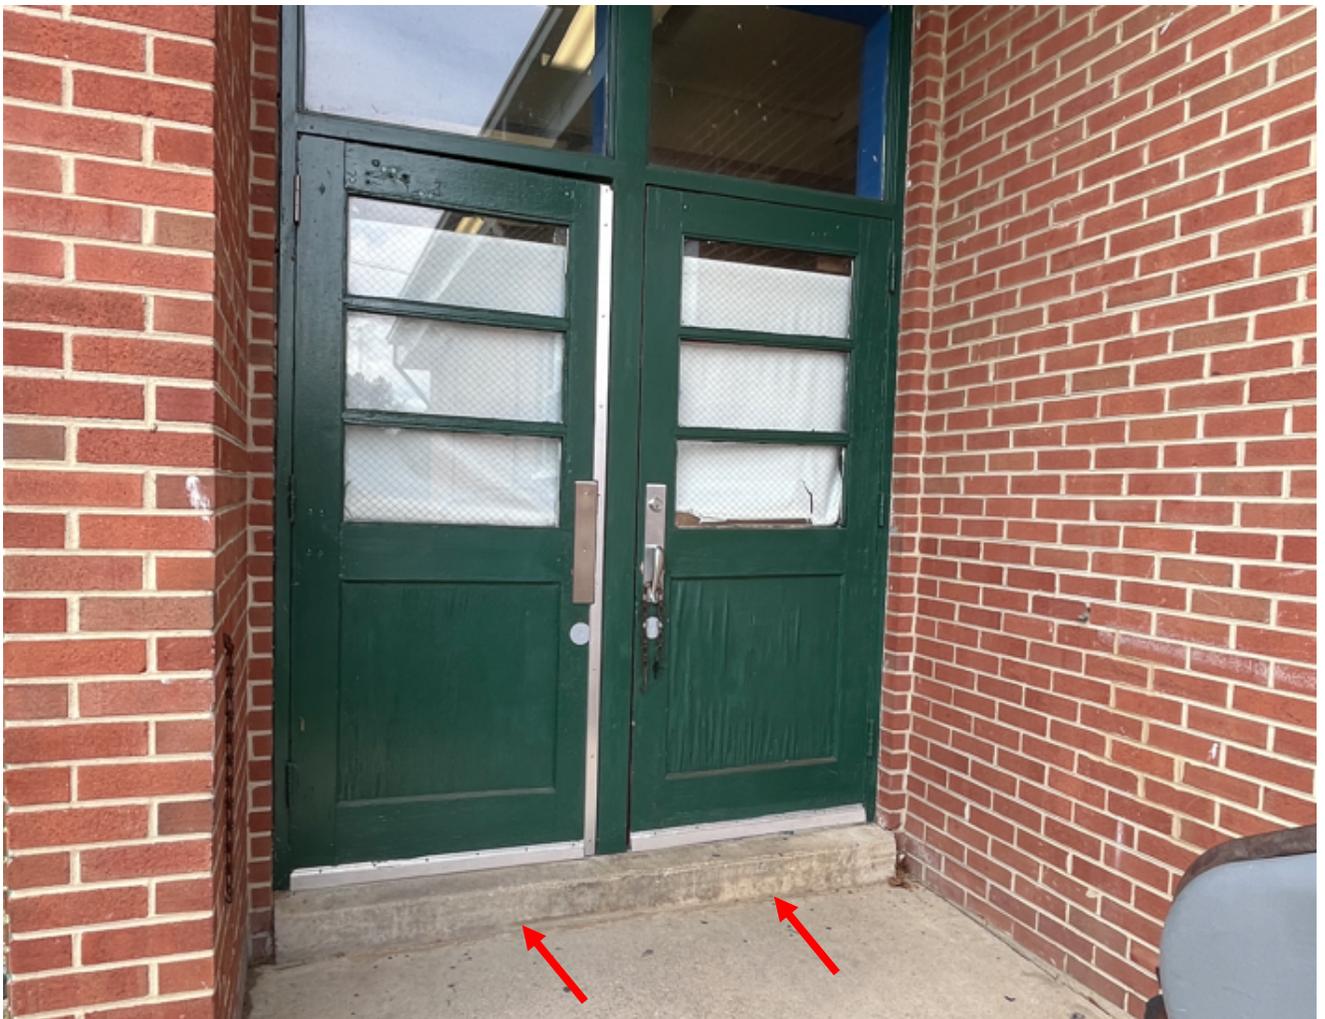
**PHOTO AB.01**

### **EXIT DISCHARGE ROUTE REQUIREMENTS (NFPA 101 & OSHA 1910)**

*Condition: Poor / Fair*

Ensure Straight & Level Walkways, Guardrails for Fall Hazards and Adequate Capacity of Exit Route
