## SCHOOL BOARD OFFICE

### Facility Condition Assessment

Caroline County Public Schools

April 4, 2024

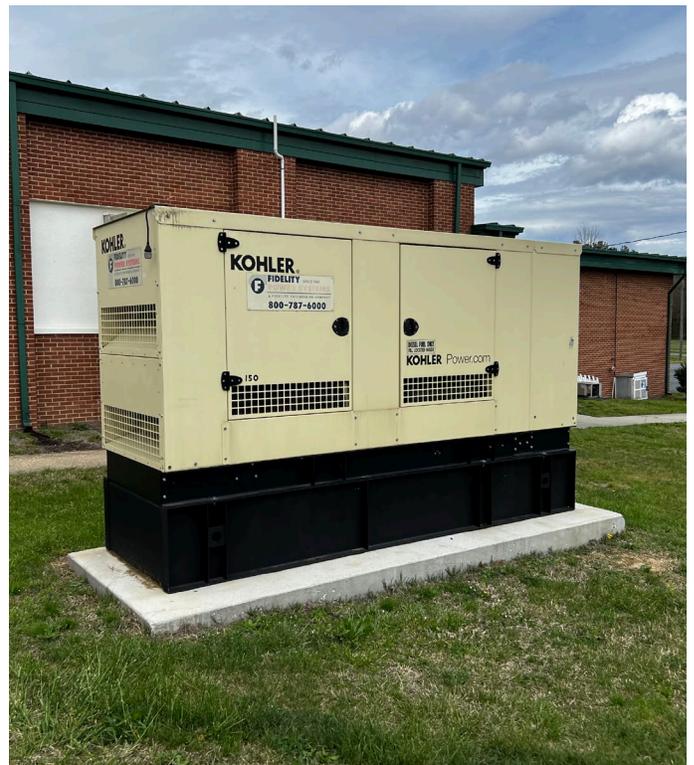
**PHOTO E.04  
GENERATOR**

*Condition: Poor / Fair  
Quantity: (1)*

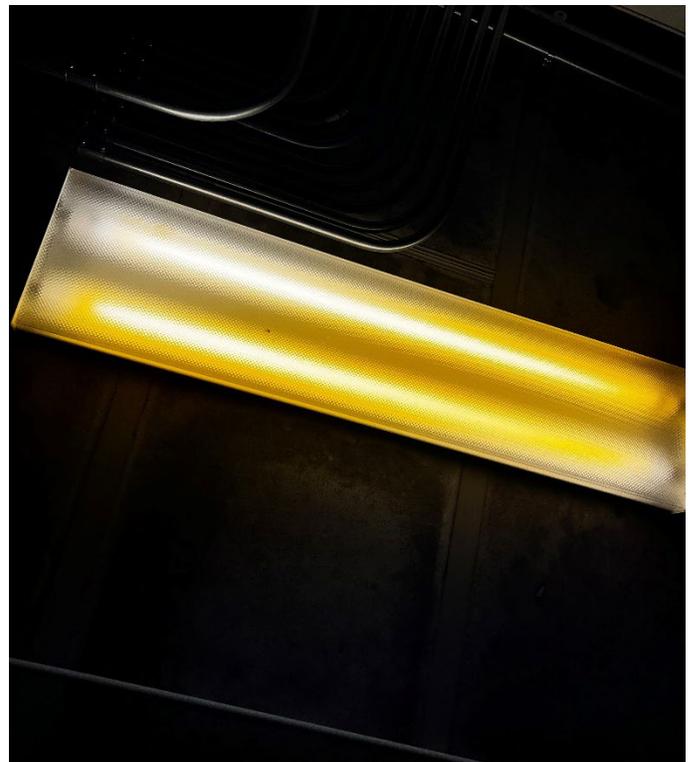
**Interior lighting** consists of a mixture of fixture types and lamp types, none seemed to be LED. The controllability is very limited and doesn't meet the current energy code, namely the International Energy Conservation Code (IECC). They consume much higher levels of energy, thus costing more to operate, and they provide marginal lighting levels in many locations in the building. Lighting controls are manual type only. There are no daylight harvesting or automatic lighting controls, which are also now required per the IECC.

Emergency egress lighting is predominately provided by emergency wall packs, none of the tested ones worked. Emergency wall pack light fixtures are still installed throughout the school despite a generator on site.

**PHOTO E.05  
LIGHTING**

*Condition: Poor / Fair  
Quantity: Approx. 36,235 SF*

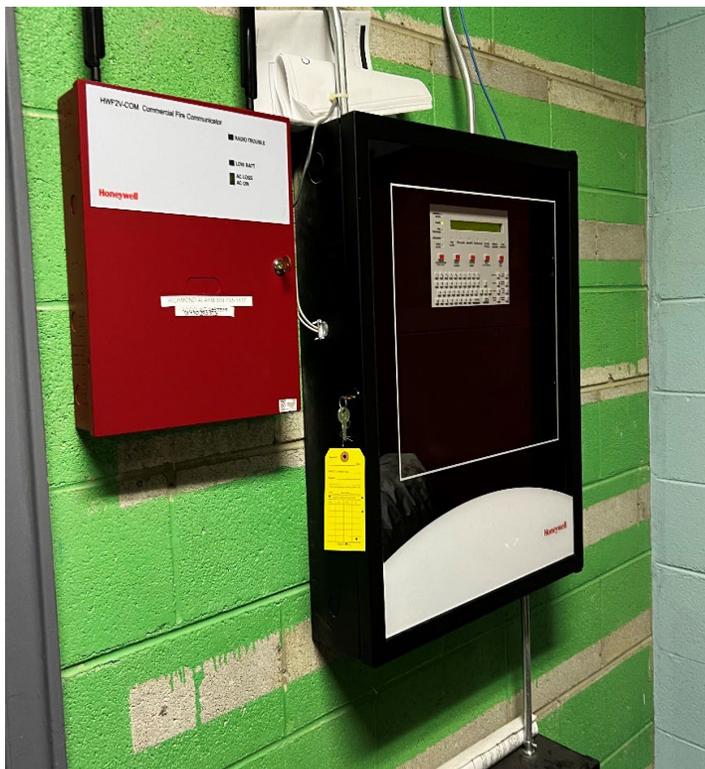
The **fire alarm system** has been updated in 2020 according to the building engineer, upon inspection this system utilized and older FACP but is still in good condition and does not need to be replaced.

**PHOTO E.10  
FIRE ALARM CONTROL PANEL**

*Condition: Good  
Quantity: (1)*

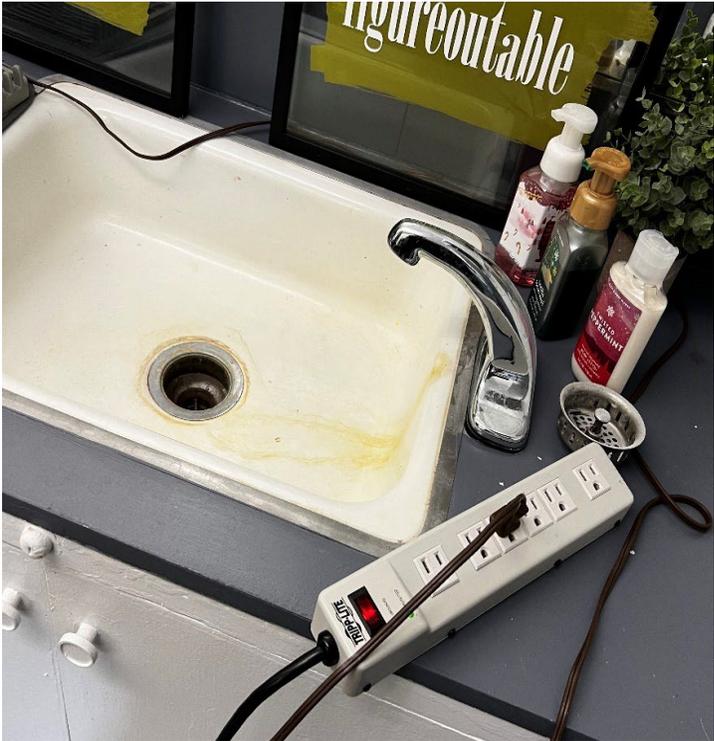
**Wiring devices** consist of devices original to the building and newer devices added overtime. There are areas where a water source is present and the receptacles are not GFCI protected as seen below. Both existing conditions related to grounding and ground-fault protection do not comply with current NEC requirements and associated devices should be replaced. There also appears to be a lack of power outlets within rooms as there are multiple power strips throughout the areas. Additionally, outlets should be provided to avoid the use of power strips. It is advisable to replace all of the devices and associated wiring.

**PHOTO E.11  
POWER STRIP**

*Condition: Poor  
Quantity: See Safety Compliance*

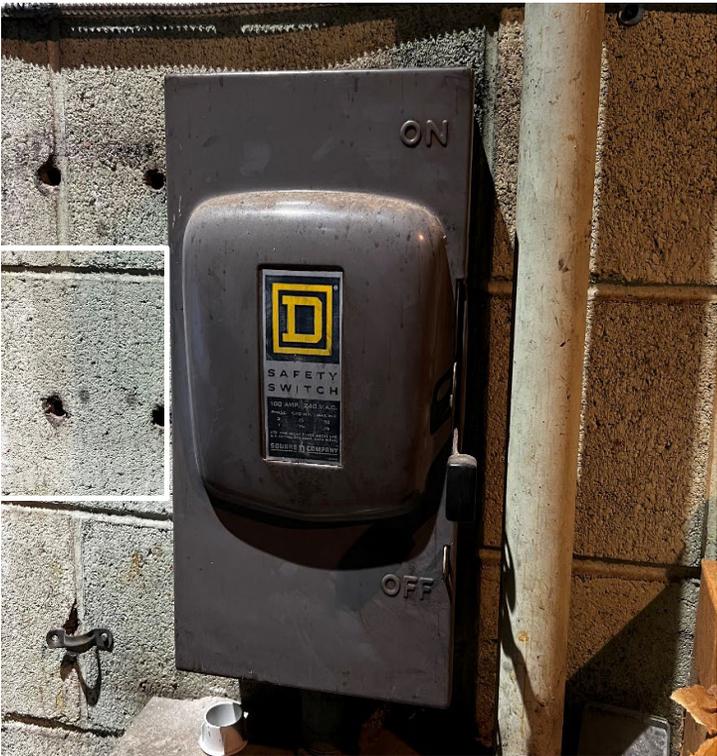
Local means of disconnects appear to be original to installation of equipment. Most of the mechanical equipment has been replaced withing the last 30 years, however most disconnects were observed to be In poor condition and except for a few that were recently installed, all should be replaced.

**PHOTO E.12  
DISCONNECT**

*Condition: Poor  
Quantity: Approx. 36,235 SF*

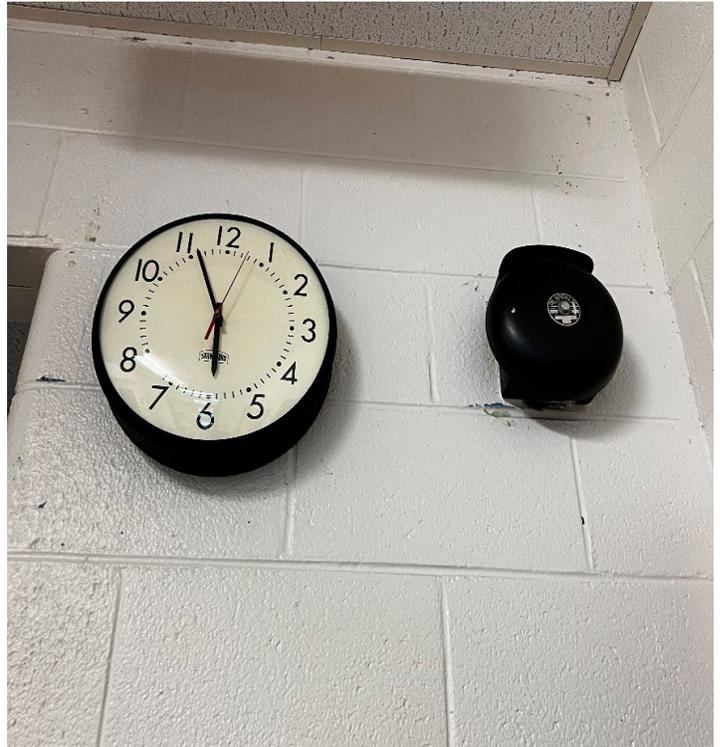
**PHOTO E.13**  
**SYSTEM CLOCK (TYPICAL)**

*Condition: Poor / Fair*

*Quantity: Approx. 36,235 SF*

The **intercom/clock system** is not currently functioning in multiple places. A new clock system should be installed to standardize the clocks across the building.

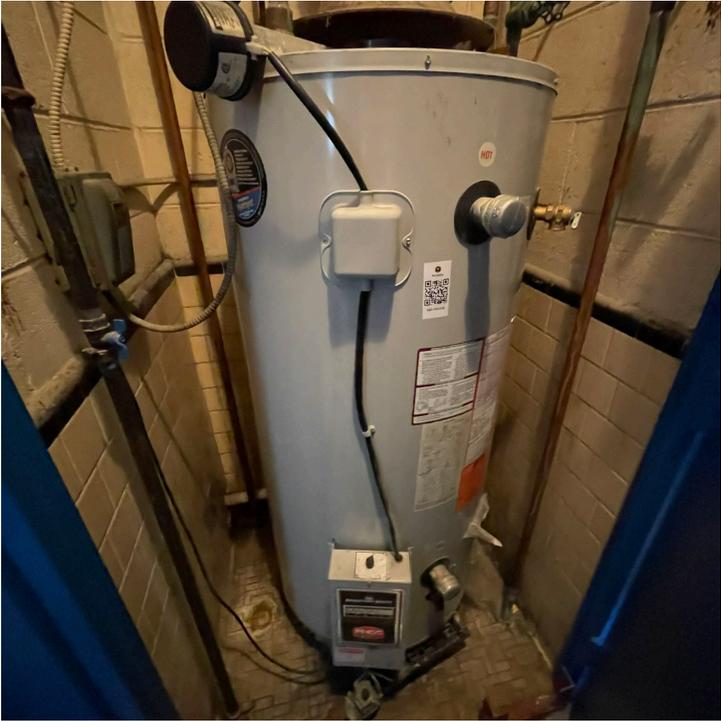
**PHOTO P.03  
DOMESTIC WATER HEATER**

*Condition: Fair  
Quantity: (3)*

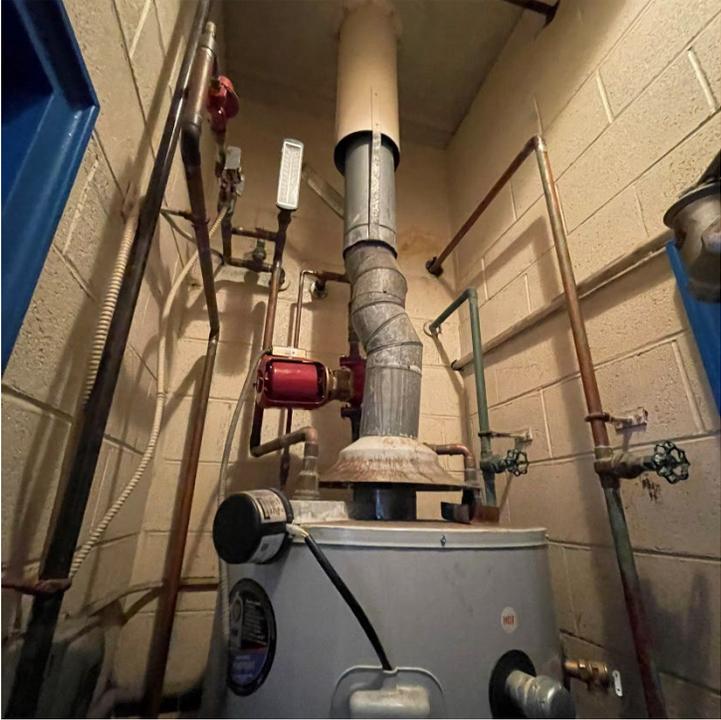
**PHOTO P.04  
DOMESTIC WATER PIPING AND  
WATER HEATER ACCESSORIES**

*Condition: Poor / Fair  
Quantity: Approx. 36,235 SF*

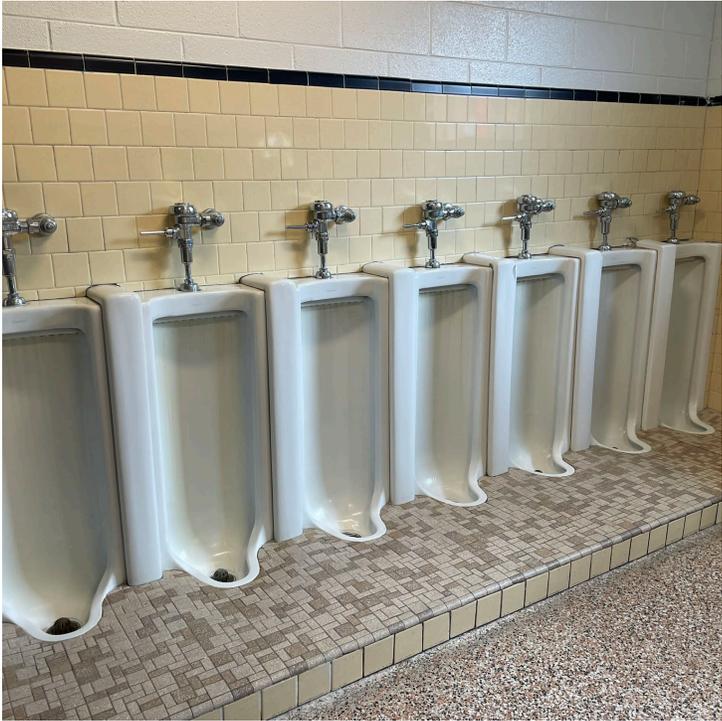
**PHOTO P.07**  
**URINAL**

*Condition: Poor*  
*Quantity: See ADA Compliance*

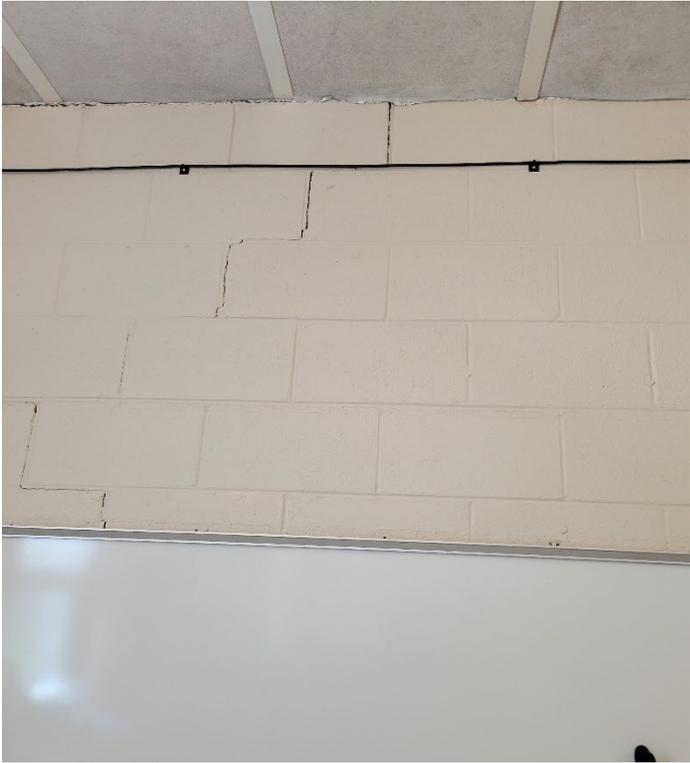
**PHOTO S.01A**  
**INTERIOR CMU WALL CRACKING**  
**AT STAIR STEP CRACKS**

*Condition: Poor*  
*Quantity: Approx. 1,710 LF (Repoint)*  
*Approx. 2,269 SF (Replace)*

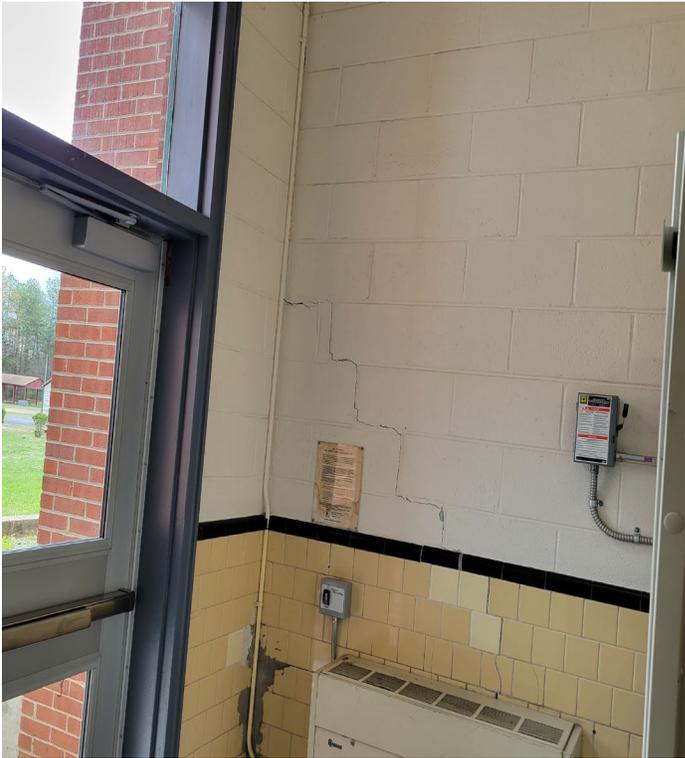
**PHOTO S.01B**  
**INTERIOR CMU WALL CRACKING**  
**AT STAIR STEP CRACKS**

*Condition: Poor*  
*Quantity: Approx. 1,710 LF (Repoint)*  
*Approx. 2,269 SF (Replace)*

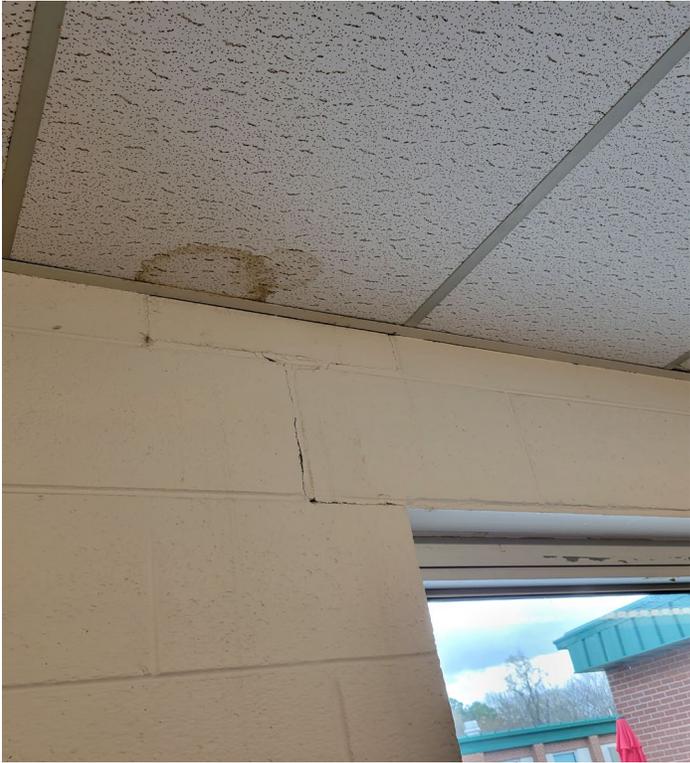
**PHOTO S.01C**  
**INTERIOR CMU WALL CRACKING**  
**AT STAIR STEP CRACKS**

*Condition: Poor*  
*Quantity: Approx. 1,710 LF (Repoint)*  
*Approx. 2,269 SF (Replace)*

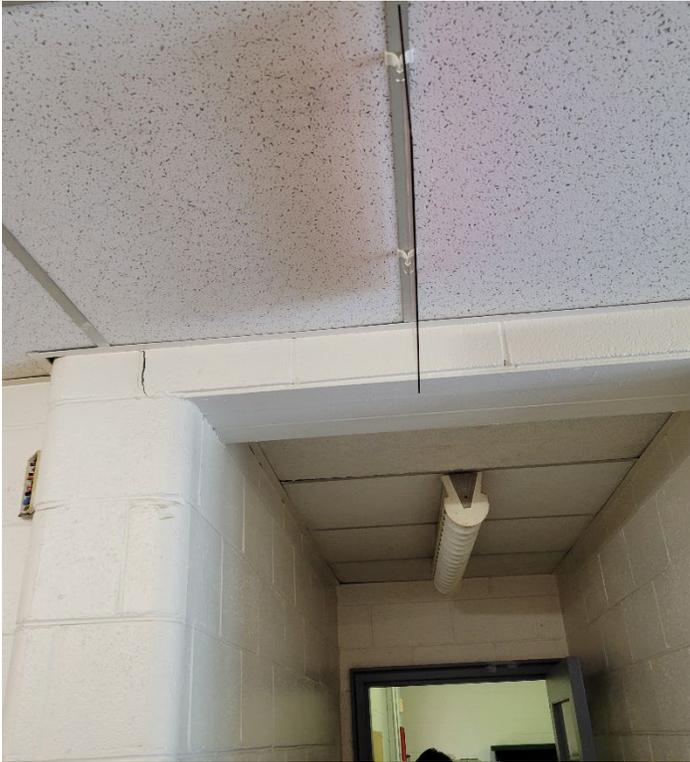
**PHOTO S.01D**  
**INTERIOR CMU WALL CRACKING**  
**AT STAIR STEP CRACKS**

*Condition: Poor*  
*Quantity: Approx. 1,710 LF (Repoint)*  
*Approx. 2,269 SF (Replace)*

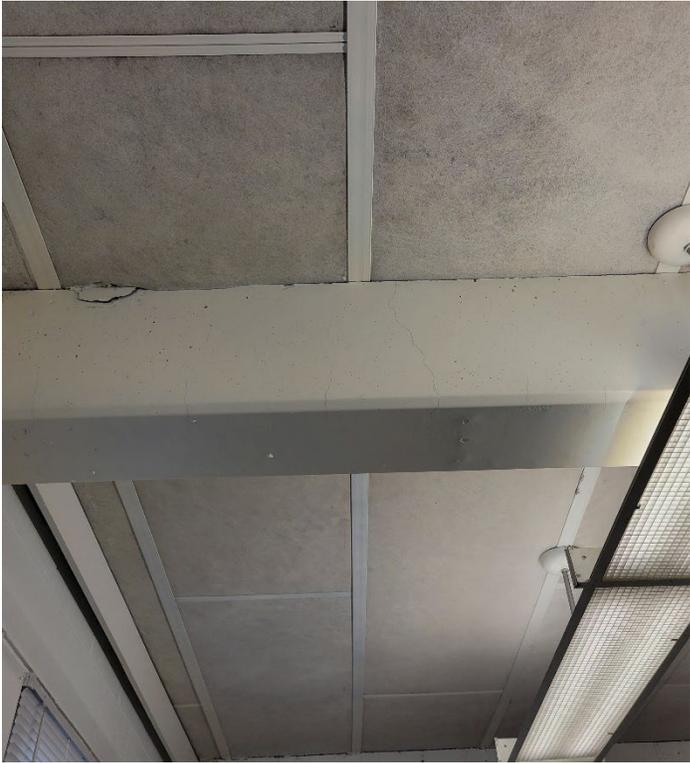
**PHOTO S.02  
INTERIOR BEAM CRACKING  
AND SPALLING**

*Condition: Fair  
Quantity: Approx. 240 LF*

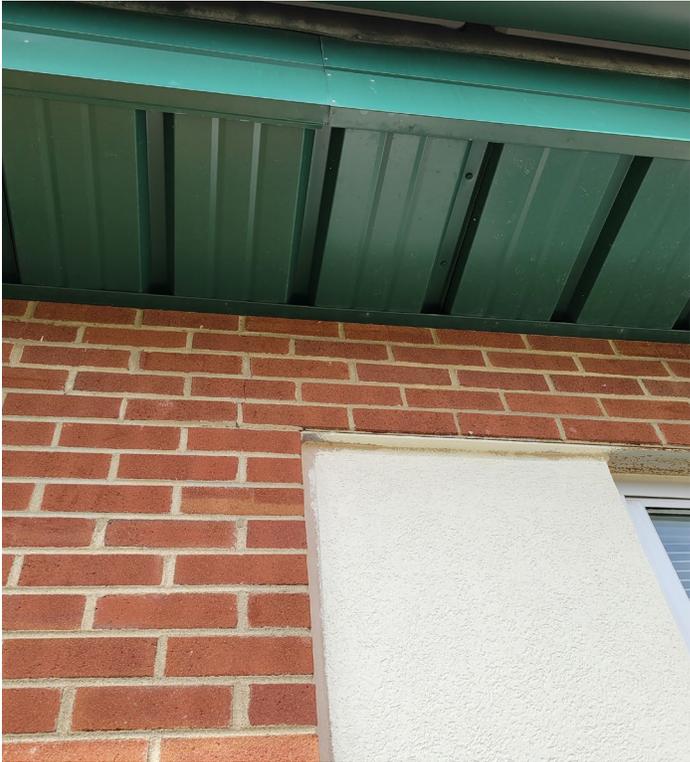
**PHOTO S.03  
EXTERIOR BRICK VENEER CRACKS**

*Condition: Poor / Fair  
Quantity: See Architectural - Exterior*

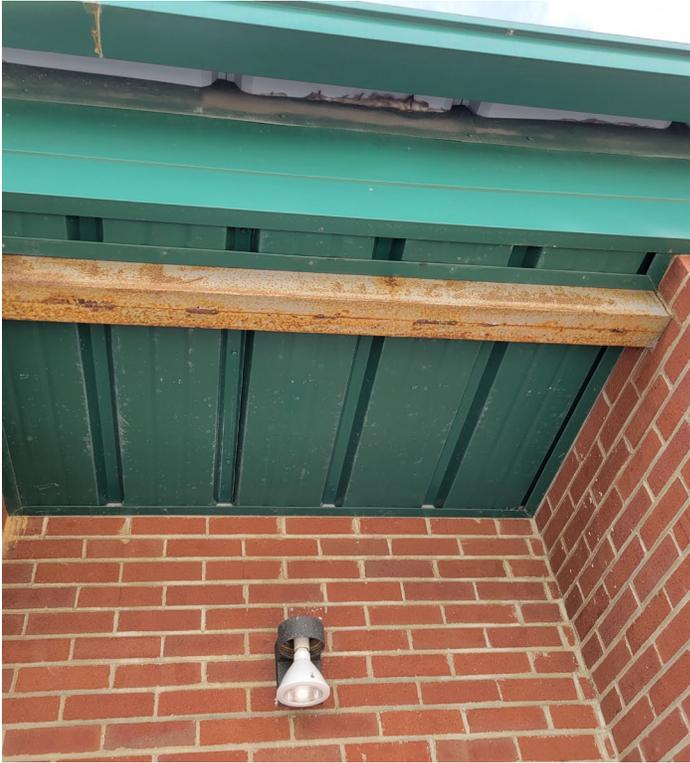
**PHOTO S.04**  
**EXTERIOR CORRODED STEEL AT**  
**ENTRIES**

*Condition: Fair*  
*Quantity: Approx. 16 LF*

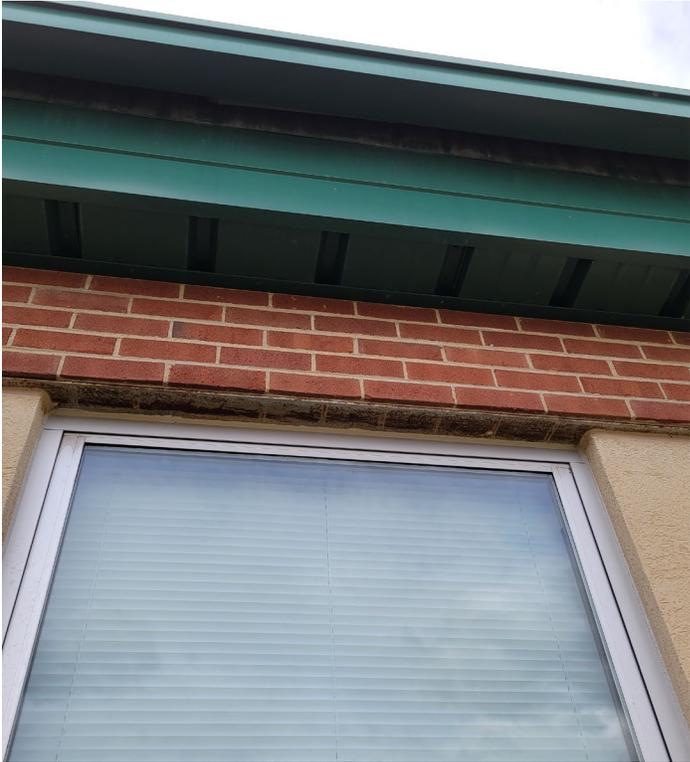
**PHOTO S.05**  
**EXTERIOR CORRODED STEEL LINTELS**

*Condition: Poor*  
*Quantity: Approx. 460 LF*

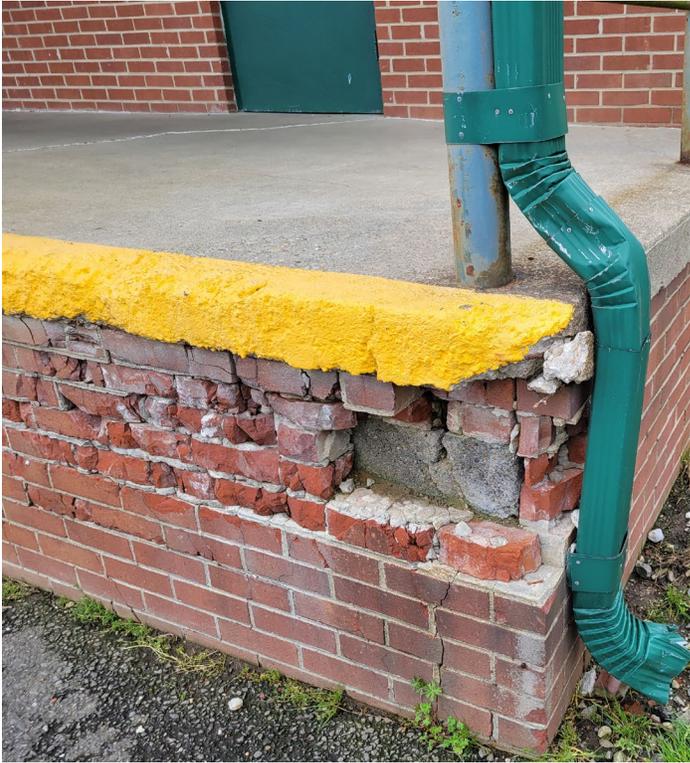
**PHOTO S.06**  
**EXTERIOR LOADING DOCK - DAMAGED**  
**MASONRY AND CORRODED COLUMNS**

*Condition: Poor*  
*Quantity: See Architectural - Exterior*
