MADISON ELEMENTARY SCHOOL

Facility Condition Assessment

Caroline County Public Schools

April 2, 2024

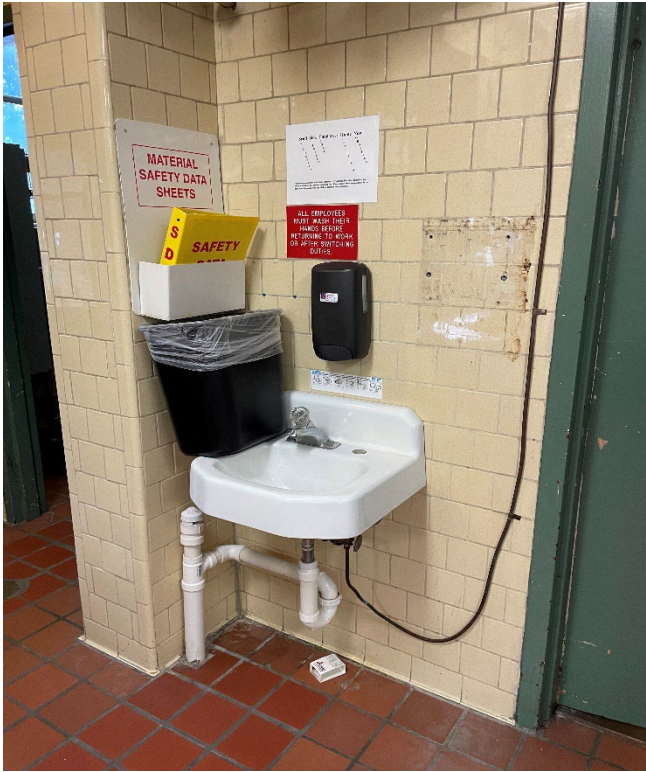
PHOTO K.2 THE HAND SINK FAUCET NEEDS TO BE REPLACED AND A TOWEL DISPENSER NEEDS TO BE INSTALLED.

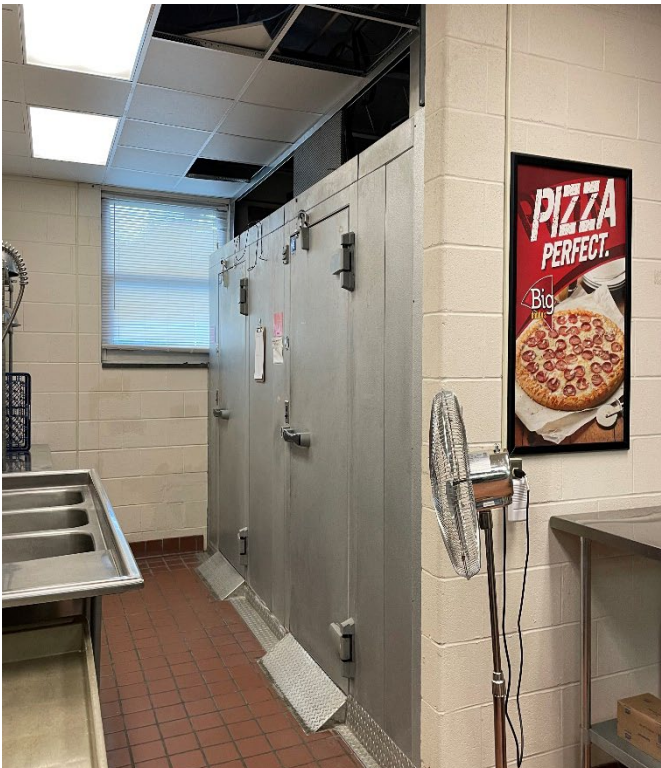
PHOTO K.3 THERE ARE STEEP RAMPS UP TO THE WALK-INS AND THERE ARE MANY CEILING TILES AND TRIM MISSING.
