MADISON ELEMENTARY SCHOOL

Facility Condition Assessment

Caroline County Public Schools

April 2, 2024

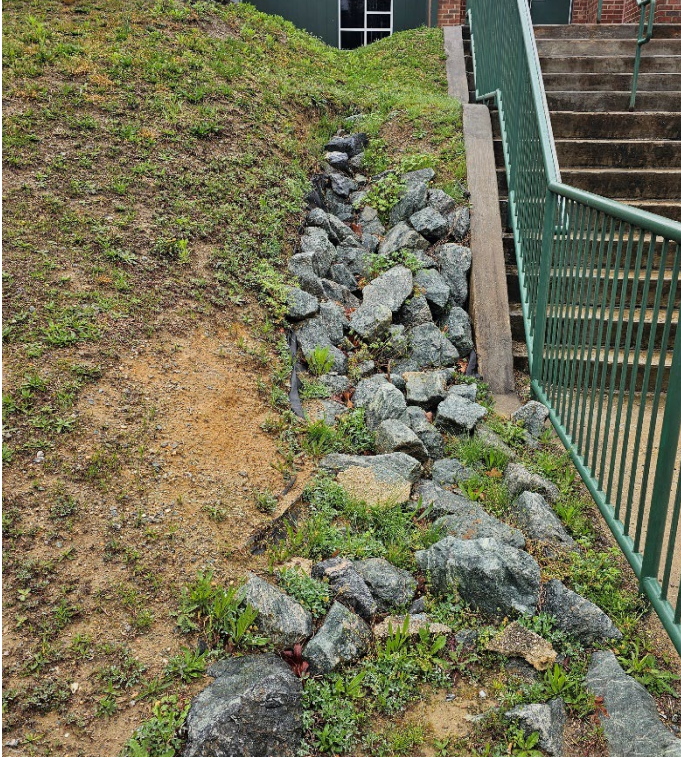
PHOTO C2.2
REPAIR/REPLACE RIP RAP ALONG STEEP SLOPE

Condition: Fair
Quantity: Approx. 100 SF

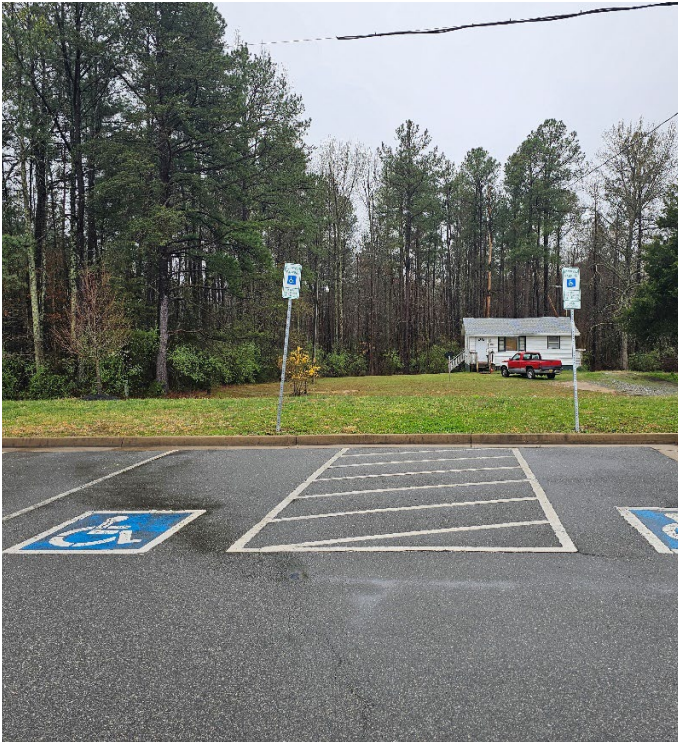
PHOTO C4.1
PROVIDE 2 ADDITIONAL ADA PARKING SPACES

Condition: Poor
Quantity: Stripping / Signage (2 ADA spaces)

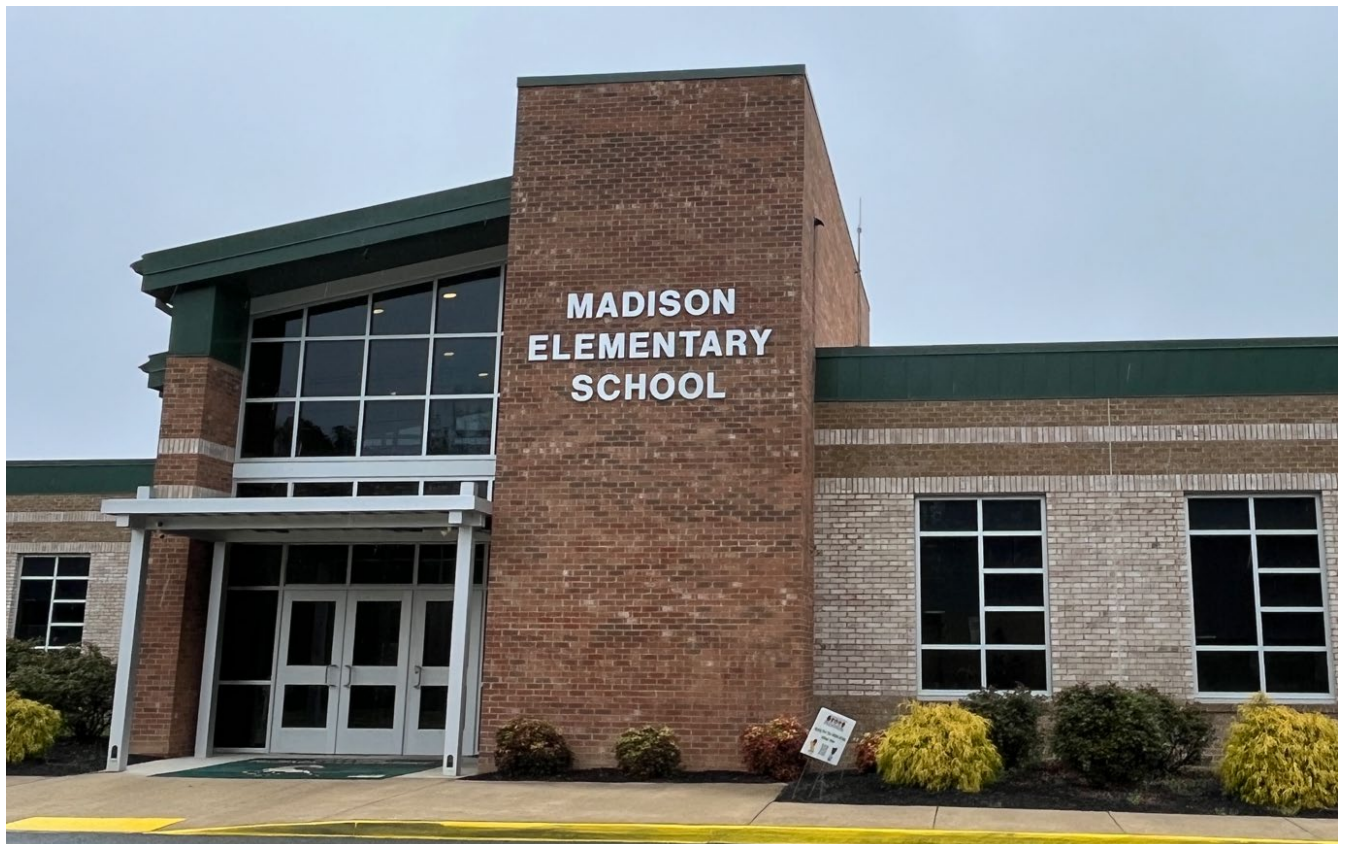
PHOTO AE.01
MORTAR DETERIORATION @ STONE SILLS

Condition: Fair
Quantity: Approx. 40 LF

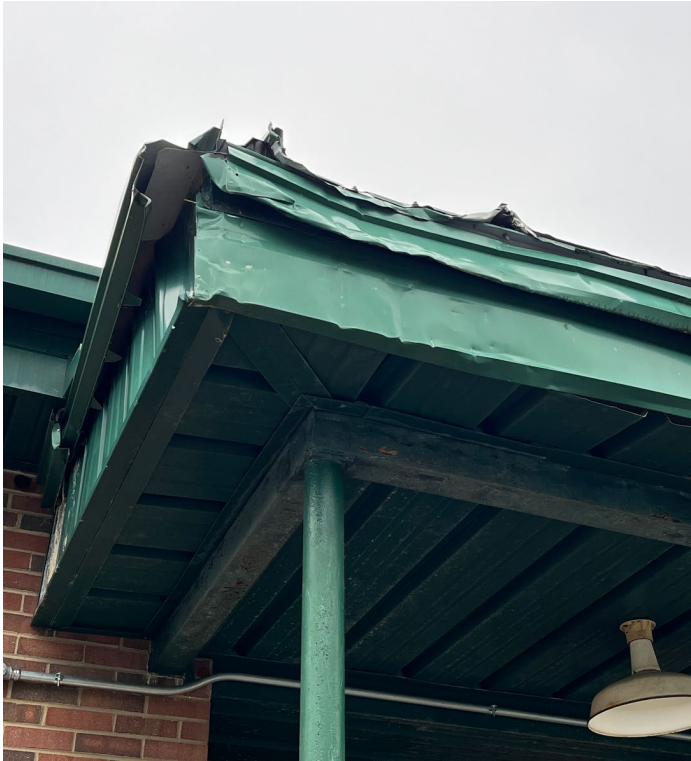
**PHOTO AE.09
DAMAGED LOADING DOCK CANOPY**

*Condition: Poor
Quantity: (1) Location*

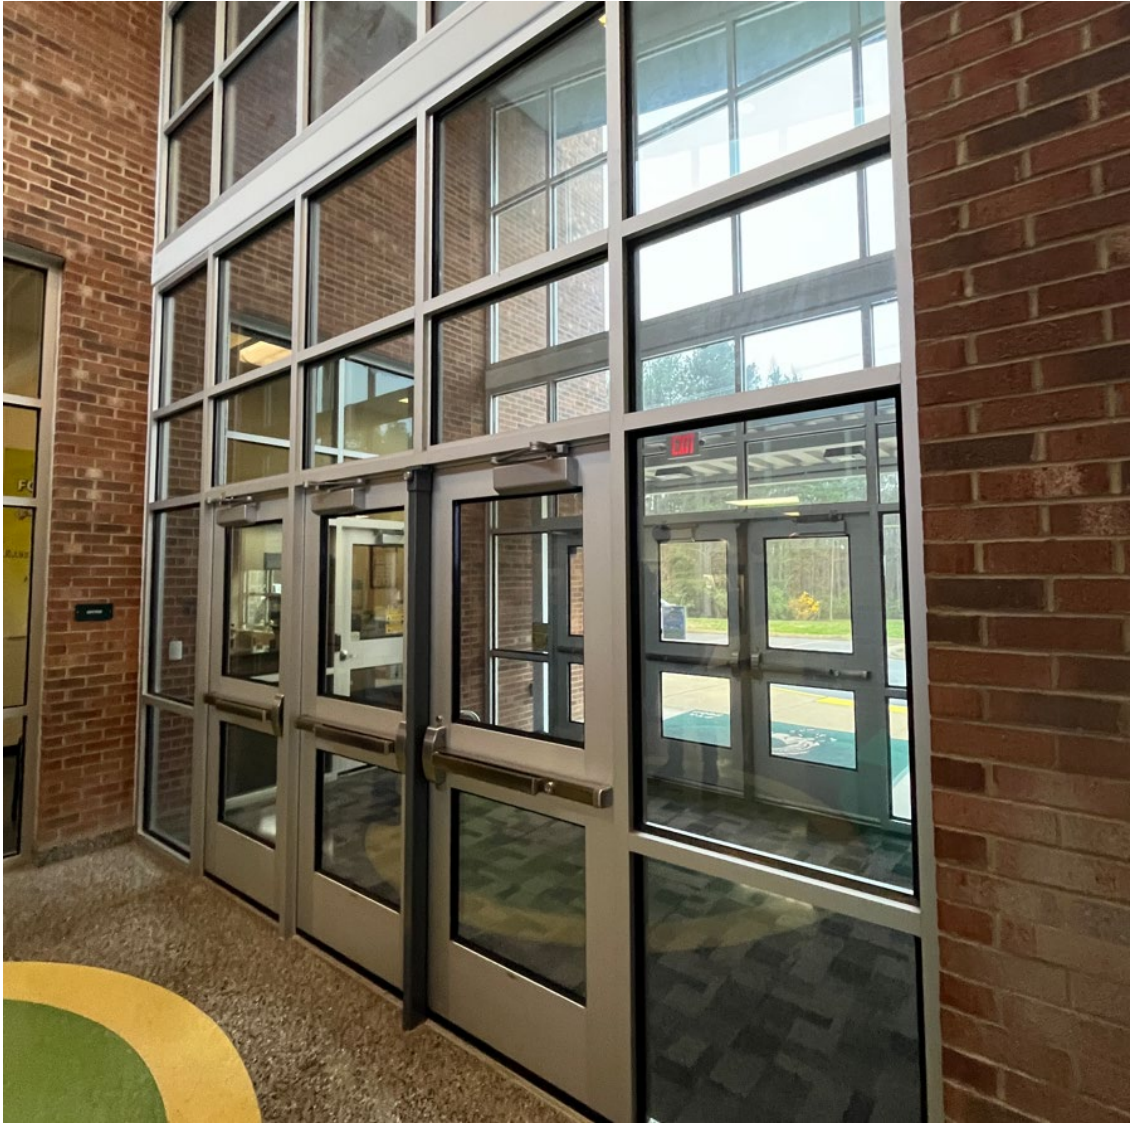
PHOTO AI.01
SCHOOL ENTRY VESTIBULE

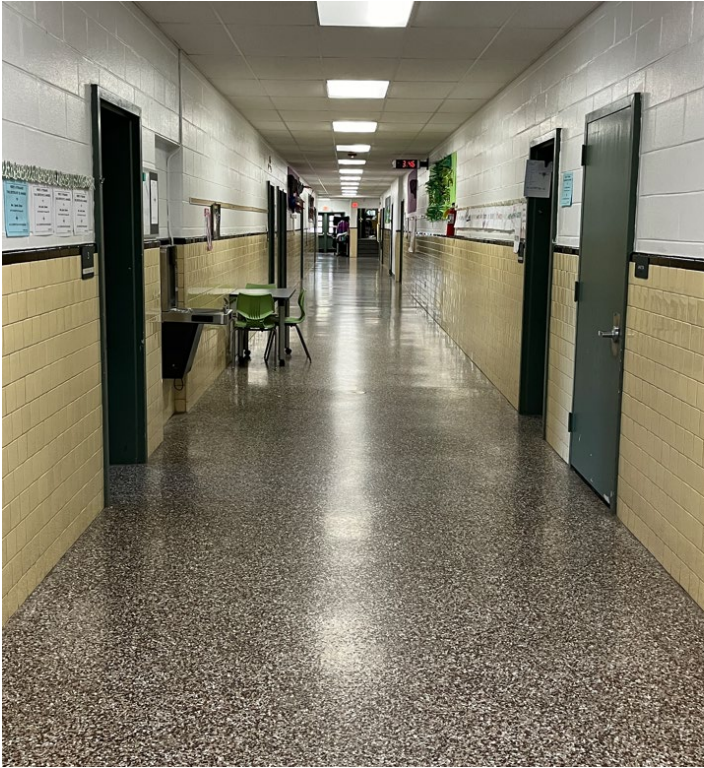
**PHOTO AI.02
TYPICAL CORRIDOR FLOORING
(TERRAZZO)**

*Condition: Good
Quantity: Approx. 12,987 SF*

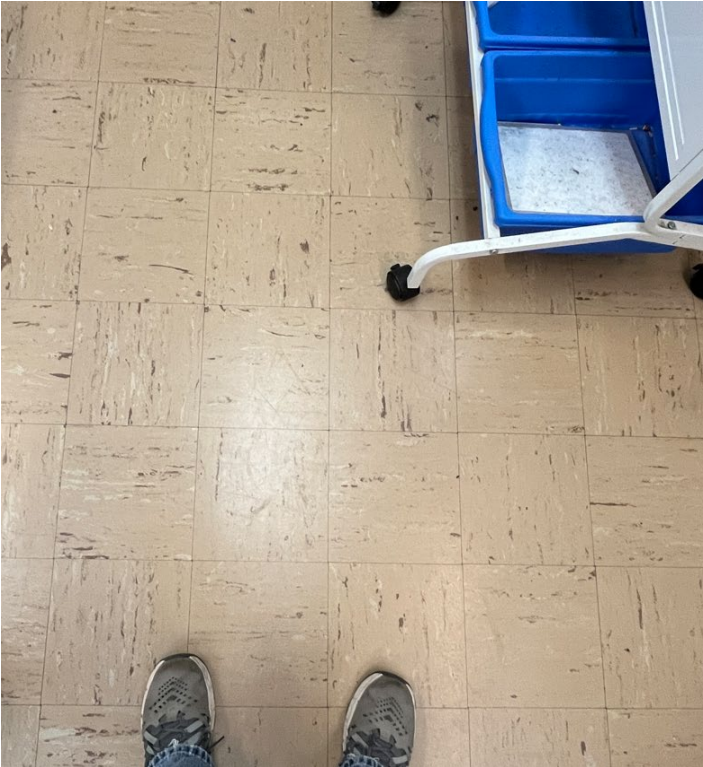
**PHOTO AI.03
TYPICAL CLASSROOM FLOORING (VCT)**

*Condition: Fair / Good
Quantity: Approx. 33,260 SF*

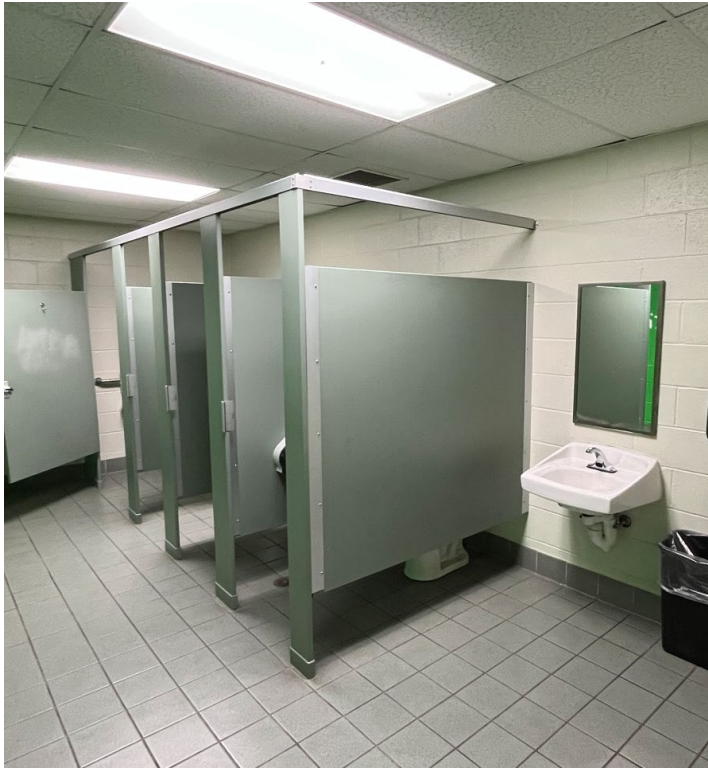
PHOTO AI.11
TYPICAL GROUP TOILET ROOMS

Condition: Fair / Good
Quantity: Approx. 925 SF

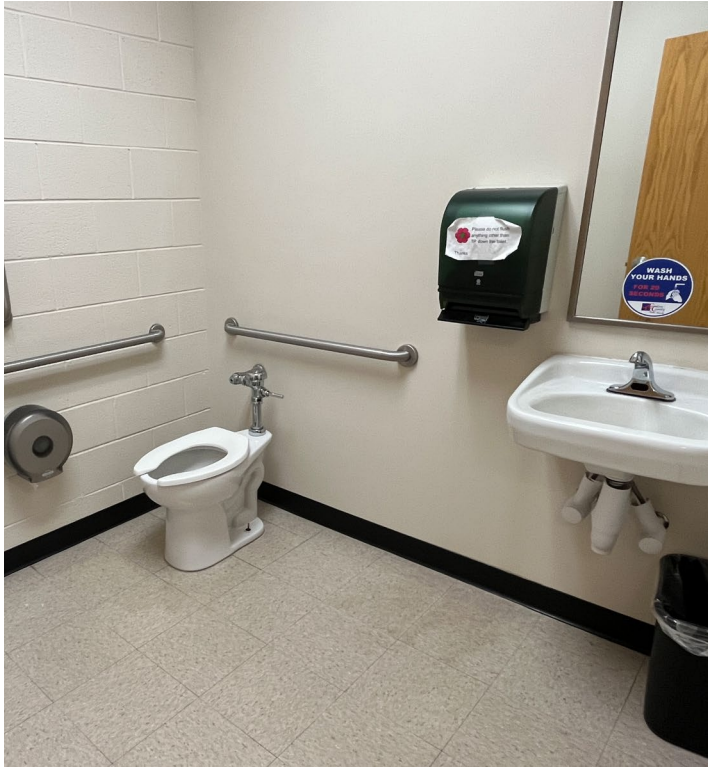
PHOTO AI.12
TYPICAL SINGLE TOILET ROOMS

Condition: Fair / Good
Quantity: Approx. 700 SF

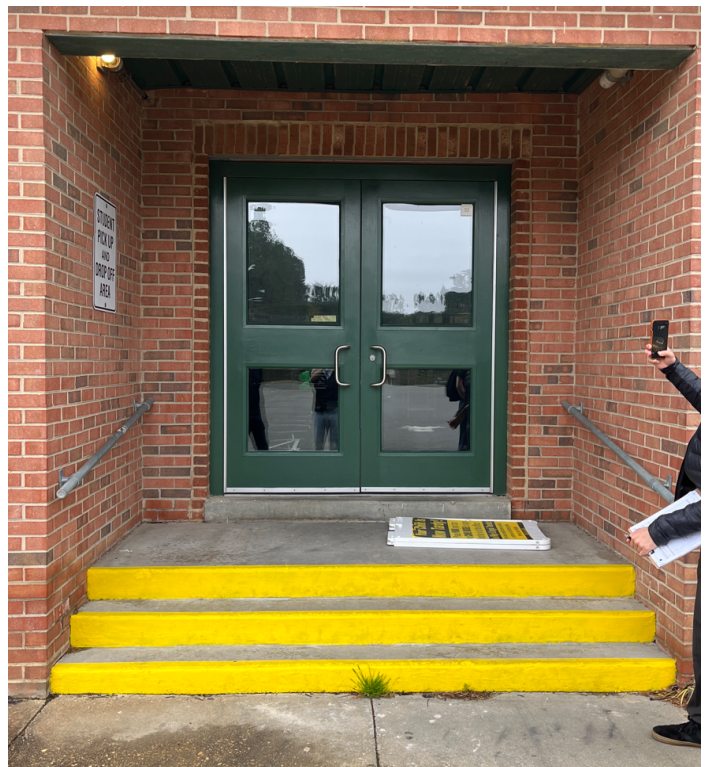
PHOTO AA.01
BUILDING ENTRANCE - ACCESSIBLE EGRESS
AND HANDRAIL EXTENSIONS
(ADAAG 402, 505.10.2, 505.10.3)

Condition: Poor / Fair
Quantity: (2) Locations

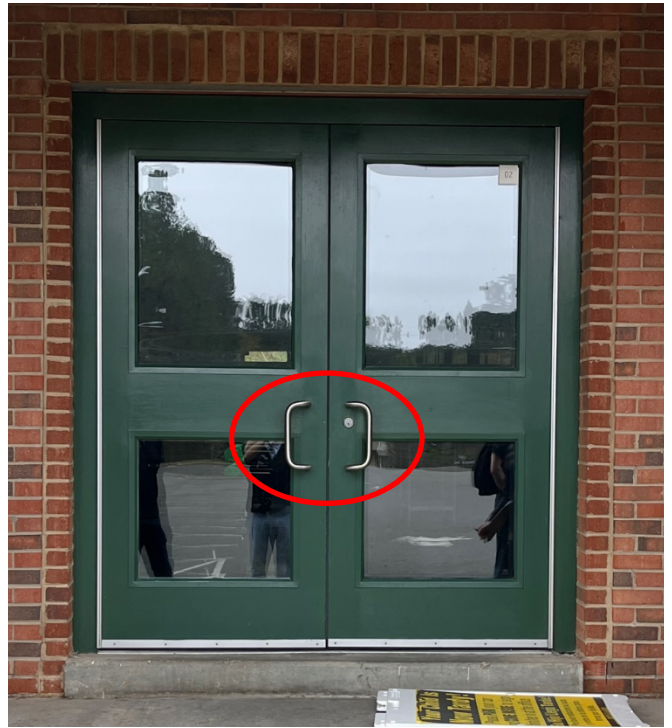
**PHOTO AB.01
PANIC EXIT DOOR HARDWARE (TRAP HAZARD)**

*Condition: Fair
Quantity: (4) Double Doors*

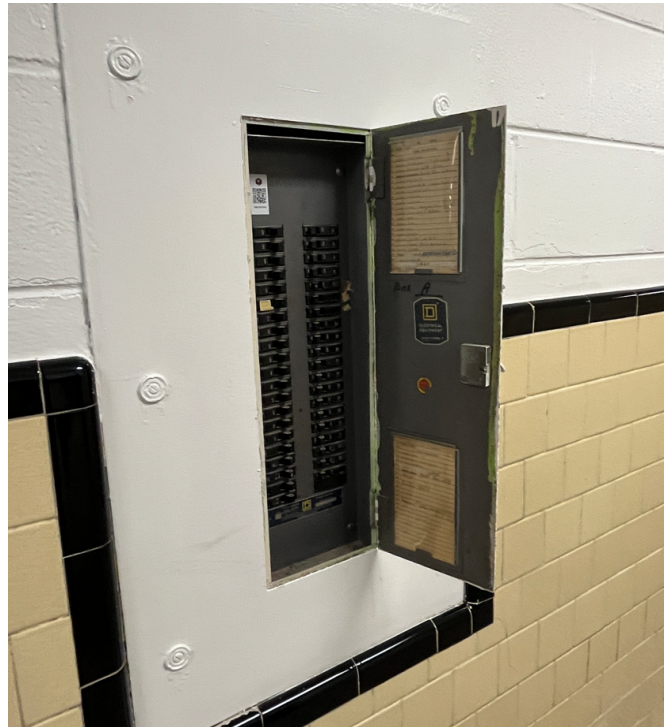
PHOTO AB.03
UNSECURED ELECTRICAL PANELS

Condition: Poor / Fair
Quantity: Multiple (School-Wide)

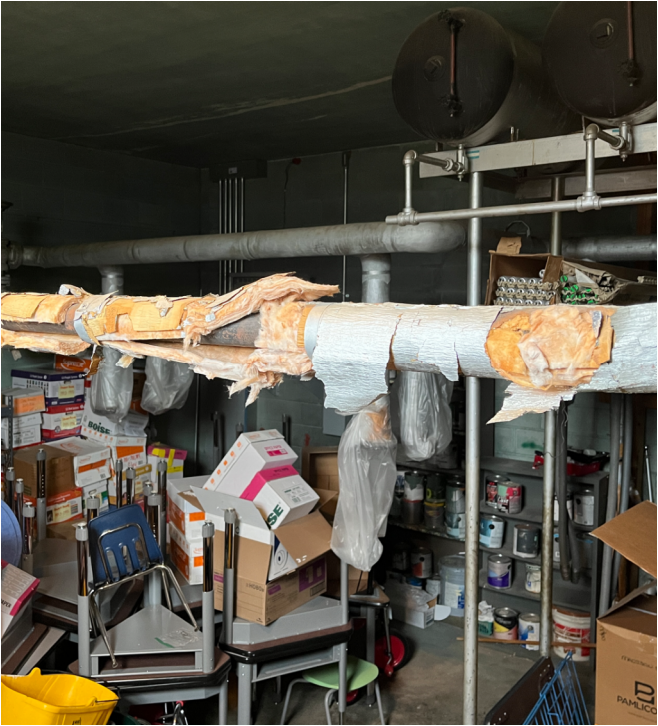
**PHOTO AB.05
IMPROPERLY STORED MATERIALS**

*Condition: Fair
Quantity: (1) Location*

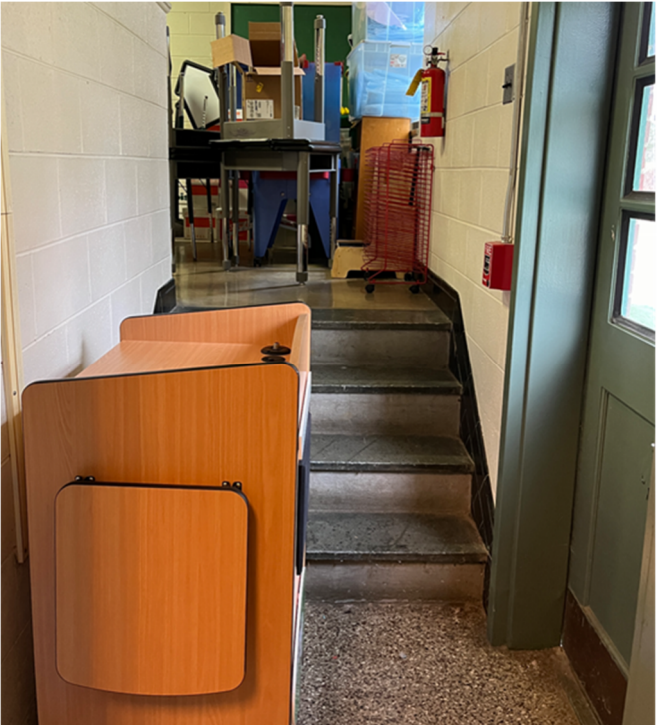
**PHOTO AB.06
BLOCKED EGRESS FROM STAGE**

*Condition: Fair
Quantity: (1) Location*

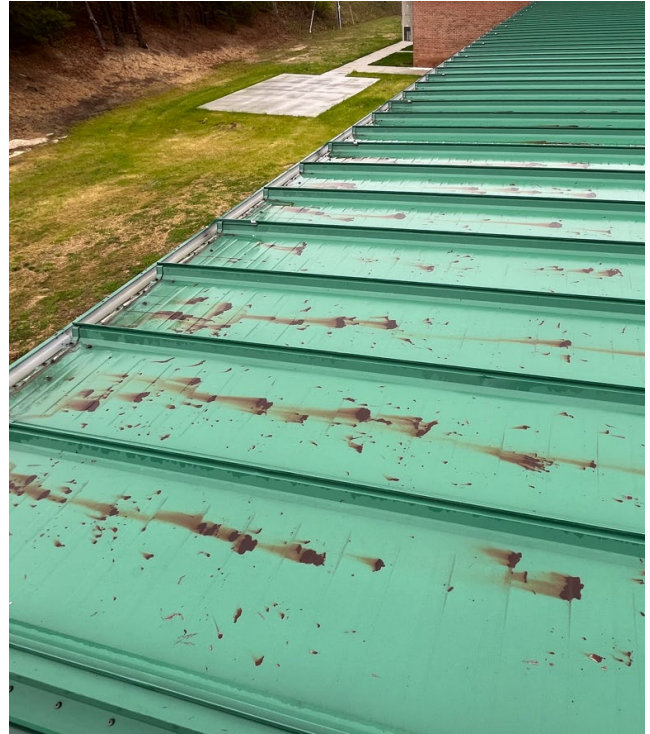
Condition: Poor

Quantity: Approx. 44,073 SF

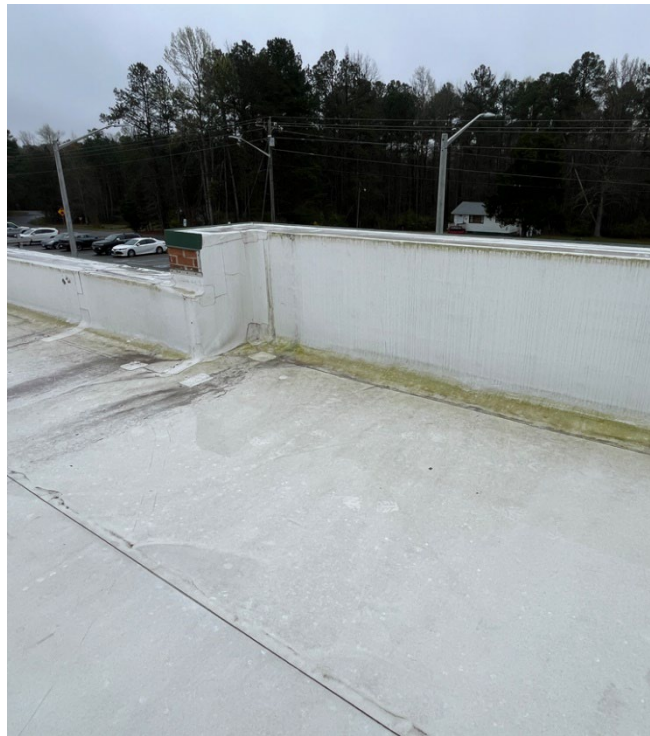
PHOTO AR.02
POLYVINYL CHLORIDE (PVC) ROOF

Condition: Good

Quantity: Approx. 18,120 SF

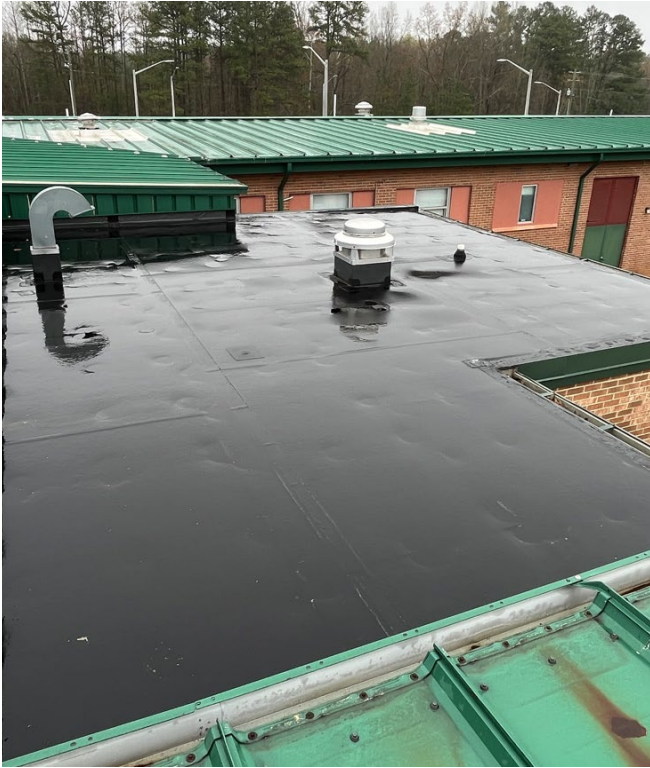
**PHOTO AR.03
EPDM ROOF**

*Condition: Fair / Good
Quantity: Approx. 833 SF*

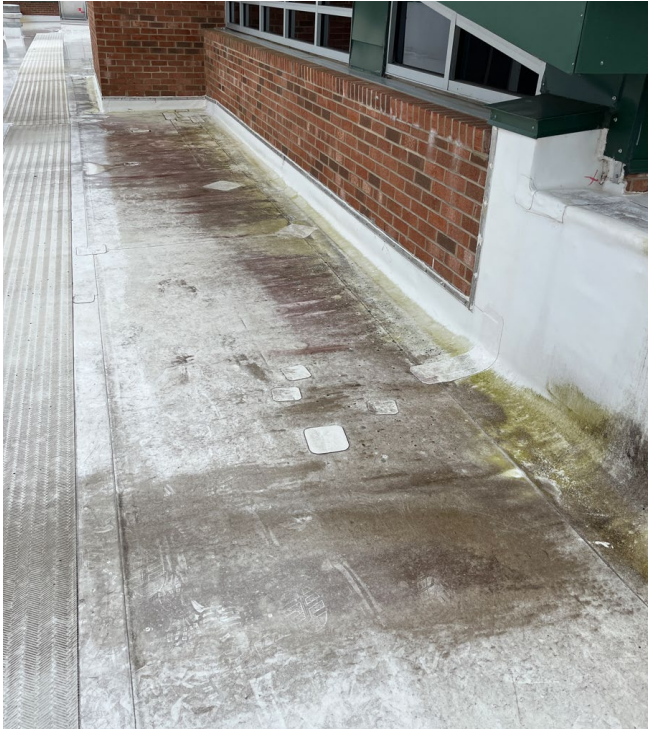
**PHOTO AR.04
ALGAE / MILDEW GROWTH (PVC ROOF)**

*Condition: Poor / Fair
Quantity: Approx. 18,120 SF*

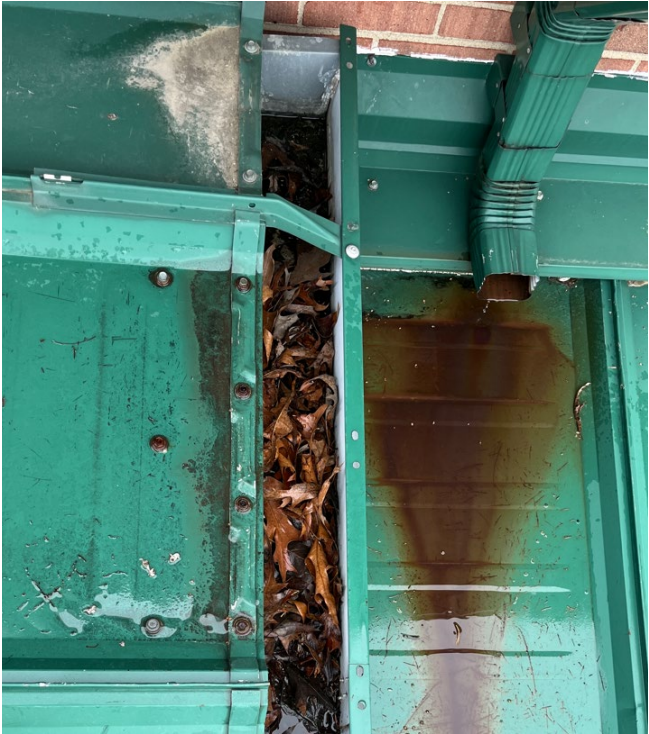
**PHOTO AR.05
DEBRIS BUILD UP (GUTTER)**

*Condition: Poor / Fair
Quantity: Approx. 1,620 LF*

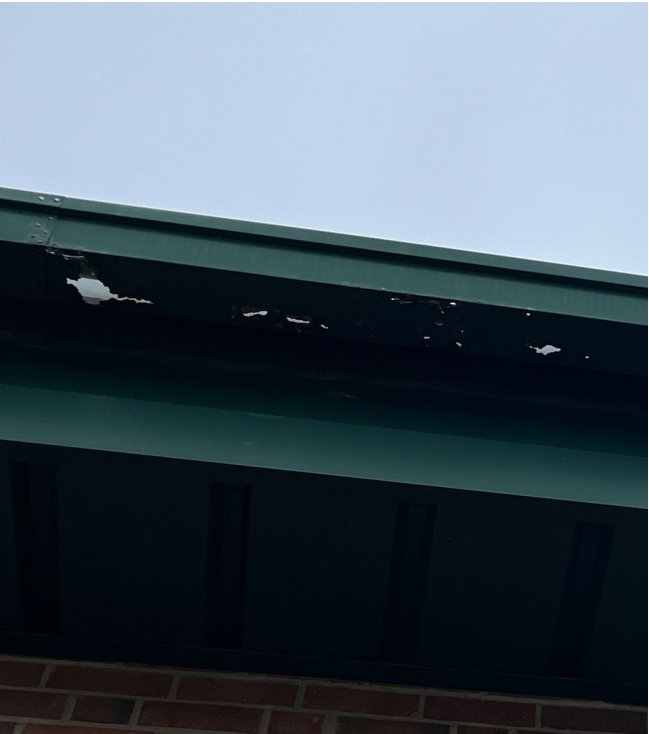
**PHOTO AR.06
GUTTER RUSTING AND HOLES**

*Condition: Poor
Quantity: Included in Item AR.01*

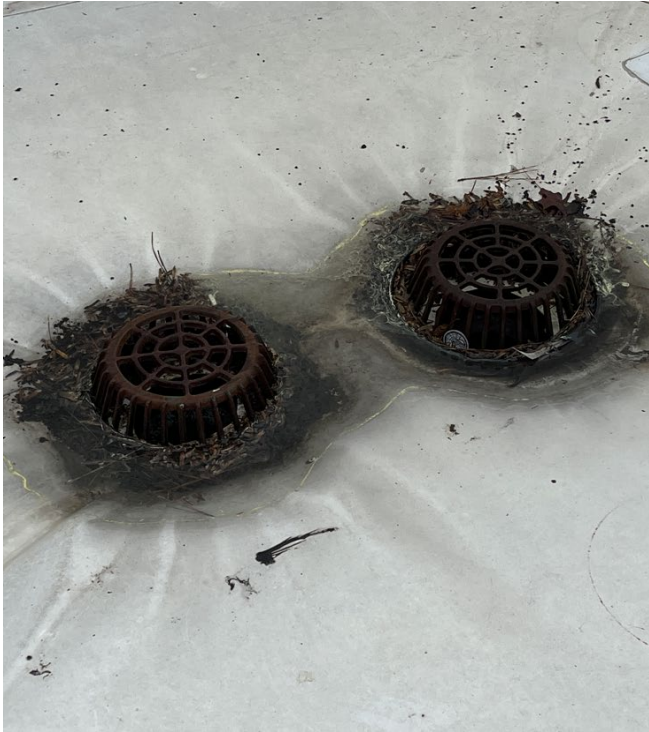
PHOTO AR.07
ROOF DRAIN COVERAGE / BUILD-UP

Condition: Fair
Quantity: Included in Item AR.04

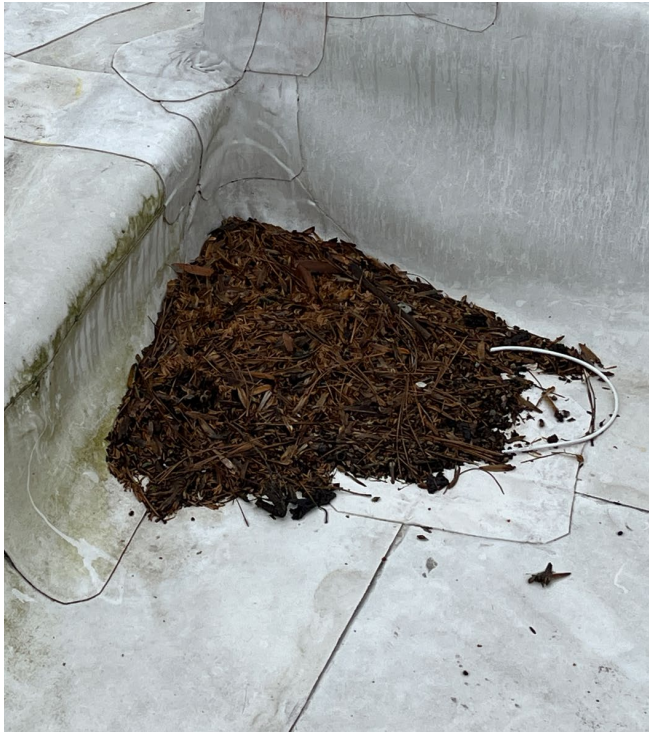
PHOTO AR.08
VEGETATIVE DEBRIS BUILD-UP

Condition: Fair
Quantity: Included in Item AR.04

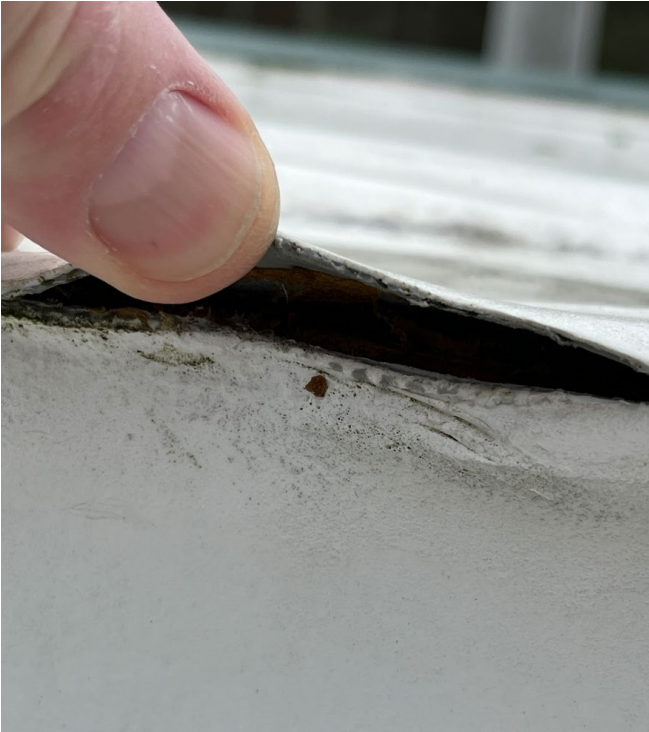
PHOTO AR.09
RIPPED/TORN PVC ROOF

Condition: Poor
Quantity: (1) Location

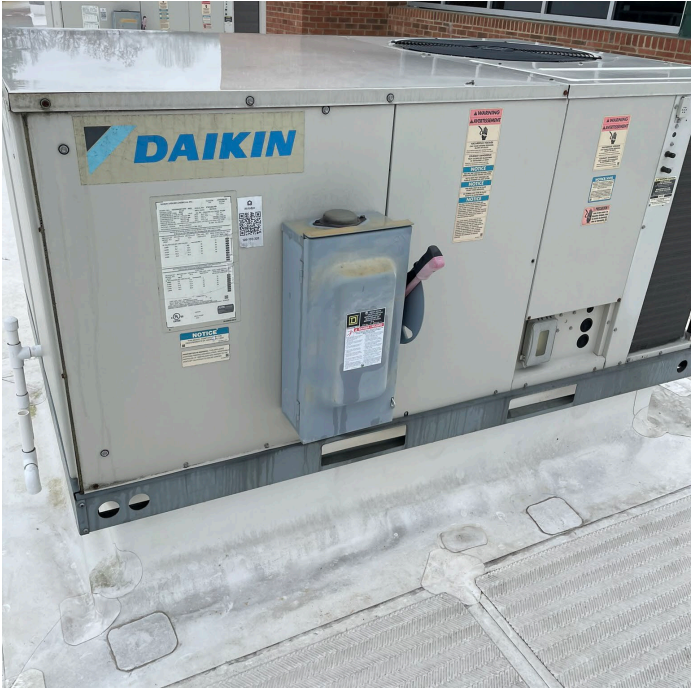
PHOTO M.01
ADMIN AREA ROOFTOP DOAS UNIT

Condition: Good
Quantity: (5)

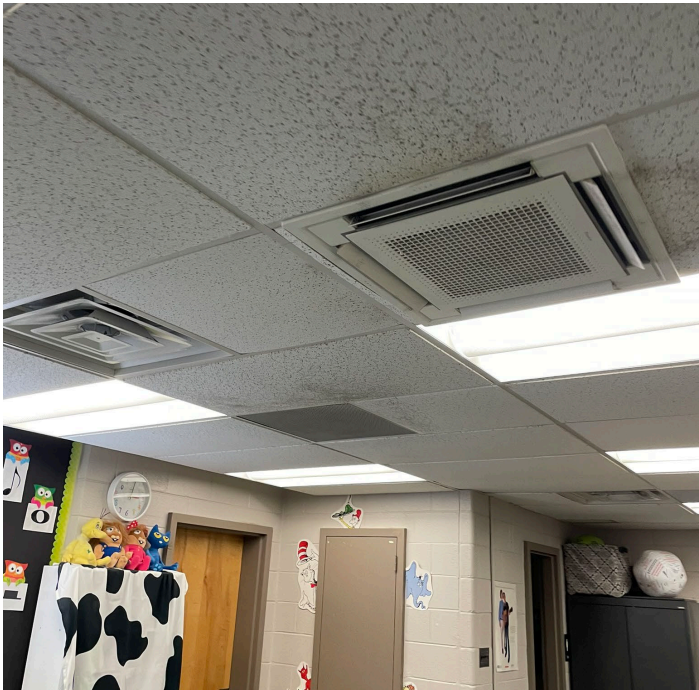
PHOTO M.02
AIR TERMINAL AND VRF IN ADMIN

Condition: Good
Quantity: 10,229 SF

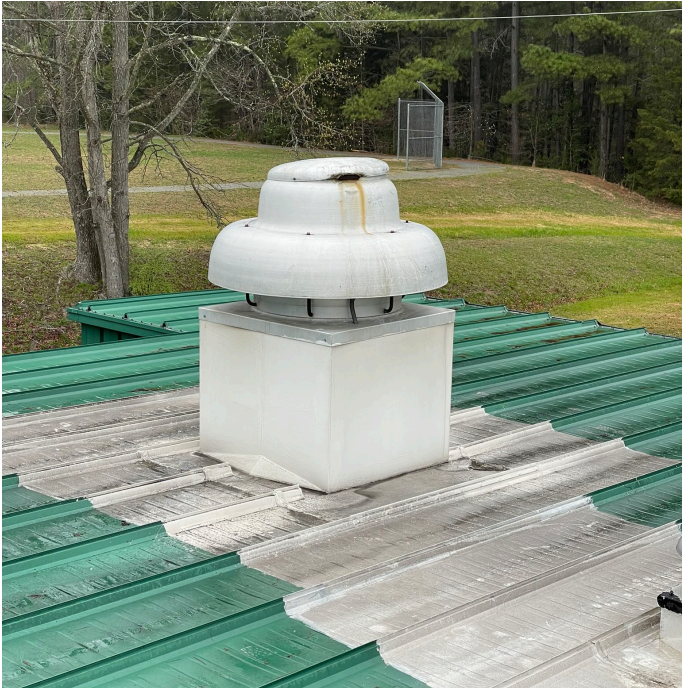
PHOTO M.03
KITCHEN EXHAUST FAN

Condition: Poor
Quantity: (1)

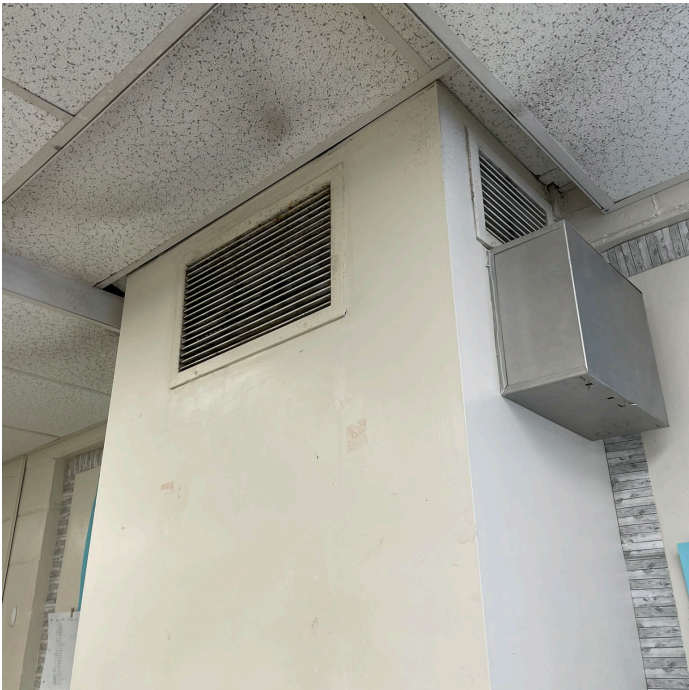
PHOTO M.04
CLASSROOM AIR TERMINAL

Condition: Fair
Quantity: 42,672 SF

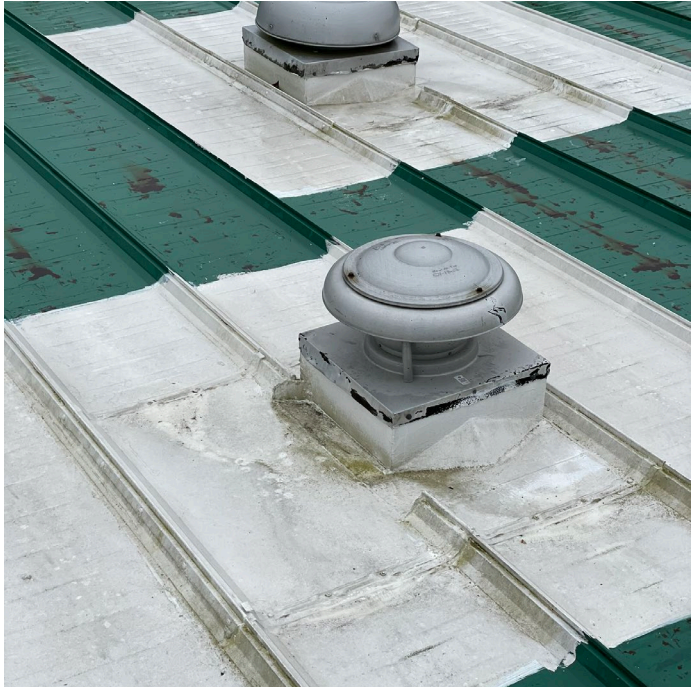
**PHOTO M.05
EXHAUST FANS**

*Condition: Fair
Quantity: Approx. 12 Fans*

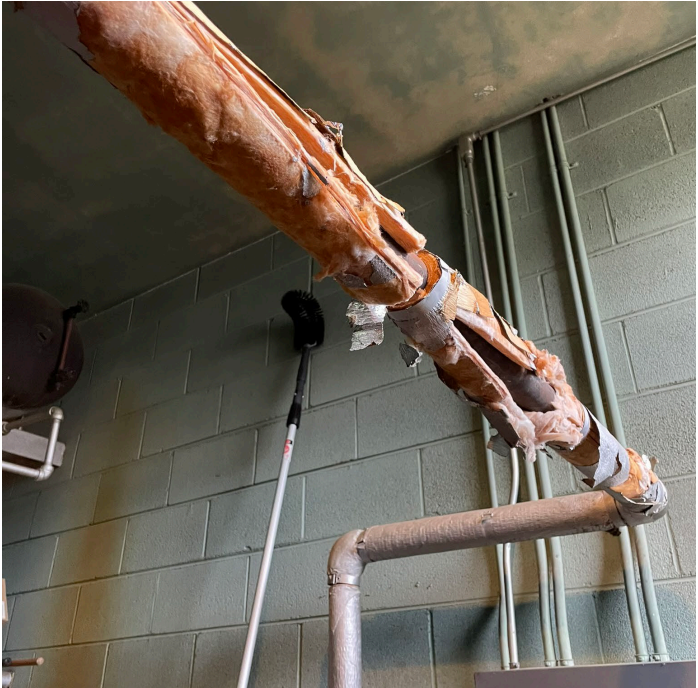
**PHOTO M.07
HYDRONIC PIPING**

*Condition: Abandoned
Quantity: 1,865 SF*

1. The central heating plant is abandoned in place and should be removed to utilize the space better. Before this work is completed, an asbestos report should be completed if one has not already been completed.
2. The rooftop units and VRF system are in good condition and have most of their expected life in them.
3. The Bard style units serving the classrooms should be replaced within the next 5 years as they will hit their 20-year expected lifespan. The air terminals should be replaced as well, as they are showing signs of rust.
4. The kitchen exhaust fan should be replaced as it is showing signs of damage and rust. The rest of the exhaust fans can be replaced in 5-10 years.
5. Provide a mini-split in the teacher break room and remove the circulation fan. There is nothing in the space to condition the heat put off by the 2 refrigerated vending machines.

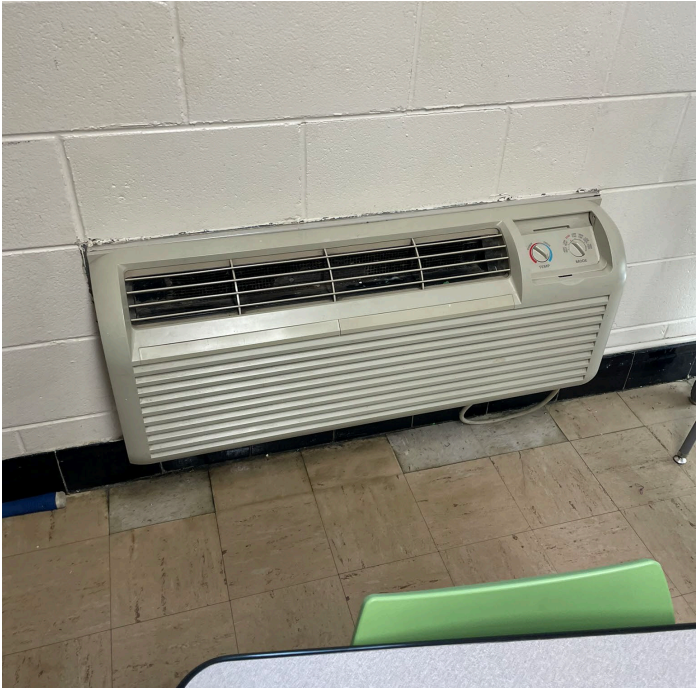
**PHOTO M.08
OFFICE PTAC**

*Condition: Fair
Quantity: (2)*

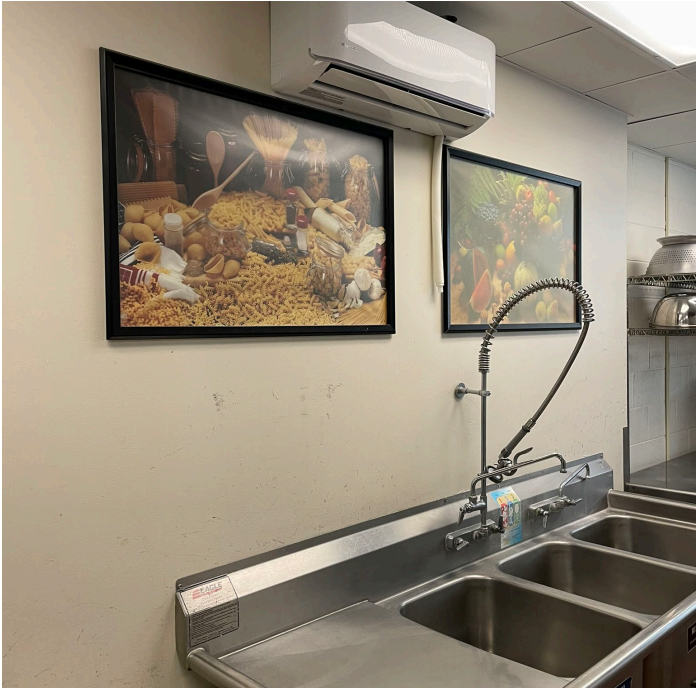
**PHOTO M.09
KITCHEN MINI-SPLIT**

*Condition: Good
Quantity: (1)*

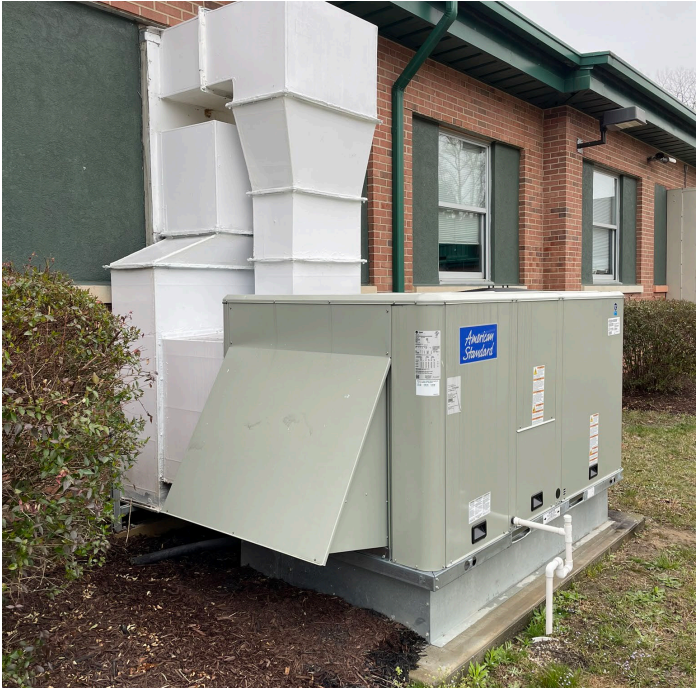
**PHOTO M.10
CLASSROOM DX HEAT PUMP UNIT**

*Condition: Good
Quantity: (2)*

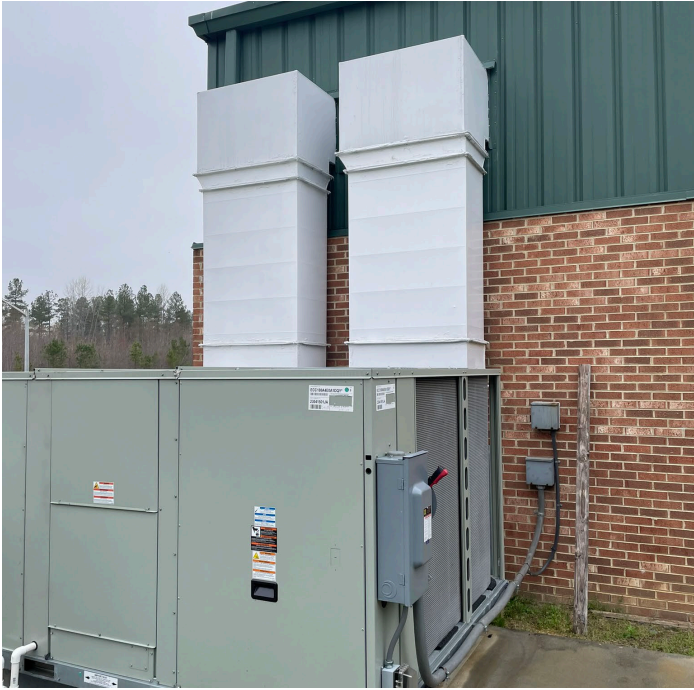
**PHOTO M.11
GYMNASIUM DX HEAT PUMP UNIT**

*Condition: Good
Quantity: (1)*

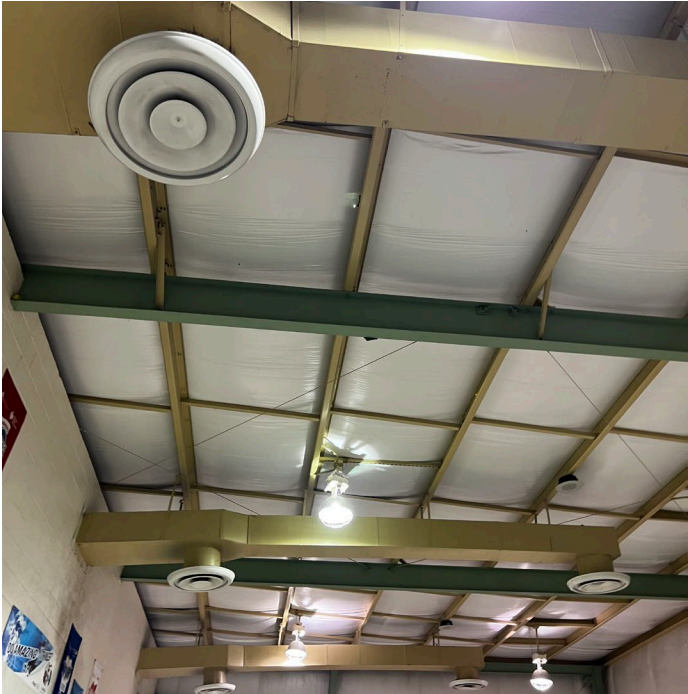
**PHOTO M.14
GYMNASIUM DUCTWORK AND AIR
TERMINALS**

*Condition: Fair
Quantity: 2,666 SF*

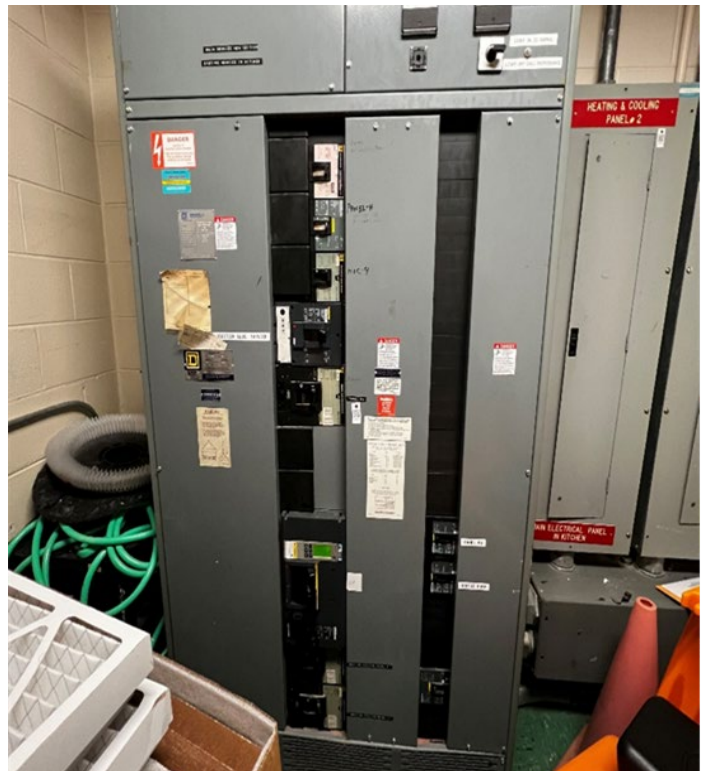
Power distribution is by a single Square D 480V-3 Phase-1200A electrical service. The switchboard, which was installed about 30 years ago, and seems to be in fair condition considering its age and is currently operational without any problems. Nevertheless, it is worth noting that the switchboard is outdated.

Condition: Fair

Quantity: (1) Electrical Room

1. The existing 480V switchboard is in fair condition and does not need to be replaced in the near future.
2. All panelboards that are original to the building and that no longer have replacement parts, should be replaced.

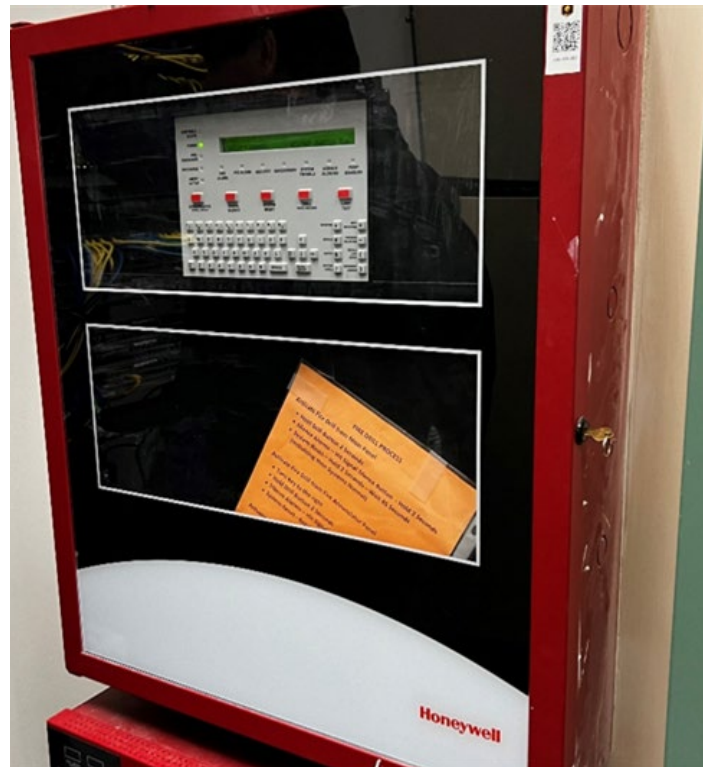
The **fire alarm system** consists of wall mounted audio/visual devices, manual pull stations located at most exit passages, but missing smoke/heat detectors located in mechanical rooms and missing devices throughout the old section of the building. Devices needed per code should be added to bring the rest of the building up to code where needed. The existing fire alarm control panel is outdated, but functional. A new system would be an addressable system that provides additional information to first responders and provides the ability to pinpoint any alarms down to the device that caused the alarm. The current system does not seem to have that ability.

**PHOTO E.09
FIRE ALARM CONTROL PANEL**

*Condition: Fair
Quantity: (1)*

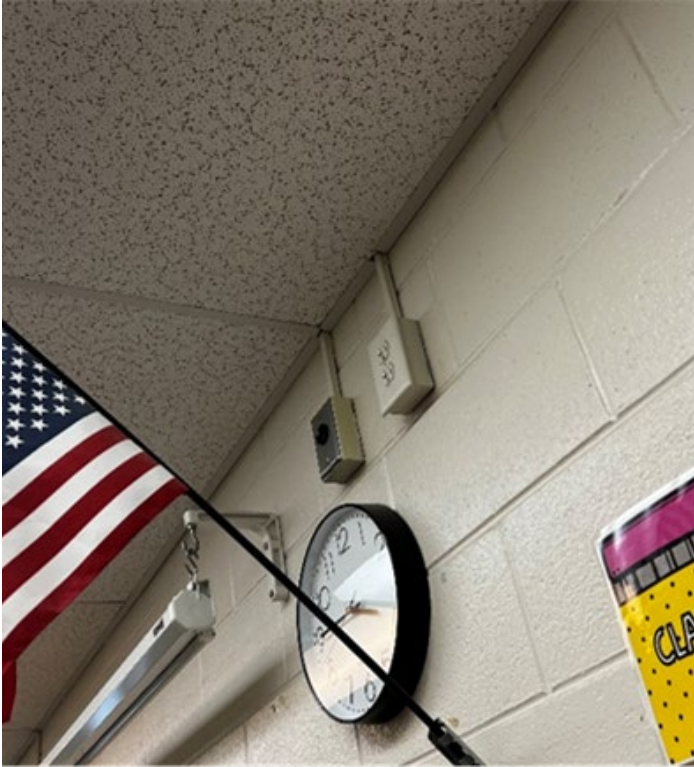
PHOTO E.11B
BATTERY OPERATED CLOCK (TYPICAL)

Condition: Fair
Quantity: Approx. 63,026 SF

8. It is recommended that the clock system be utilized across all rooms, and all battery clocks be replaced.
9. It is recommended that nonoperational existing data wiring and associated outlets be replaced.

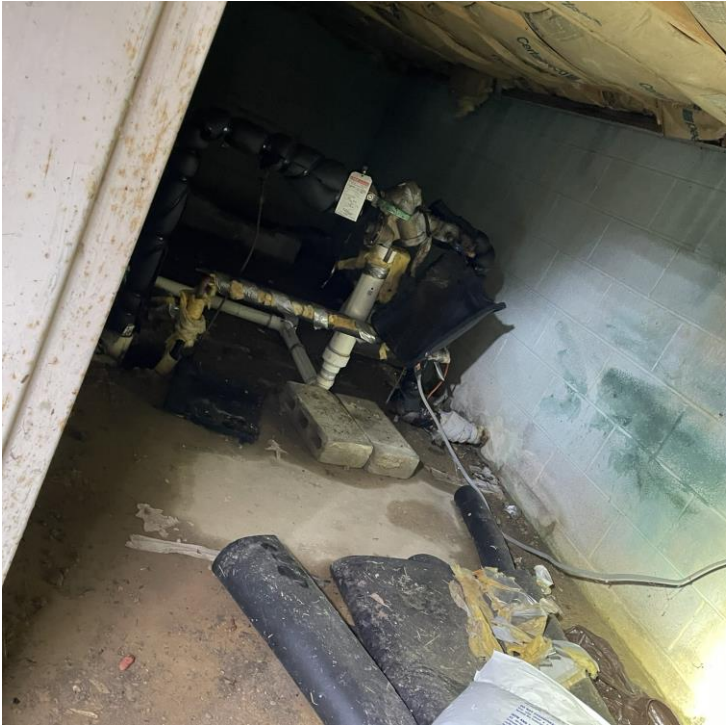
Domestic Water service enters the building into a small external enclosure and is then distributed throughout the building. There is a backflow preventer at the service entrance that is in poor condition. There are two (2) electric hot water heaters. One water heater serves the addition. One water heater provides domestic hot water for the original portion of the building. The hot water heaters were installed in 2016 and are in good condition. There are no recirculation pumps on the hot water heaters. Recirculation pumps will need to be added to comply with VPC 607.2.1. The insulation on the domestic hot water piping in the mechanical room is in good condition. All the domestic cold water and hot water piping distributed in the admin area was installed in 2016 and is good condition. The domestic cold water and hot water distributed to the rest of the building is original to the building and is in fair condition.

**PHOTO P.01
DOMESTIC BACKFLOW
PREVENTER**

*Condition: Poor
Quantity: (1)*

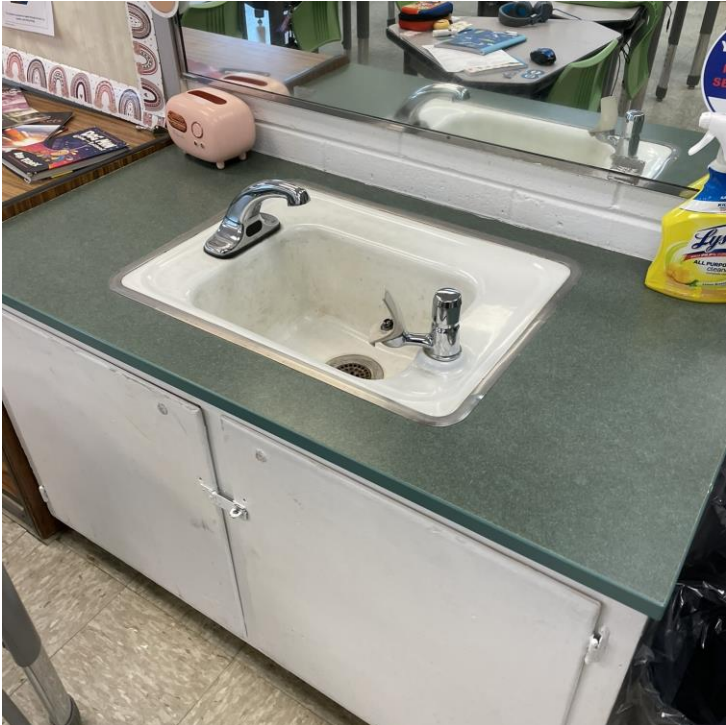
**PHOTO P.02
CLASSROOM LAVATORY**

*Condition: Fair
Quantity: (30)*

1. The lavatories and sinks with manual faucets are at or near the end of their life and should be considered for replacement. The lavatories and sinks with automatic faucets are in good condition with significant life remaining.
