MADISON ELEMENTARY SCHOOL

Facility Condition Assessment

Caroline County Public Schools

April 2, 2024

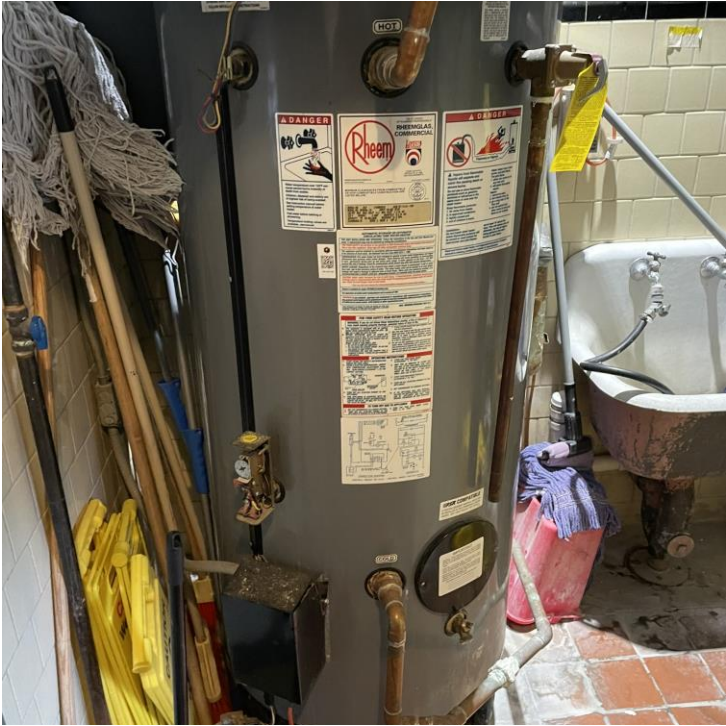
**PHOTO P.03
DOMESTIC WATER HEATER**

*Condition: Good
Quantity: (2)*

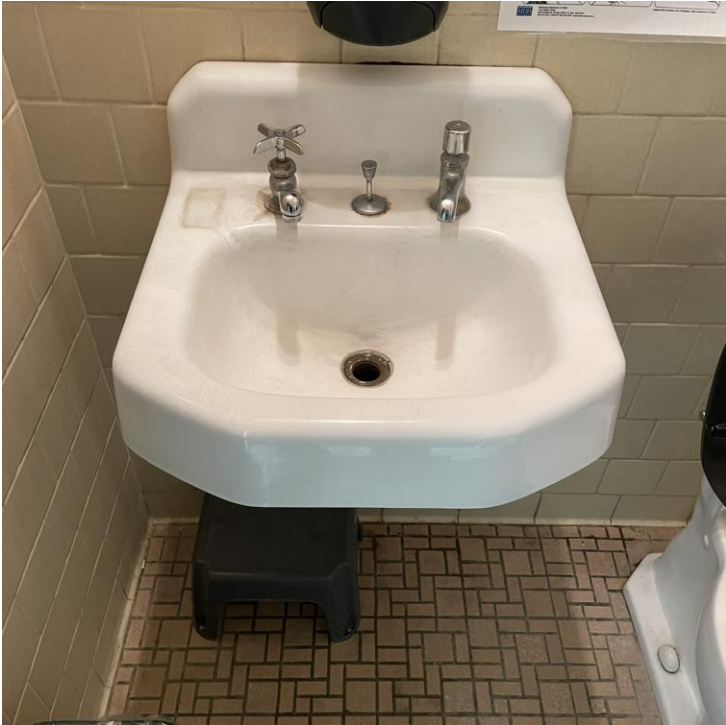
**PHOTO P.4
LAVATORY**

*Condition: Poor
Quantity: (7)*

1. The lavatories and sinks with manual faucets are at or near the end of their life and should be considered for replacement. The lavatories and sinks with automatic faucets are in good condition with significant life remaining.

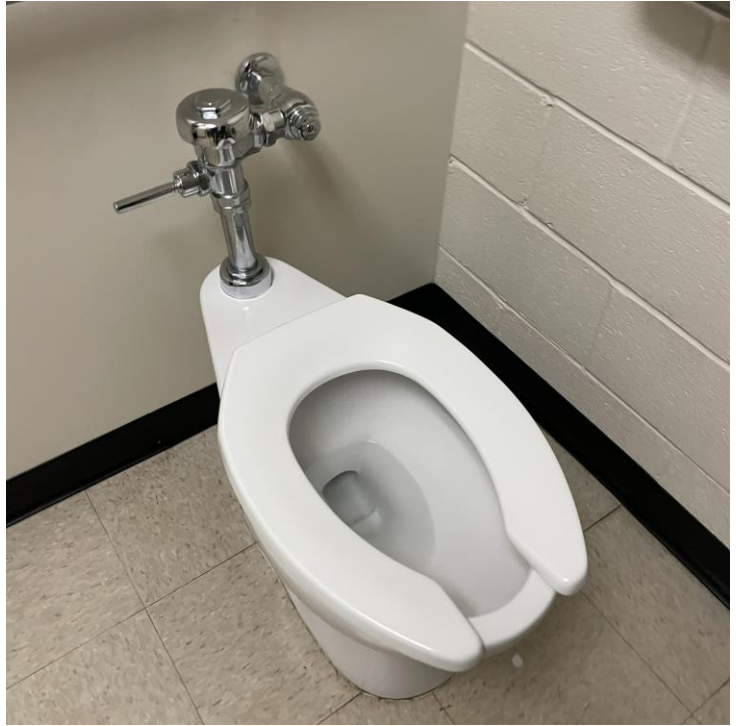
**PHOTO P.5
WATER CLOSET**

*Condition: Fair
Quantity: (44)*

2. The water closets and urinals are in fair condition and should be considered for replacement in five to ten years.
3. Recirculation pumps will need to be added to comply with VPC 607.2.1.

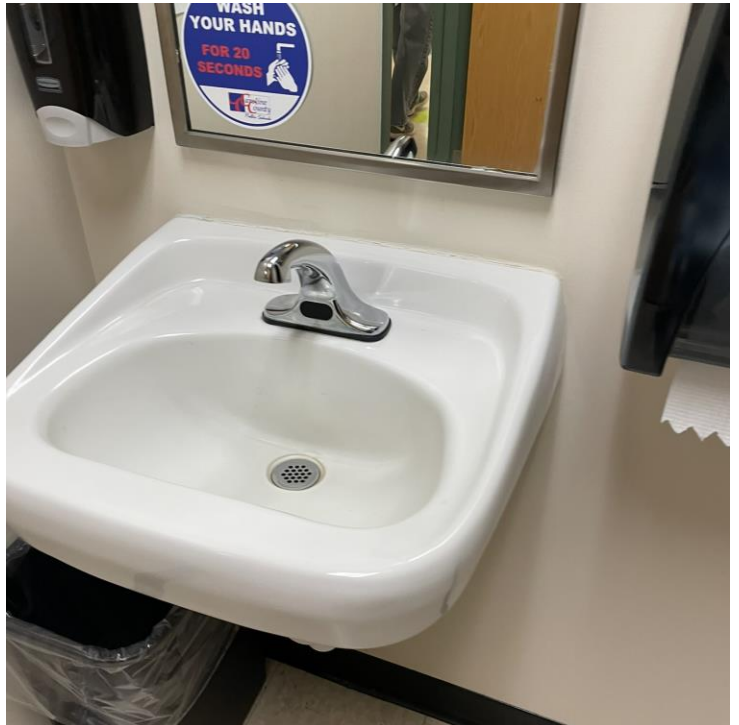
**PHOTO P.6
LAVATORY**

*Condition: Good
Quantity: (7)*

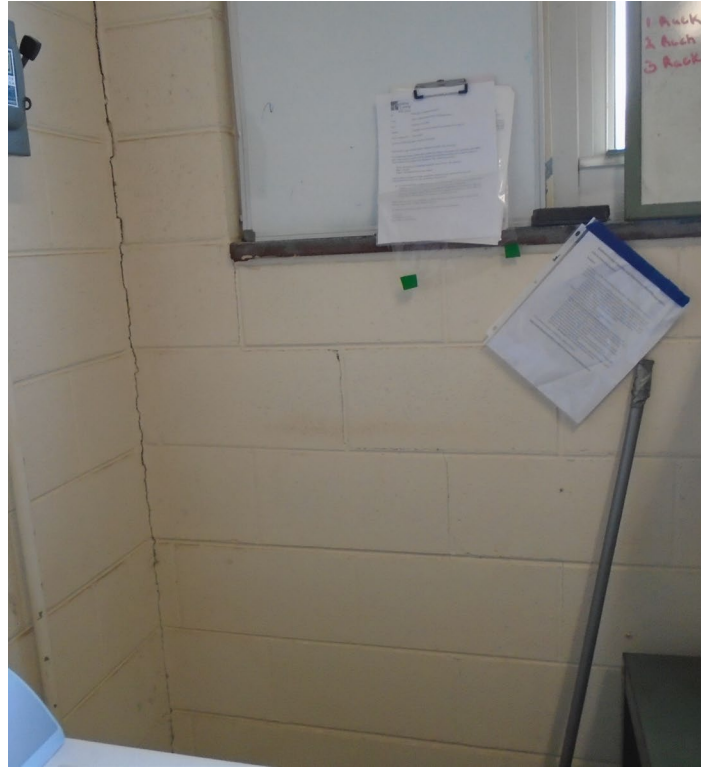
Interior structural issues were limited to CMU cracks in isolated locations, especially where the interior walls intersected the exterior walls (Photo S.01) and vertical cracks in CMU walls where no vertical control joints were installed (Photo S.02).

The cracking is most likely due to the natural movement of the building over time and the insufficient number of control joints in the masonry and no horizontal reinforcement at the intersections. Control joints allow for the anticipated expansion and contraction of the walls, and without sufficient control joints, stresses are relieved through the creation of cracks. Clean corroded surfaces with a wire brush or wire wheel attachment to remove the corrosion from the surface to solid steel. Prepare surface in accordance with coating manufactures recommendations. Prime with epoxy precoat and epoxy topcoat paint approved for exposed structural steel. The lintels with corrosion must be repaired to ensure continued structural integrity and to minimize the potential for further corrosion/damage.

PHOTO S.01
INTERIOR CMU WALL CRACKING

Condition: Poor
Quantity: Approx. 300 LF

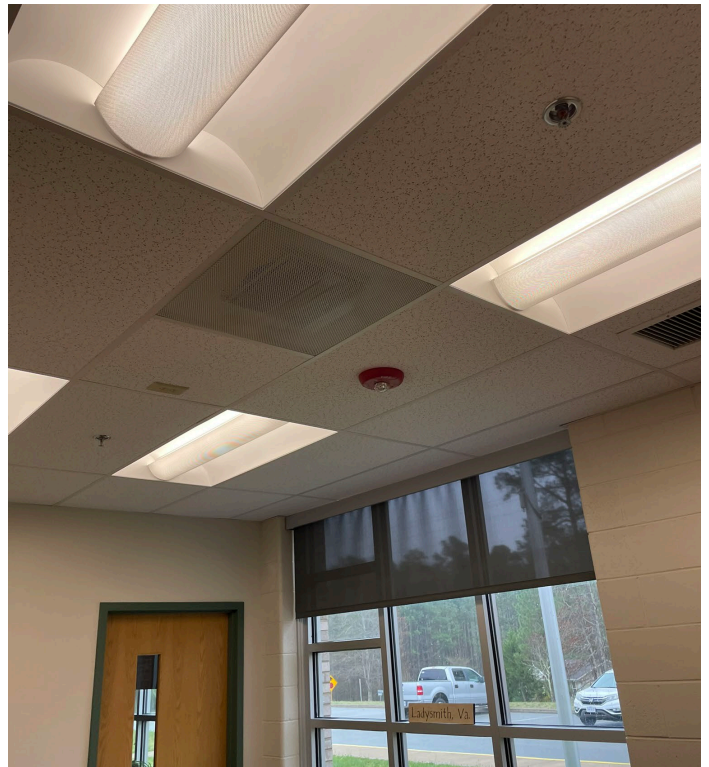
PHOTO FS.1
ADMIN AREA

Condition: Good
Quantity: Approx. 18,953 SF

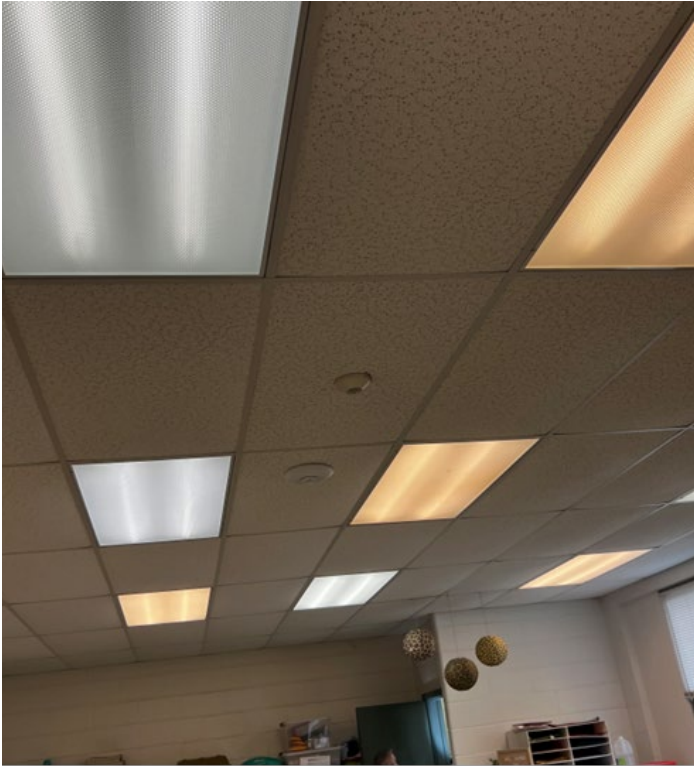
Madison Elementary School is partially protected with a fire suppression (sprinkler) system and has wall mounted fire extinguishers located in the corridors throughout the building. The original portion of the building is not protected with a fire suppression sprinkler system but has wall mounted fire extinguishers adjacent to exterior doors. The addition is protected by a fire suppression sprinkler system that is in good condition. It is recommended that the fire protection system be upgraded to provide adequate fire suppression coverage throughout the original portion of the school.

**PHOTO FS.2
ORIGINAL BUILDING CLASSROOMS**

*Condition: Not Applicable
Quantity: None*

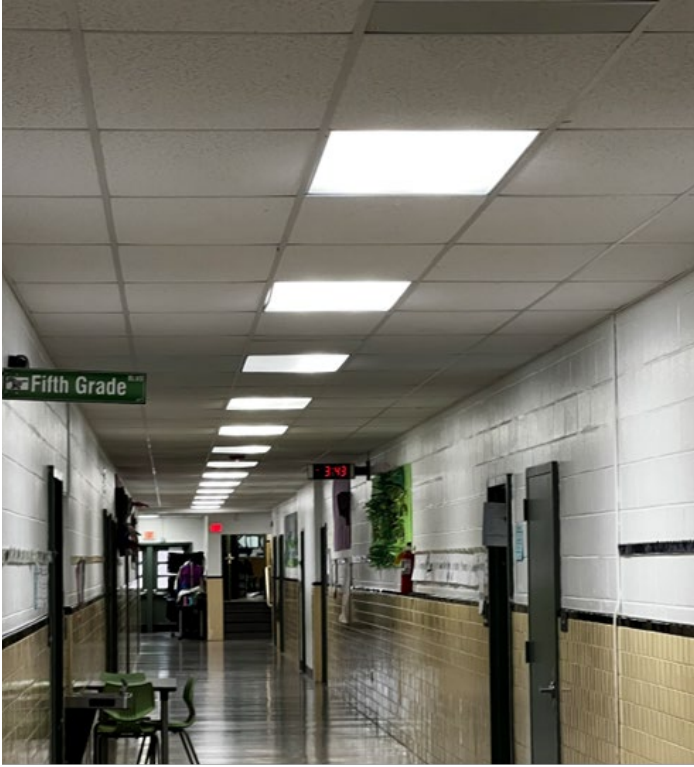
**PHOTO FS.3
ORIGINAL BUILDING CORRIDOR WITH
CORRIDOR FIRE EXTINGUISHER**

*Condition: Not Applicable
Quantity: None*

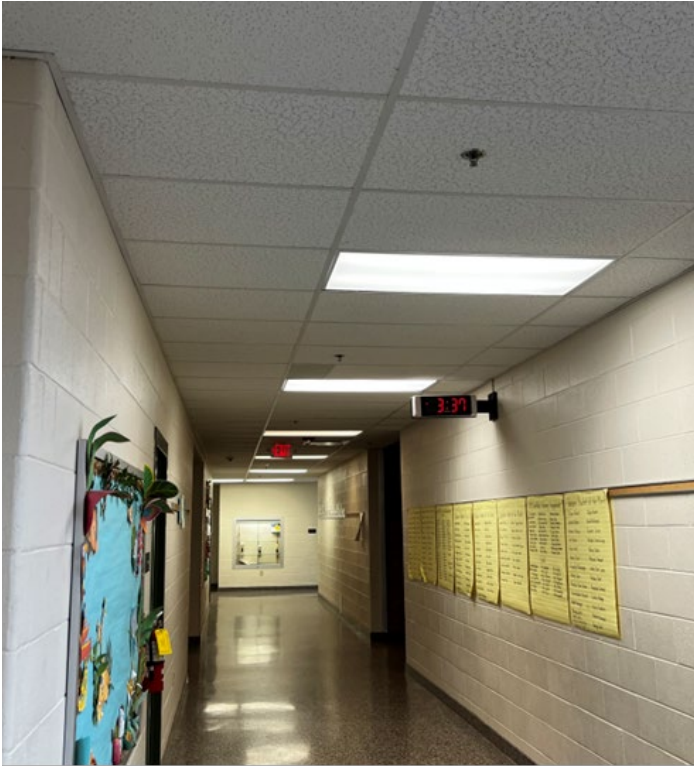
**PHOTO FS.4
ADDITION CORRIDOR**

*Condition: Good
Quantity: Approx. 18,953 SF*

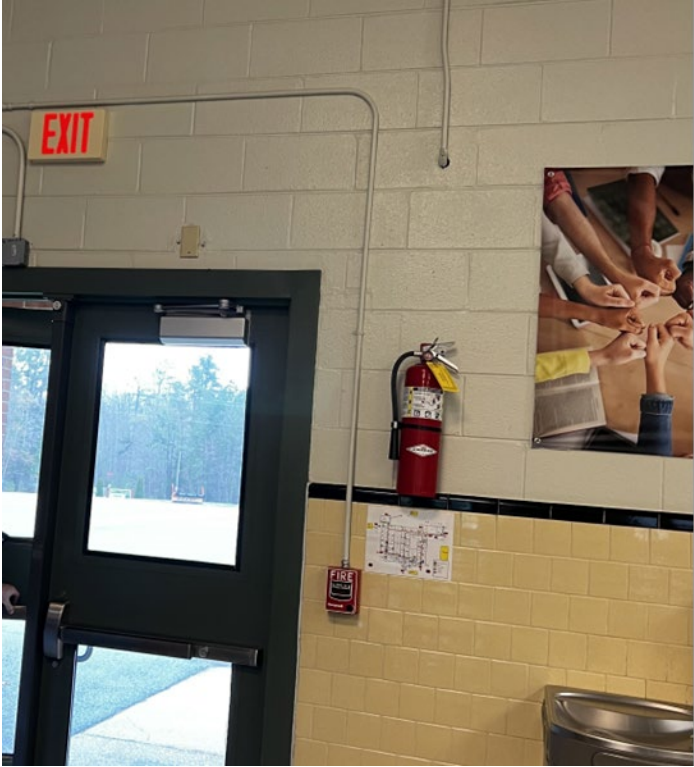
**PHOTO FS.5
WALL MOUNTED FIRE EXTINGUISHERS**

*Condition: Good
Quantity: Approx. 63,026 SF*

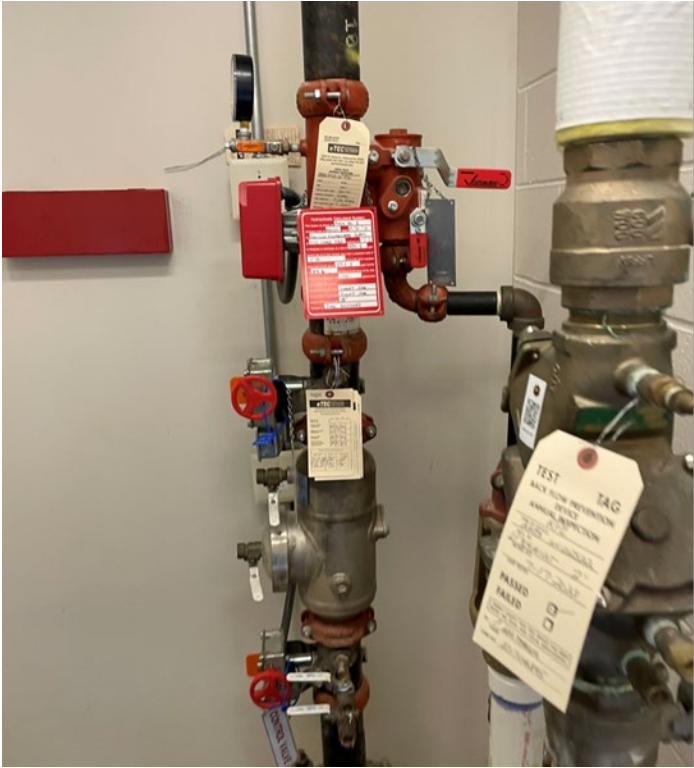
**PHOTO FS.6
FIRE ALARM RISER WITH BACKFLOW
PREVENTER**

*Condition: Good
Quantity: (1)*

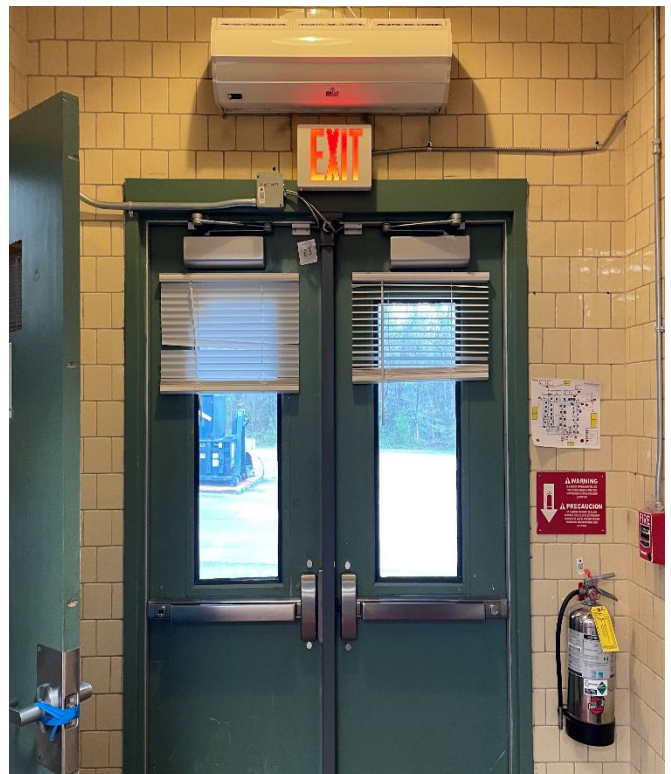
PHOTO K.1 THE INSECT AIR SCREEN FAN IS UNDERSIZED FOR THIS DOOR OPENING.

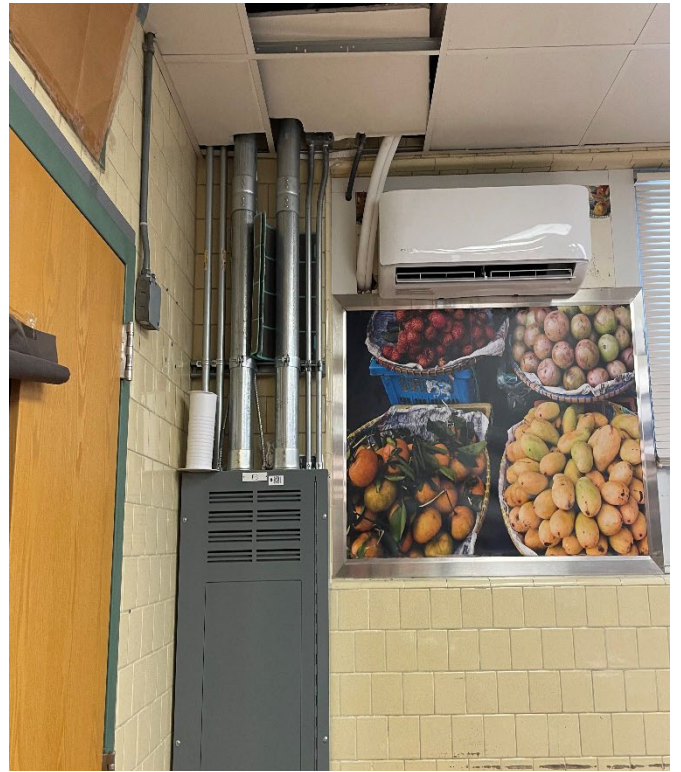
PHOTO K.4 THERE ARE MANY EXPOSED UTILITIES AND MISSING CEILING TILES.
