OLD LADYSMITH ELEMENTARY SCHOOL (LOTUS ACADEMY)

7278 Ladysmith Road, Ruther Glen, Virginia 22546

Facility Condition Assessment

April 2, 2024

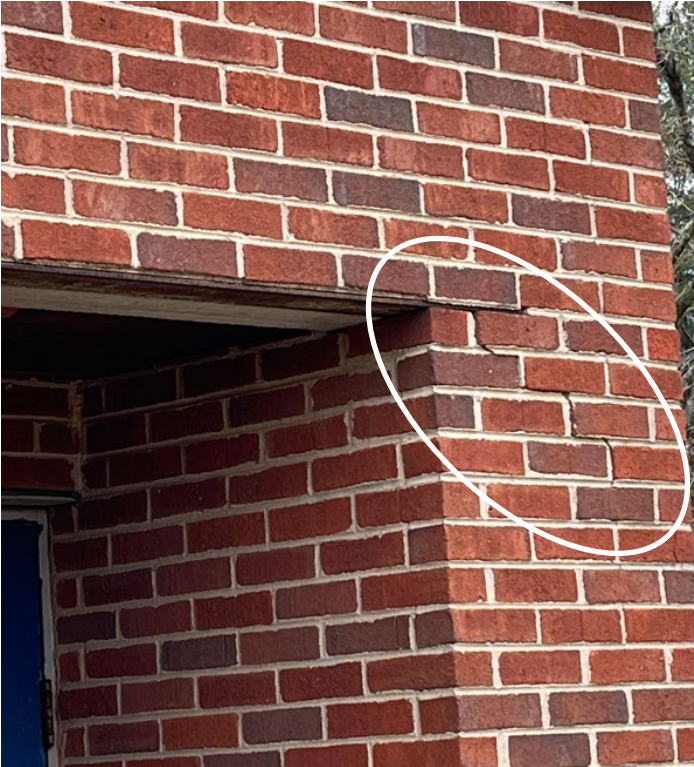
PHOTO AE.02
MASONRY CRACKS

Condition: Fair / Good
Quantity: Approx. 125 SF

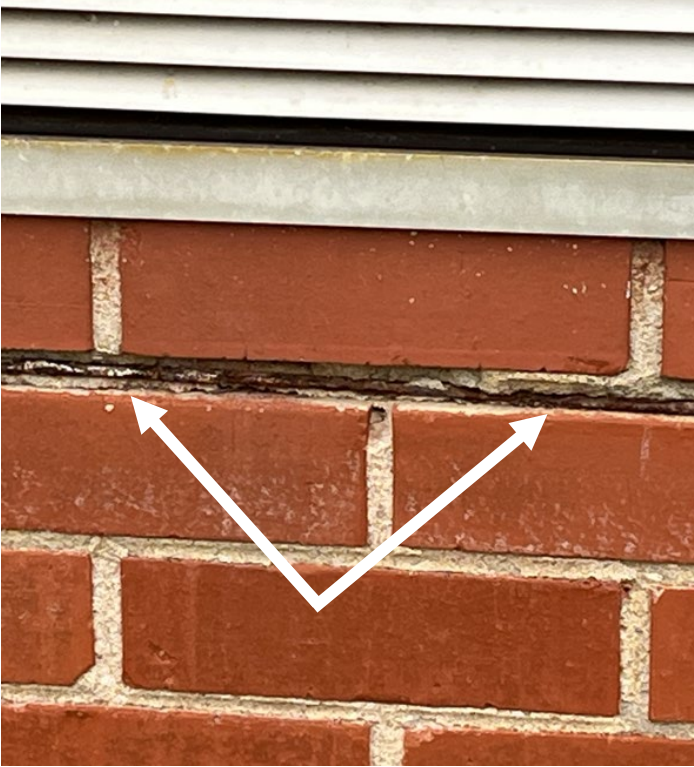
PHOTO AE.03B
MORTAR DETERIORATION

Condition: Poor / Fair
Quantity: Approx. 2,250 LF

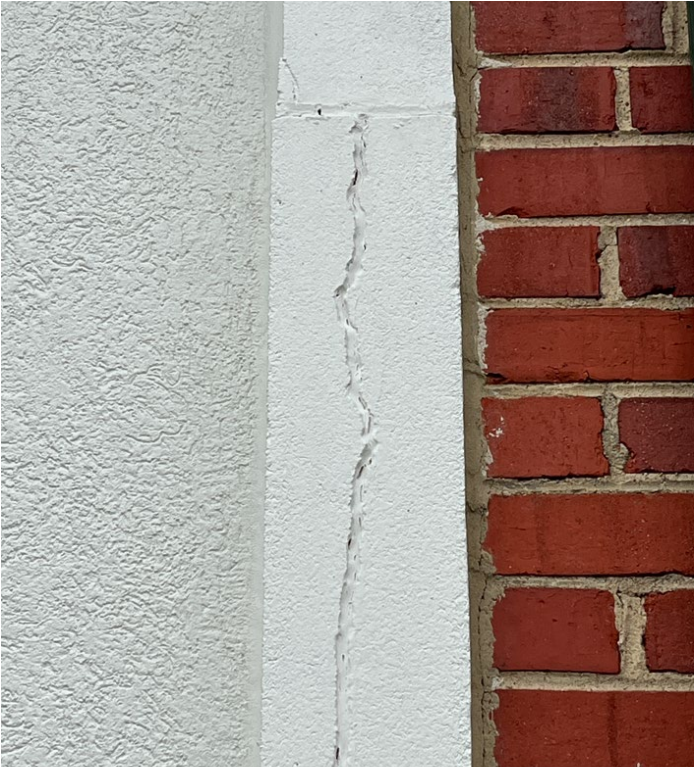
PHOTO AE.04B
PRECAST WINDOW SURROUNDS (CRACKED)

Condition: Poor / Fair
Quantity: Approx. 32 LF

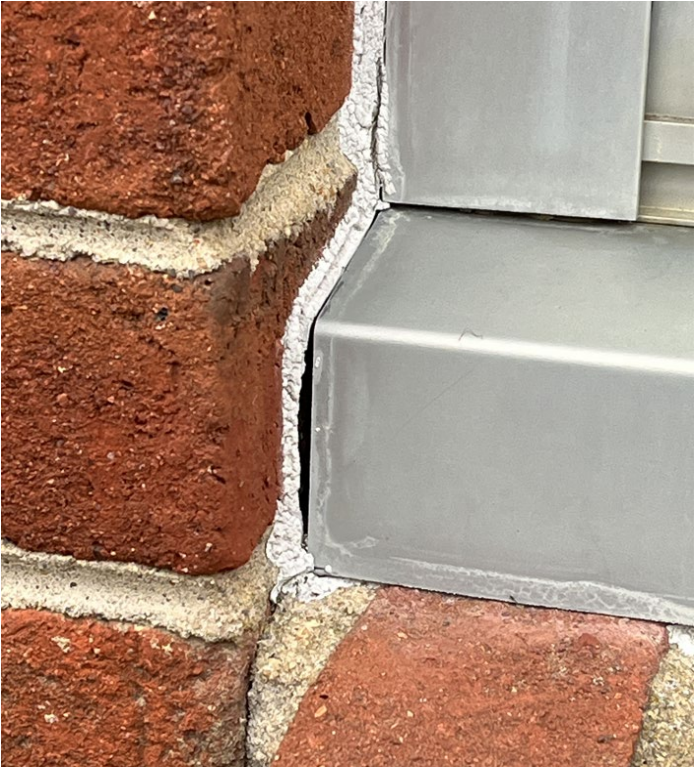
**PHOTO AE.05B
EXTERIOR CAULKING FAILURE (WINDOWS)**

*Condition: Poor
Quantity: Approx. 1,272 LF*

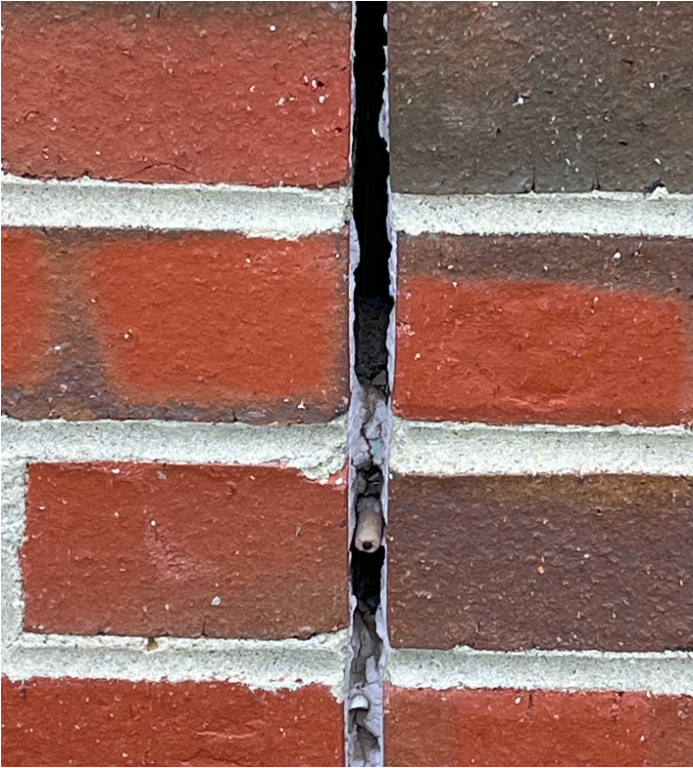
**PHOTO AE.08A
EXTERIOR CAULKING FAILURE
(CONTROL JOINTS)**

*Condition: Poor
Quantity: Approx. 140 LF*

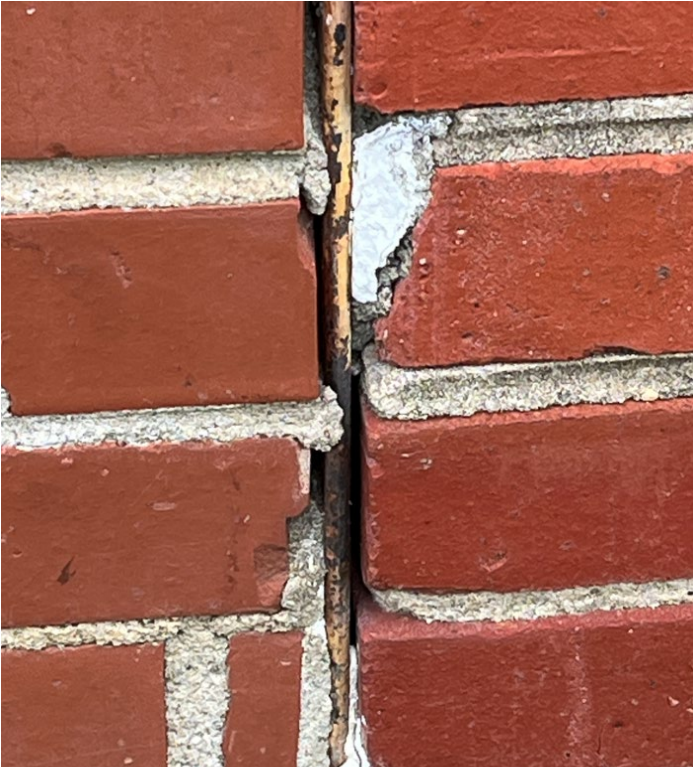
**PHOTO AE.08B
EXTERIOR CAULKING FAILURE
(CONTROL JOINTS)**

*Condition: Poor
Quantity: Approx. 140 LF*

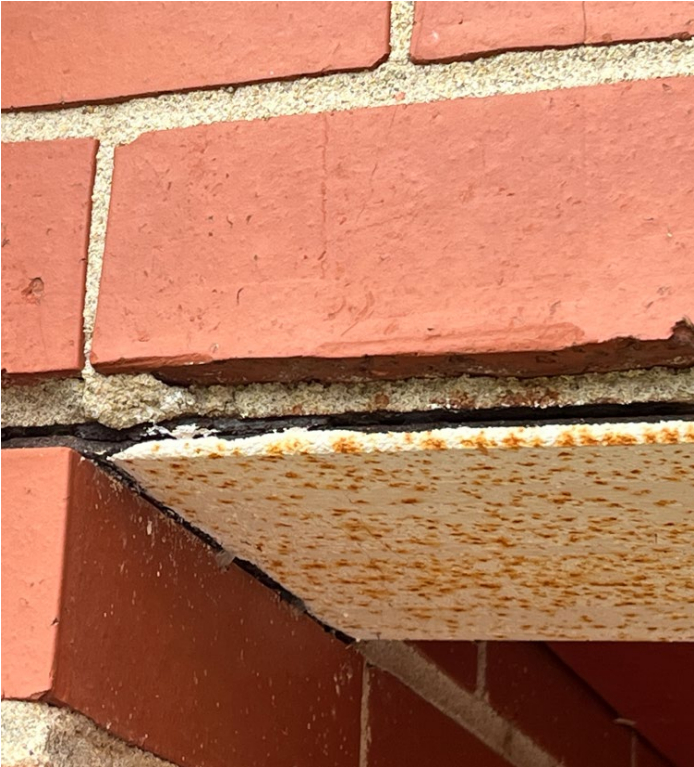
PHOTO AE.09B
EXPOSED/RUSTED STEEL LINTELS

Condition: Poor
Quantity: Approx. 442 LF

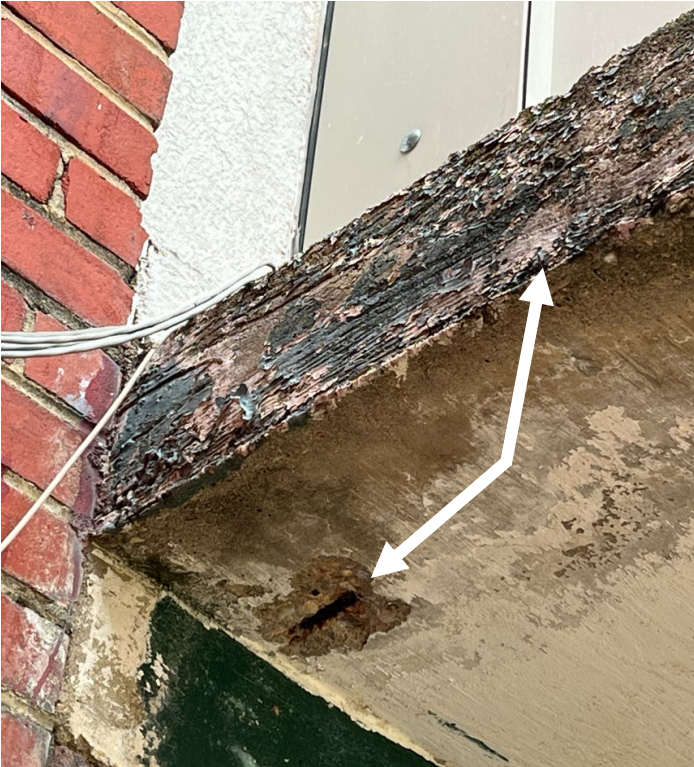
**PHOTO AE.10D
EXTERIOR CANOPY DETERIORATION**

*Condition: Poor
Quantity: Approx. (7) Canopies*

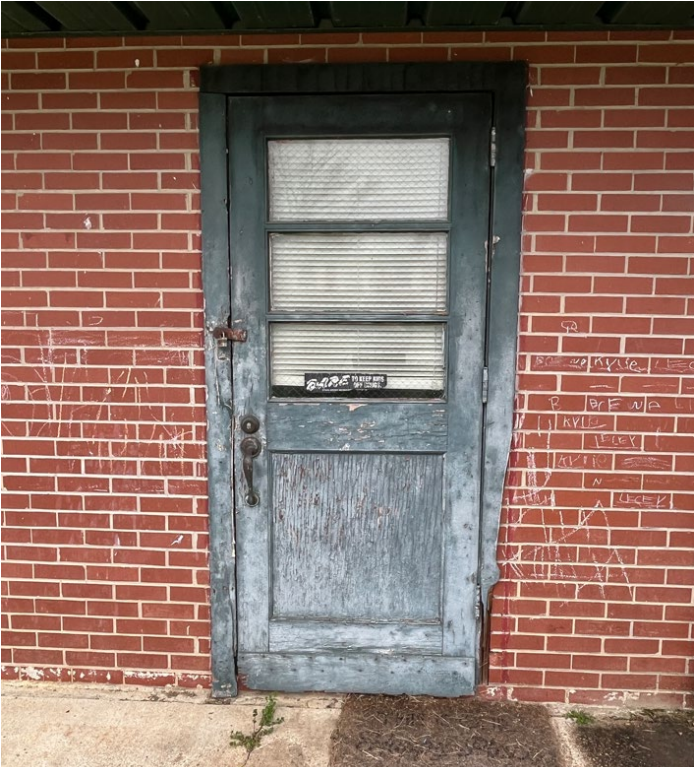
**PHOTO AE.11B
EXTERIOR DOORS & FRAMES
(DETERIORATED)**

*Condition: Poor
Quantity: Approx. (26) Doors & Frames*

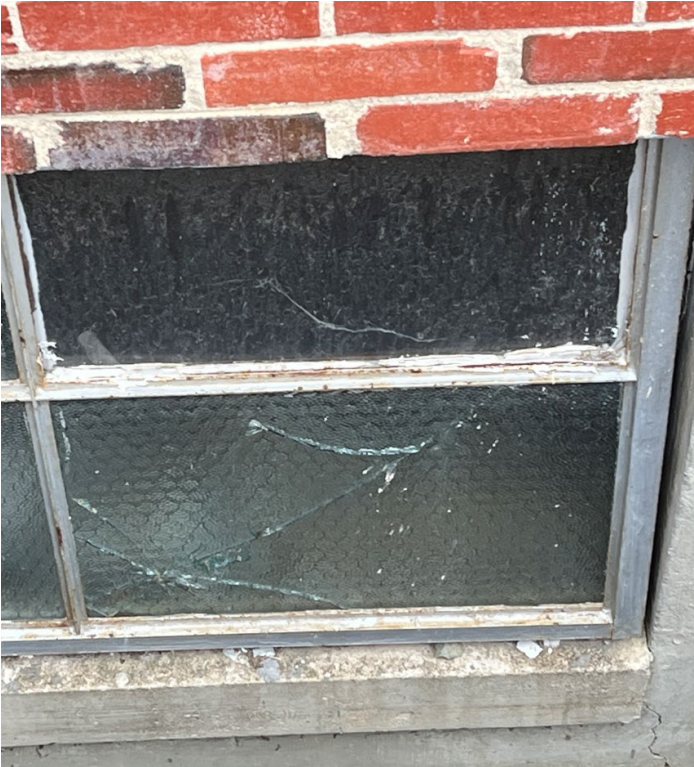
**PHOTO AE.12B
EXTERIOR WINDOWS & FRAMES
(BROKEN WINDOW GLASS)**

*Condition: Poor
Quantity: Approx. 2,070 SF*

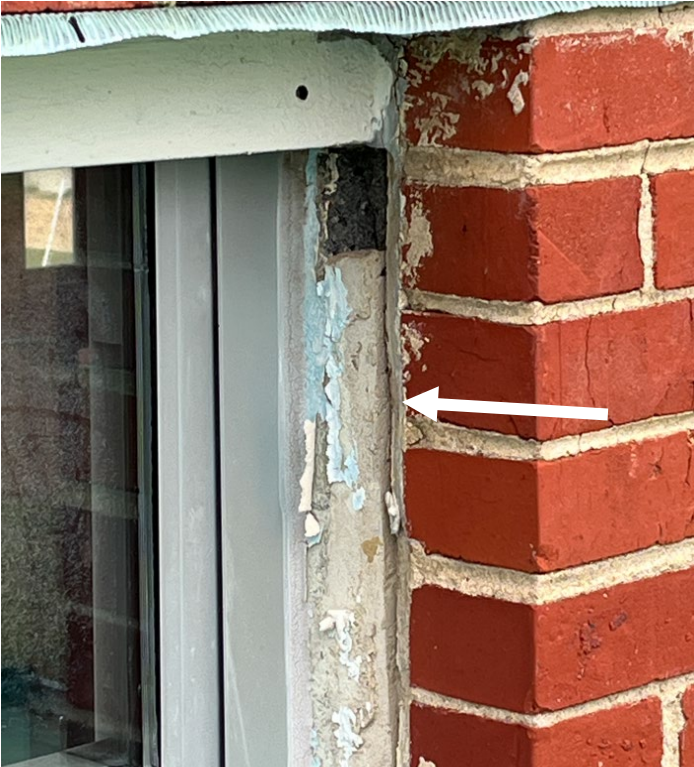
**PHOTO AE.12D
EXTERIOR WINDOWS & FRAMES
(MISSING MULLION / TRIM)**

*Condition: Poor
Quantity: Approx. 2,070 SF*

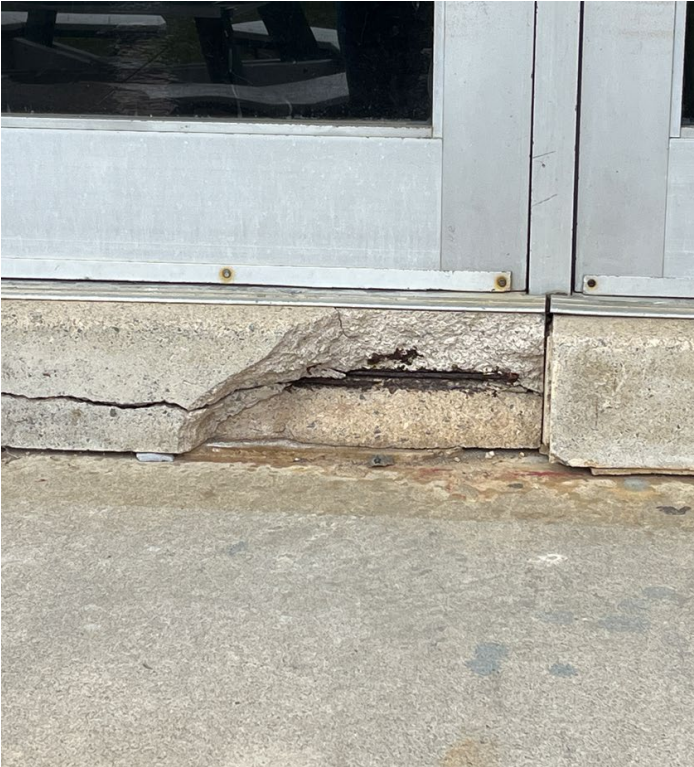
PHOTO AE.13B
CONCRETE SIDEWALK / STAIR REPAIRS

Condition: Poor / Fair
Quantity: Approx. 4,085 SF

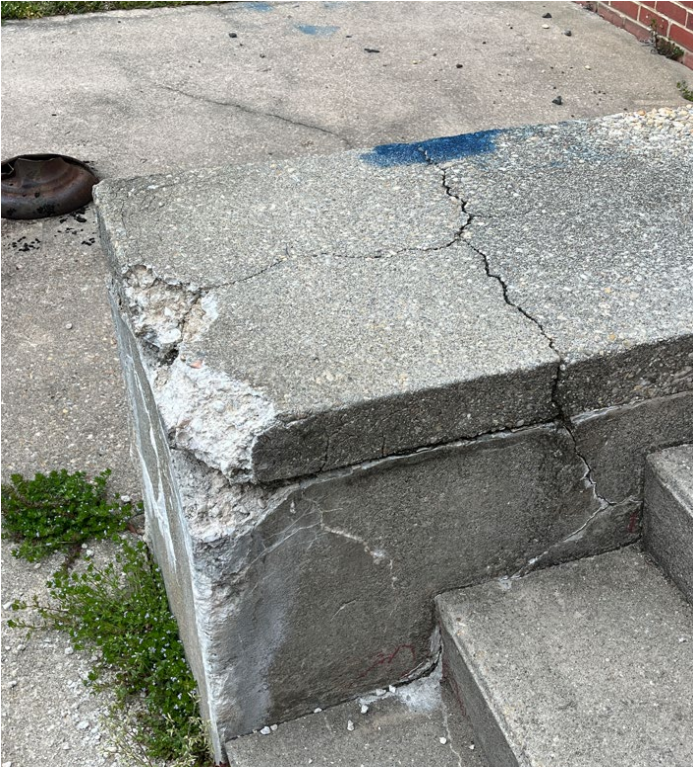
PHOTO AE.13C
CONCRETE SIDEWALK / STAIR REPAIRS

Condition: Poor / Fair
Quantity: Approx. 4,085 SF

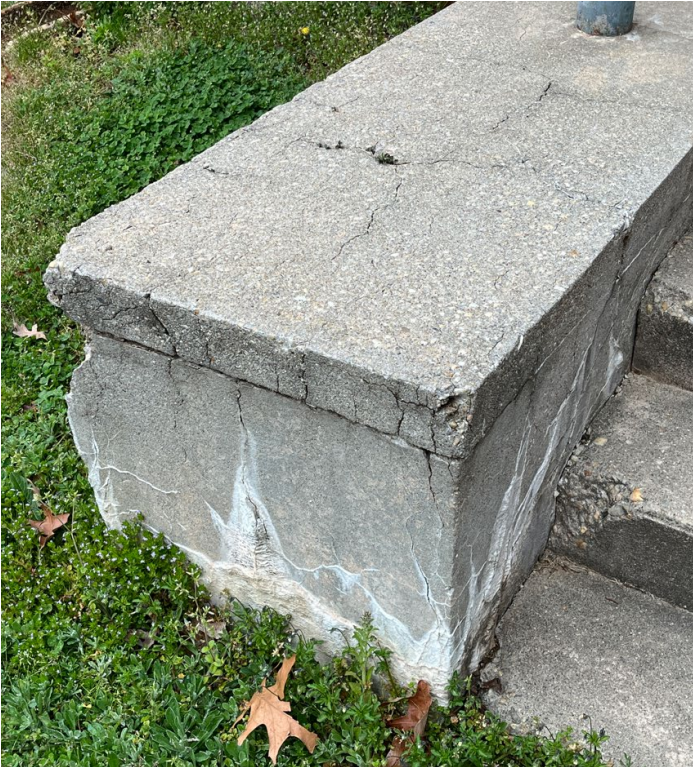
PHOTO AE.13D
CONCRETE SIDEWALK / STAIR REPAIRS

Condition: Poor / Fair
Quantity: Approx. 4,085 SF

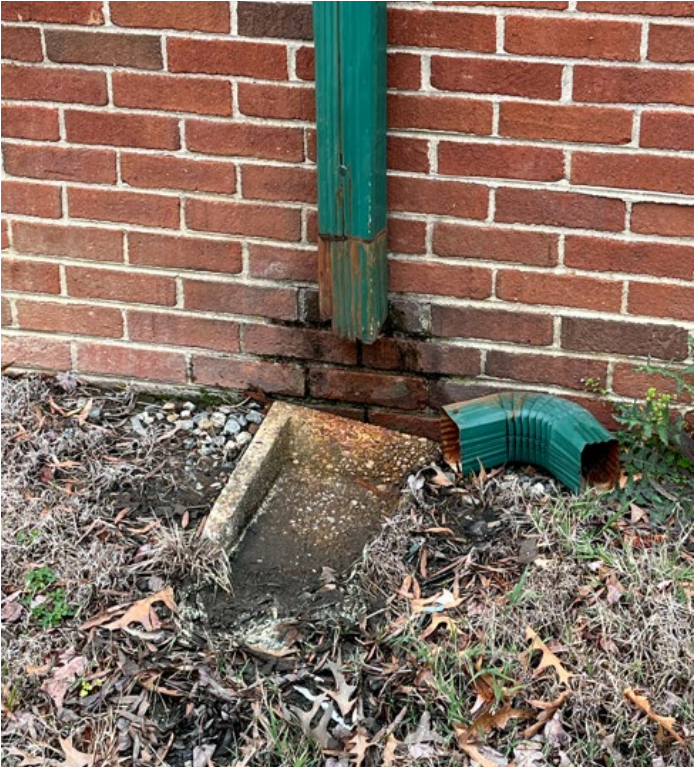
PHOTO AE.14B
DOWNSPOUTS (RUSTED & LEAKING)

Condition: Poor
Quantity: See Roof Section

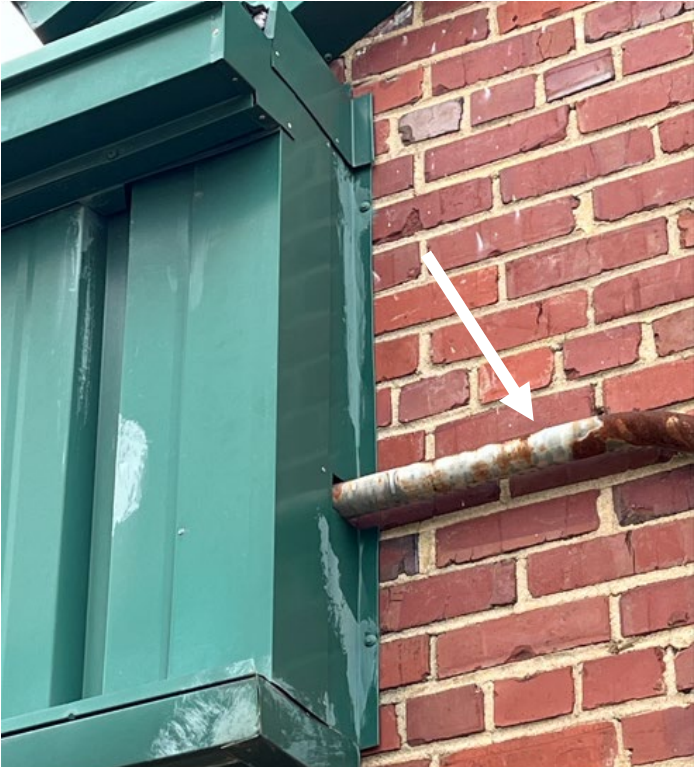
**PHOTO AE.16
EXTERIOR SURFACE METAL CONDUIT
(RUSTED)**

*Condition: Poor / Fair
Quantity: Approx. 35 LF*

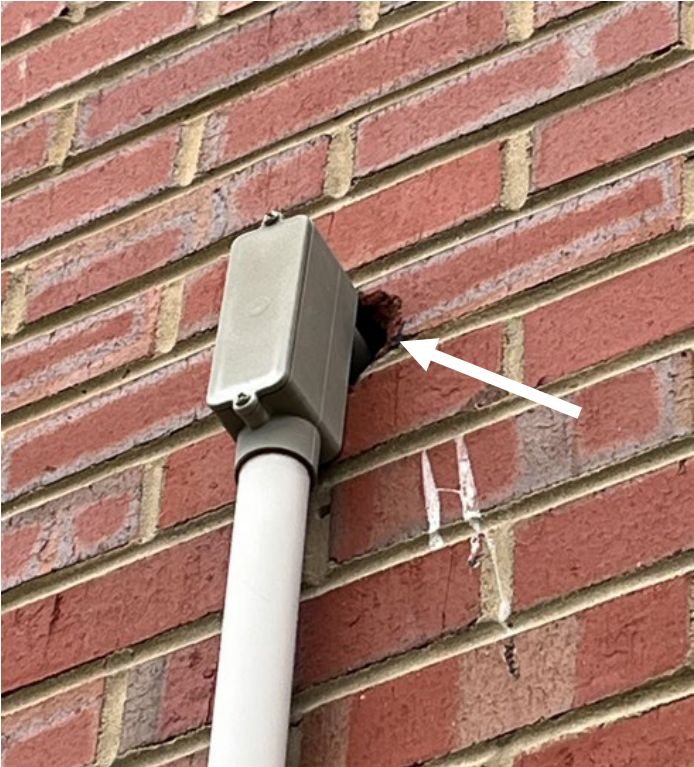
PHOTO AE.18
SEAL EXPOSED BUILDING ENVELOPE

Condition: Fair
Quantity: (1) Location

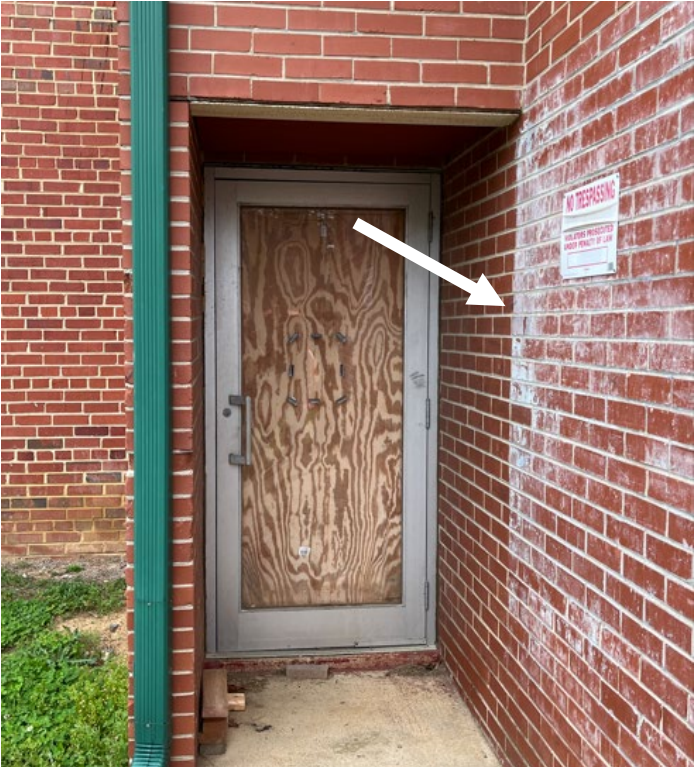
PHOTO AE.21B
EXTERIOR BUILDING CLEANING

Condition: Poor / Fair
Quantity: Approx. 43,763 SF

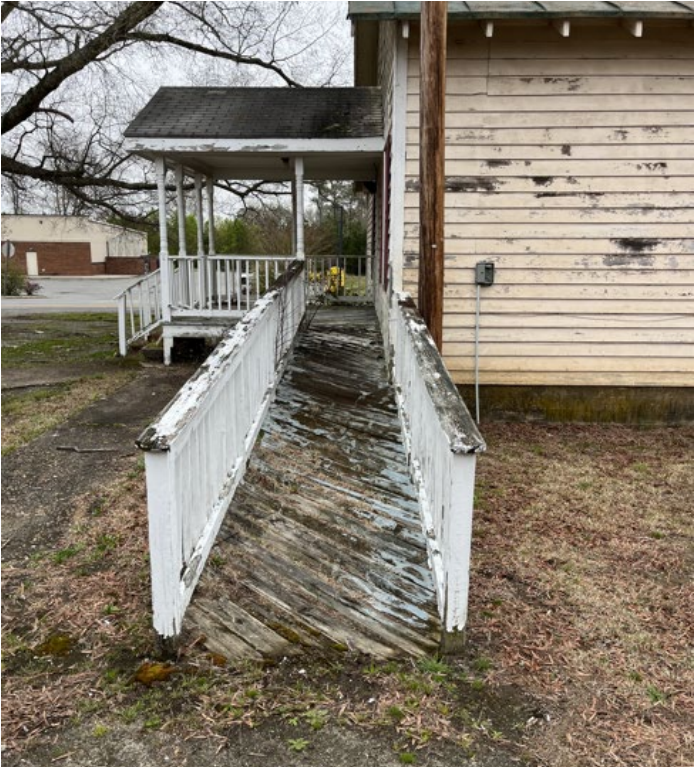
PHOTO AE.22B
STAND-ALONE STORAGE BUILDING

Condition: Poor / Fair
Quantity: Approx. 4,000 SF

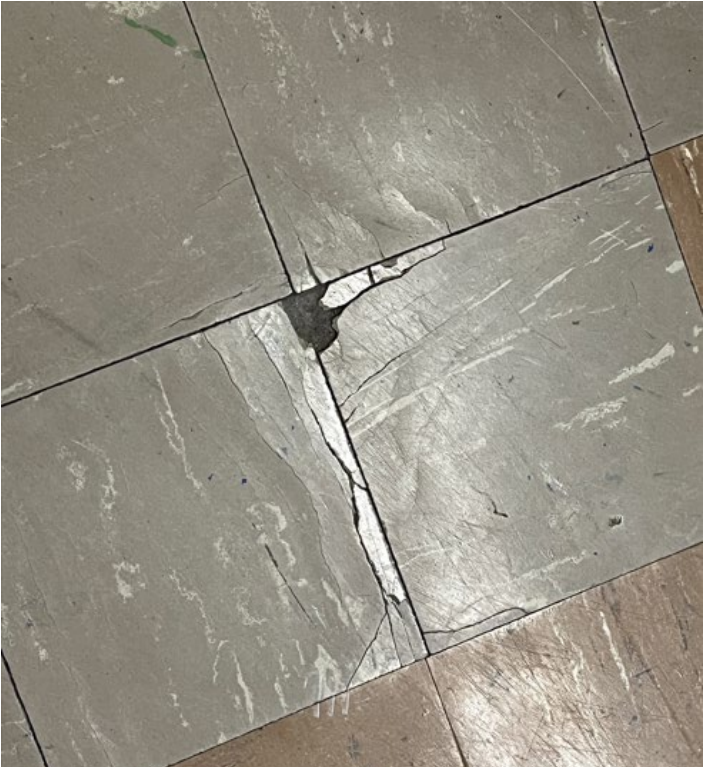
PHOTO AI.04C
TYPICAL CLASSROOM FLOORING (VCT)
(DAMAGED TILE)

Condition: Poor / Fair
Quantity: Approx. 34,005 SF

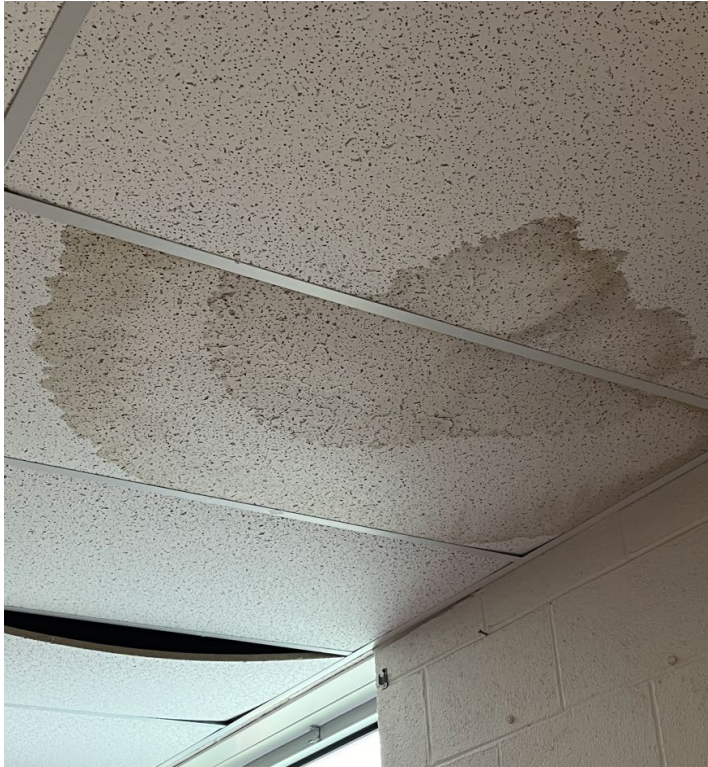
PHOTO AI.06E
WATER INFILTRATION (ACT CEILINGS)

Condition: Poor / Fair
Quantity: Approx. 23,269 SF

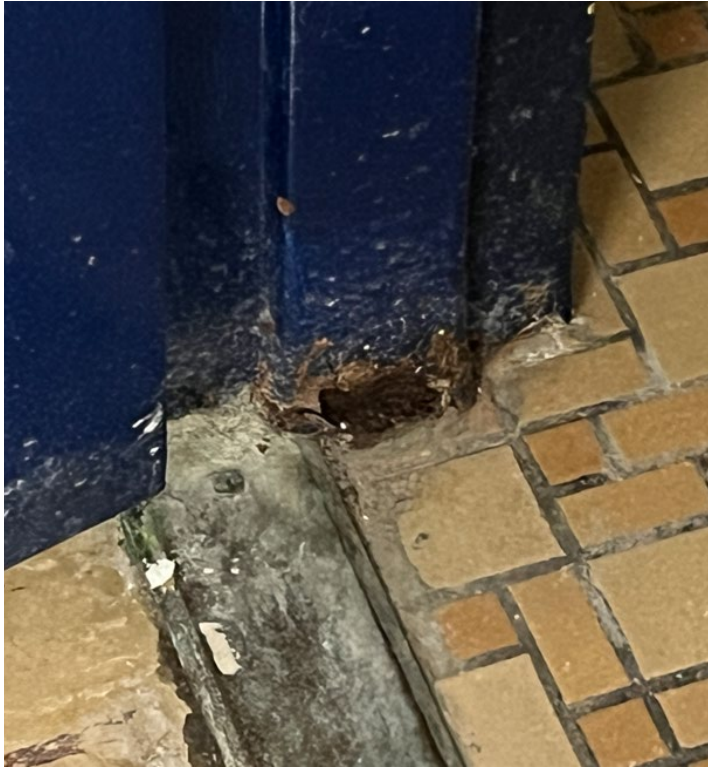
PHOTO AI.10B
INTERIOR DOOR FRAMES (RUSTED)

Condition: Poor / Fair
Quantity: Approx. 43,673 SF (84 Frames)

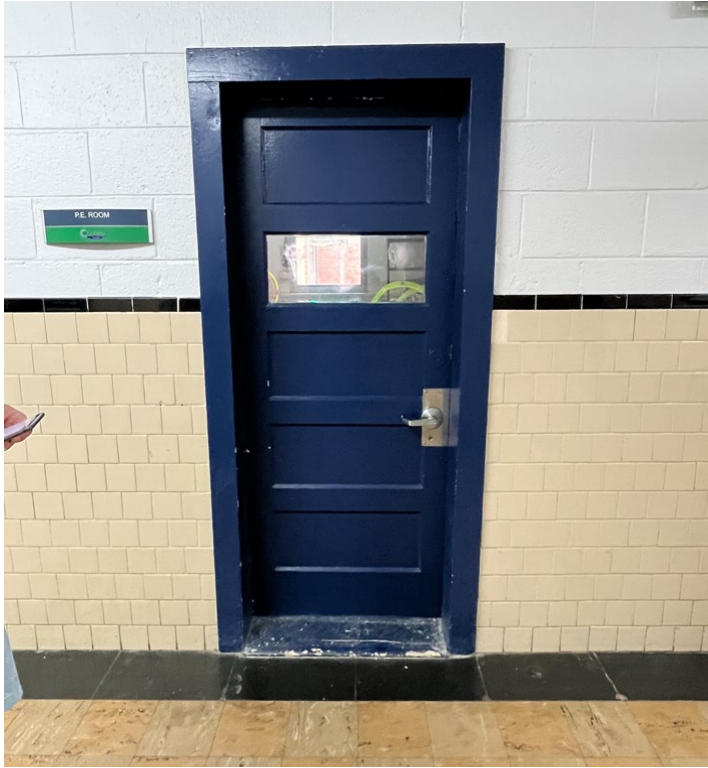
PHOTO AI.11
INTERIOR DOORS

Condition: Poor / Fair
Quantity: Included in Item AI.10A

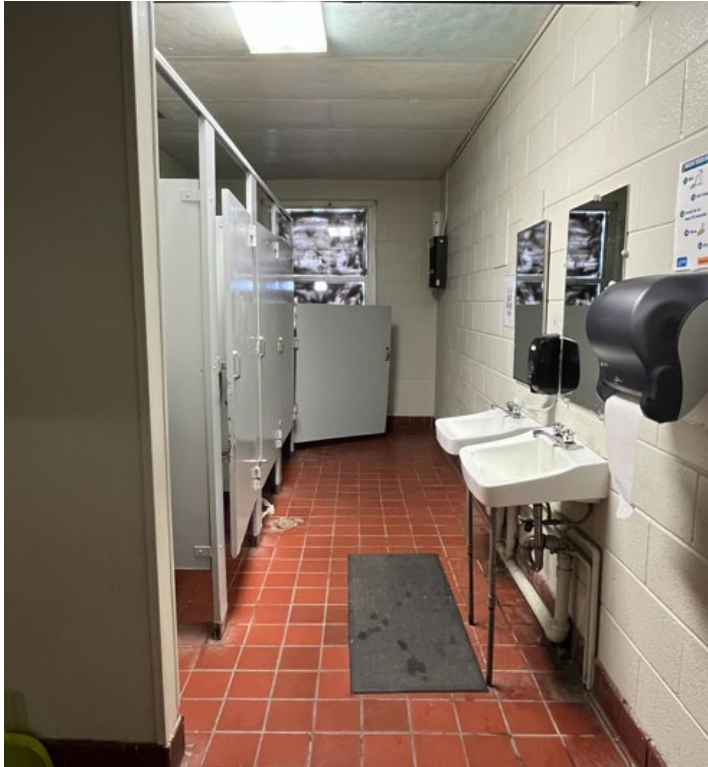
PHOTO AI.12A
TYPICAL GROUP TOILET ROOMS

Condition: Poor / Fair
Quantity: Approx. 1,346 SF

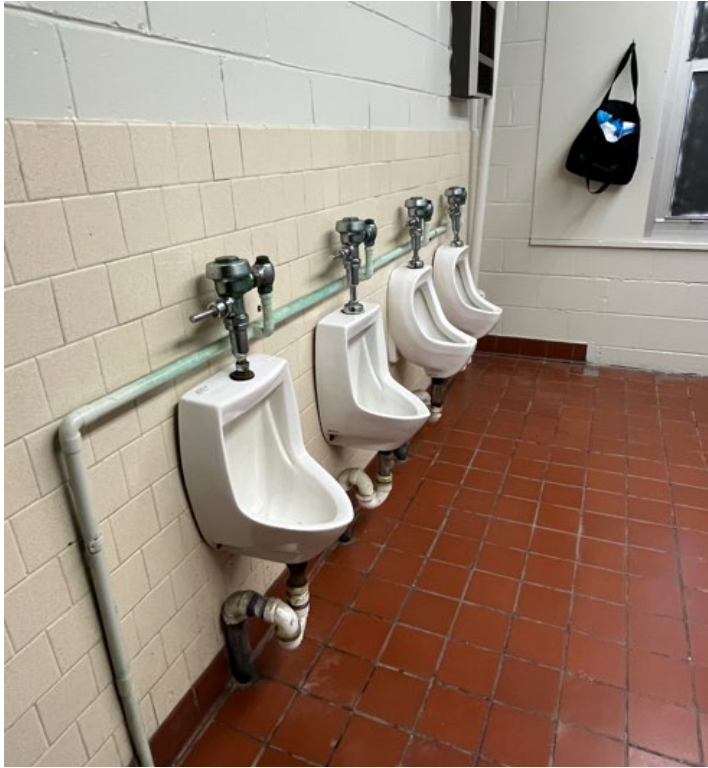
PHOTO AI.12B
TYPICAL GROUP TOILET ROOMS

Condition: Poor / Fair
Quantity: Approx. 1,346 SF

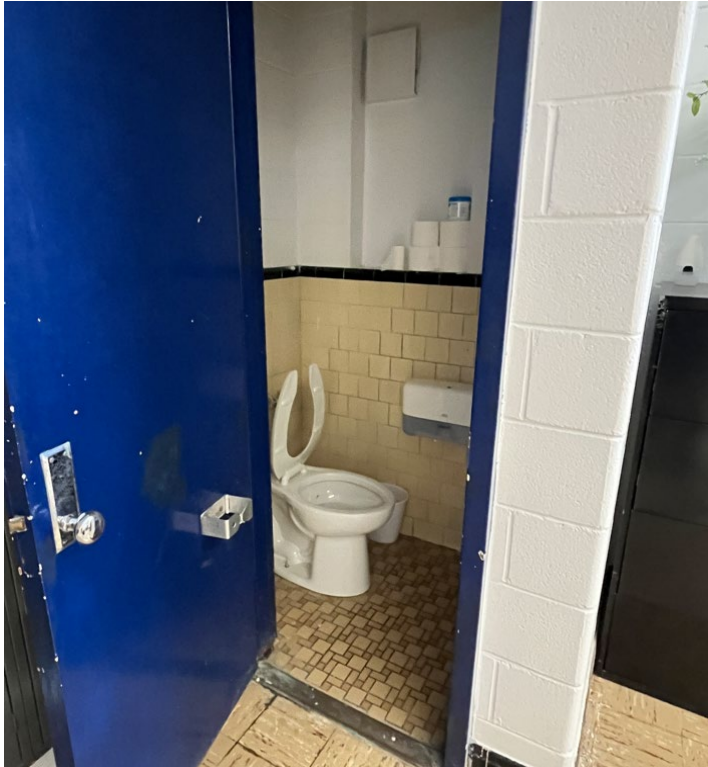
PHOTO AI.13A
TYPICAL SINGLE TOILET ROOMS

Condition: Poor / Fair
Quantity: Approx. 225 SF

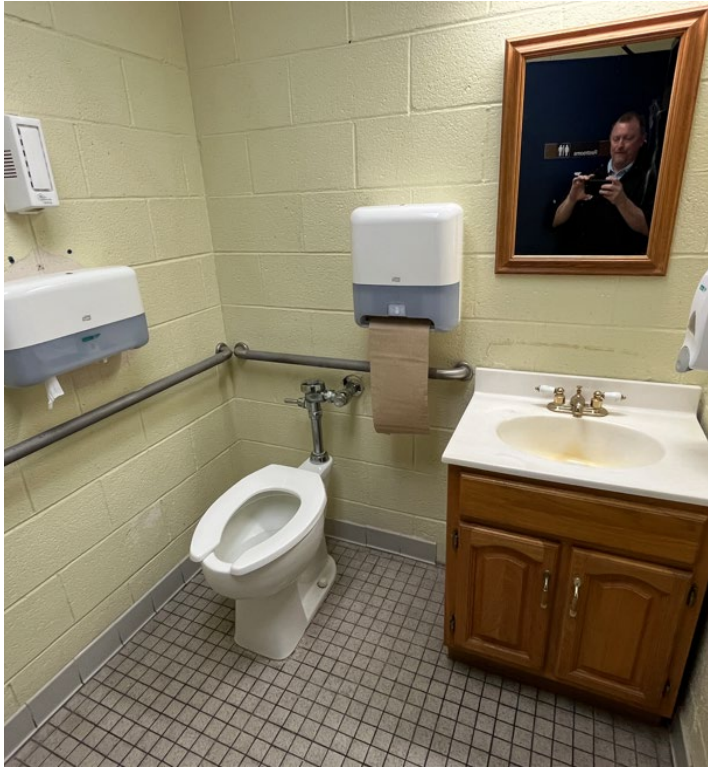
PHOTO AI.13B
TYPICAL SINGLE TOILET ROOMS

Condition: Poor / Fair
Quantity: Approx. 225 SF

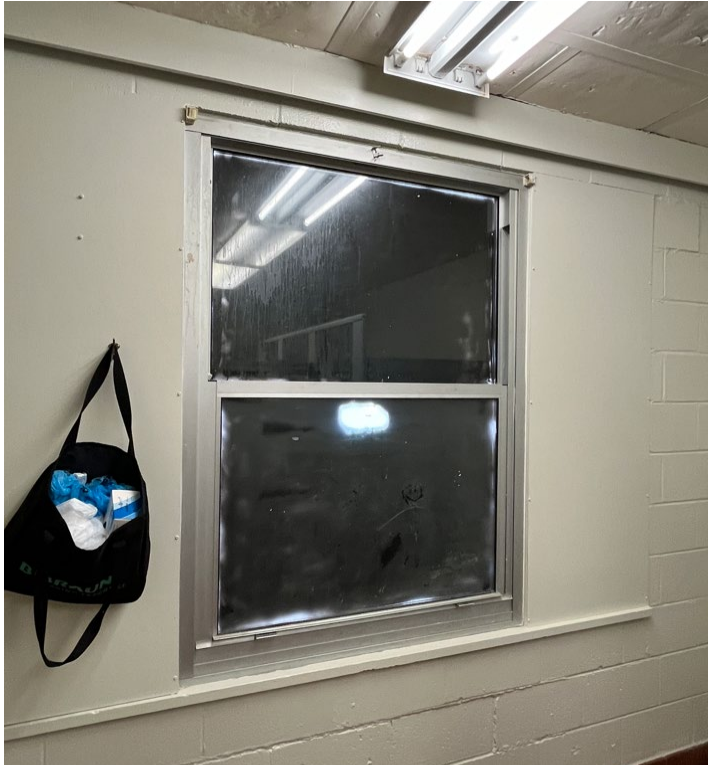
PHOTO AI.14
INTERIOR RESTROOM WINDOWS
(DARKENED)

Condition: Poor / Fair
Quantity: Approx. (4) Windows

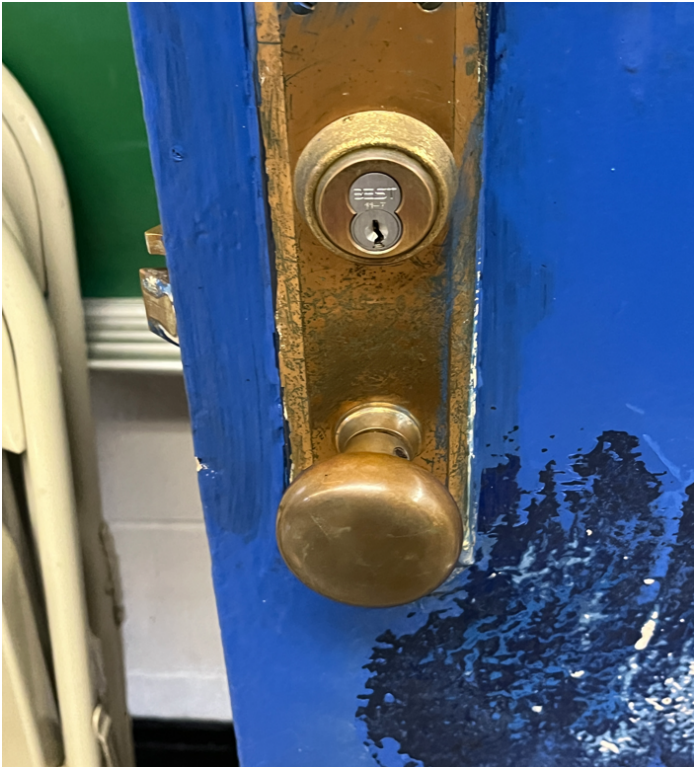
**PHOTO AA.03
DOOR HARDWARE - NON-COMPLIANT
(ADAAG 404.2)**

*Condition: Poor / Fair
Quantity: Approx. (84) Doors*

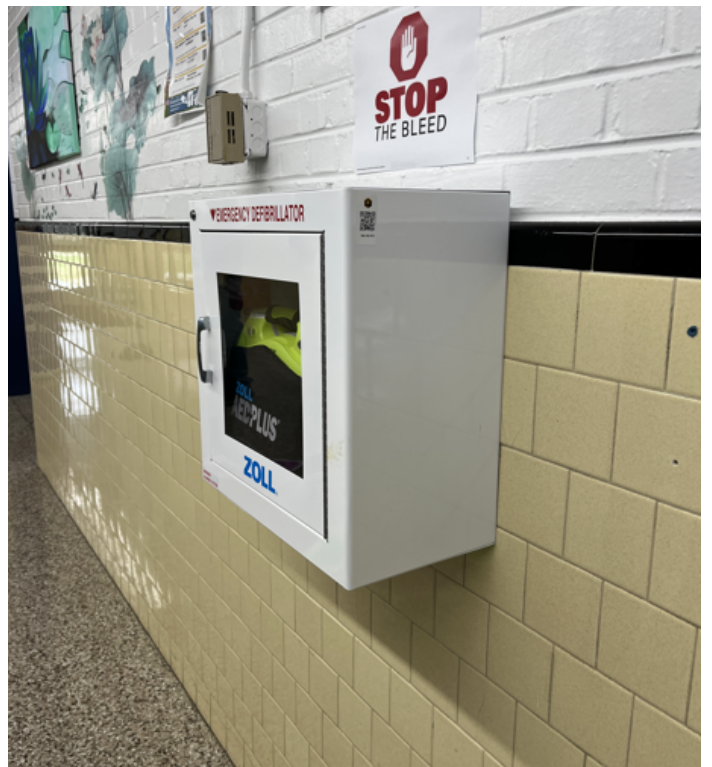
PHOTO AA.05
AED DEVICE - PROTRUSION LIMITS
(ADAAG 307.2)

Condition: Poor / Fair
Quantity: (1) Location

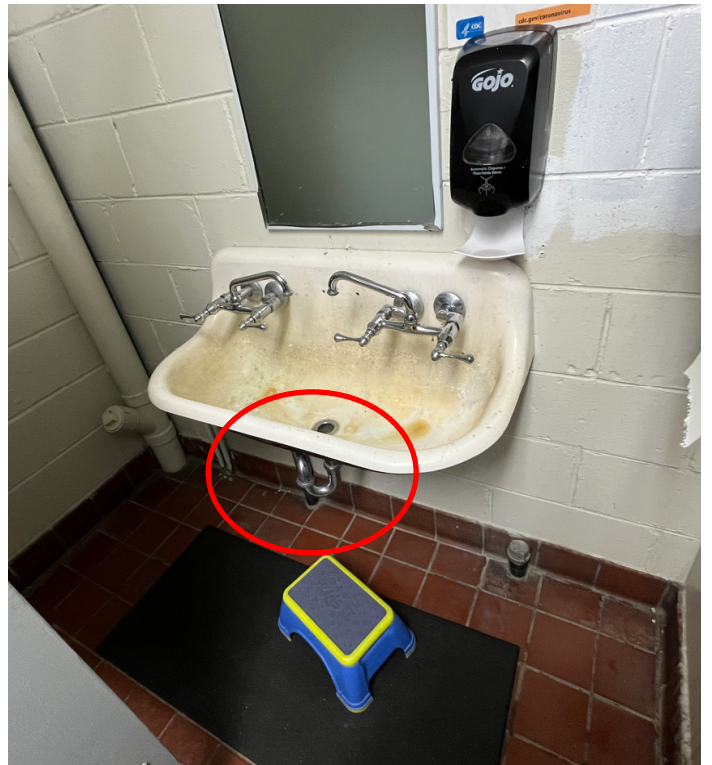
PHOTO AA.09
LAVATORIES & SINKS - EXPOSED PIPES
(ADAAG 606.5)

Condition: Poor
Quantity: Approx. (16) Sinks

9. Install pipe wrap which is missing on accessible sinks.
10. Upgrade individual and group restrooms to meet accessibility standards.
11. Replace classroom casework faucets with code compliant hardware.

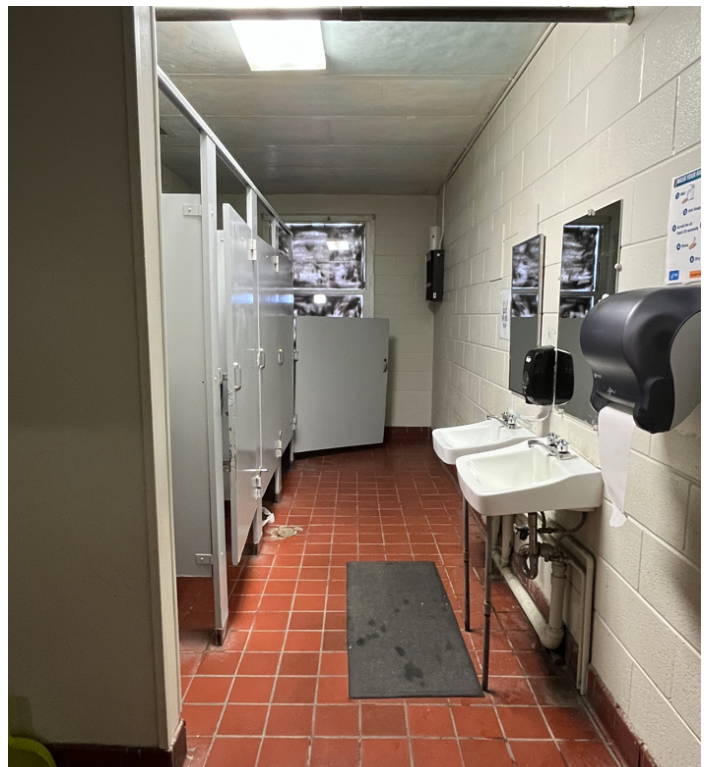
PHOTO AA.11
GROUP TOILET ROOM(S) - GRAB BARS, PATH OF TRAVEL, CLEARANCES & FIXTURES (ADAAG 309.4, 604.3, 604.5, 606.5 & 609.3)

Condition: Poor / Fair
Quantity: Approx. (6) Restrooms

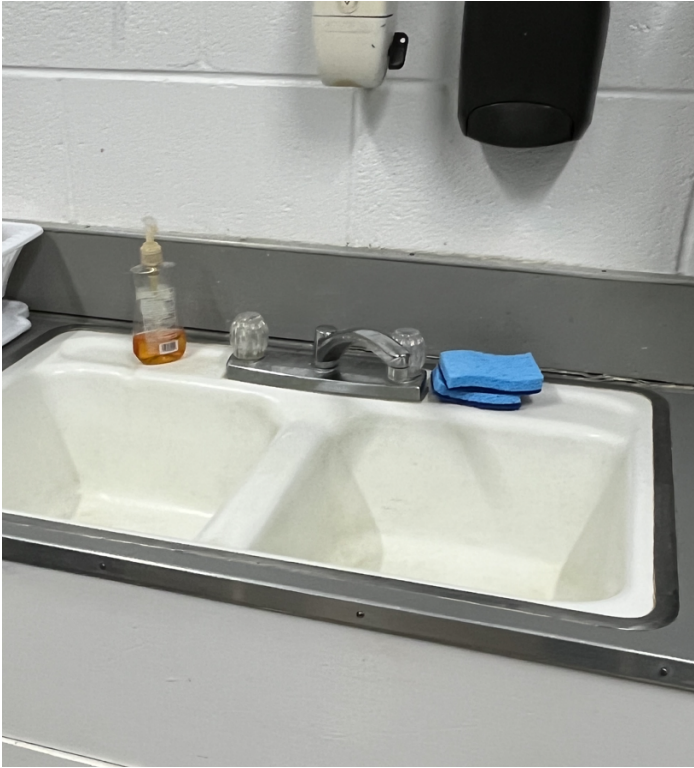
PHOTO AA.12
CLASSROOM CASEWORK FAUCETS
(ADAAG 309.4 & 606.4)

Condition: Fair
Quantity: Approx. (12) Sink Faucets

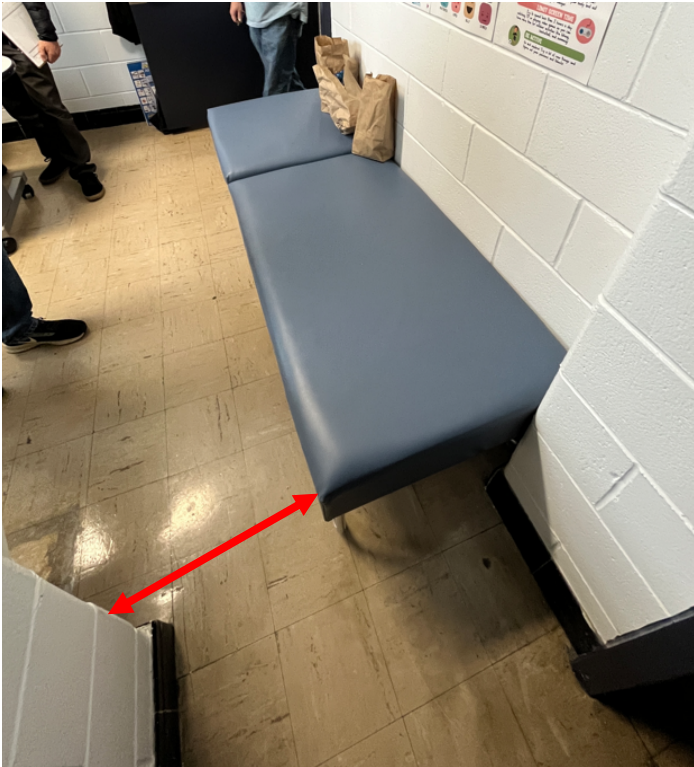
PHOTO AA.13
STORED MATERIALS - CLINIC
(ADAAG 302, 402 & 403)

Condition: Fair
Quantity: (1) Location

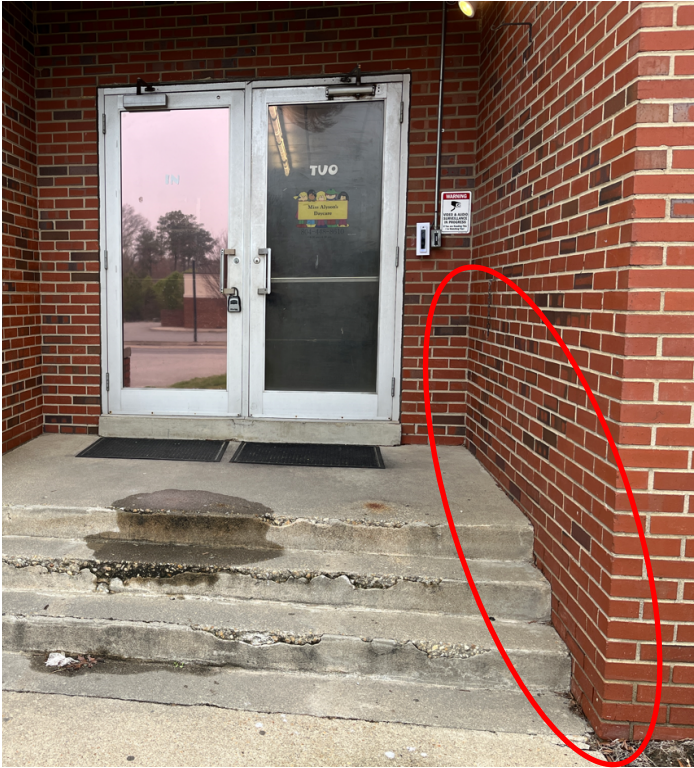
**PHOTO AA.14
HANDRAILS @ EXTERIOR STAIRS
(ADAAG 505)**

*Condition: Poor
Quantity: Approx. 60 LF*

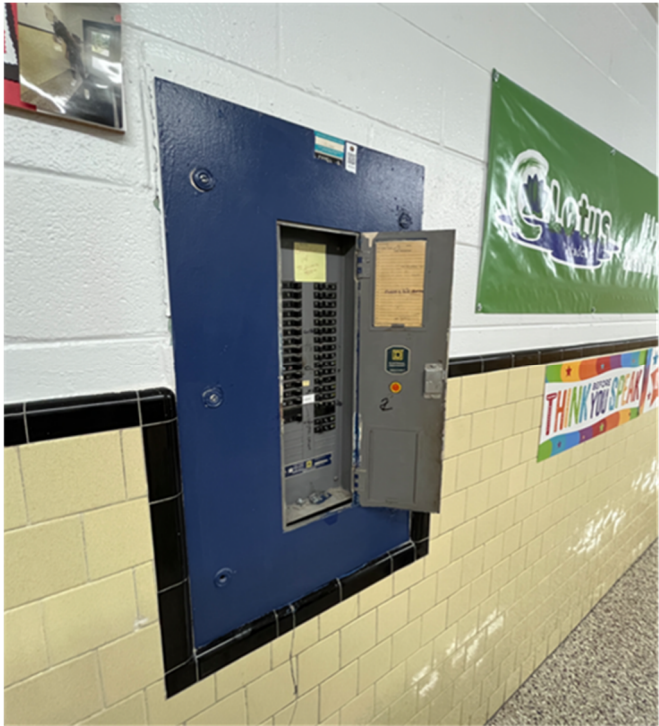
**PHOTO AB.02
UNSECURED ELECTRICAL PANELS**

*Condition: Fair / Good
Quantity: Multiple (School-Wide)*

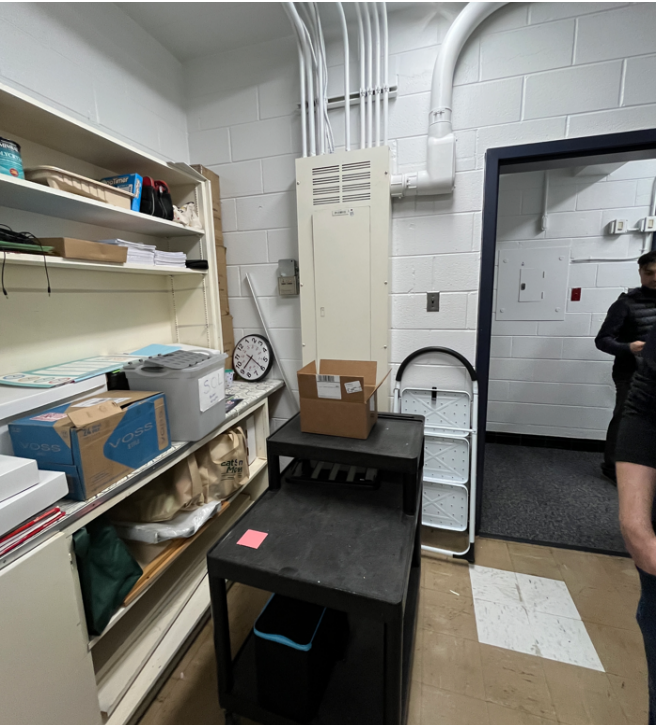
**PHOTO AB.03
PROPER ELECTRICAL PANEL CLEARANCE
(NEC 110-26)**

*Condition: Fair / Good
Quantity: (1) Location*

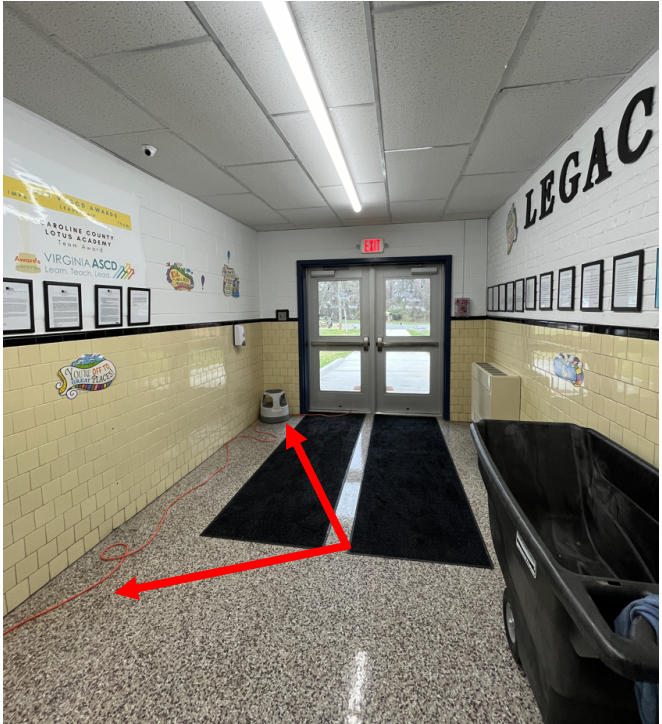
**PHOTO AB.04
USE OF EXTENSION CORDS
(NFPA 11.1.5)**

*Condition: Fair
Quantity: (1) Location*

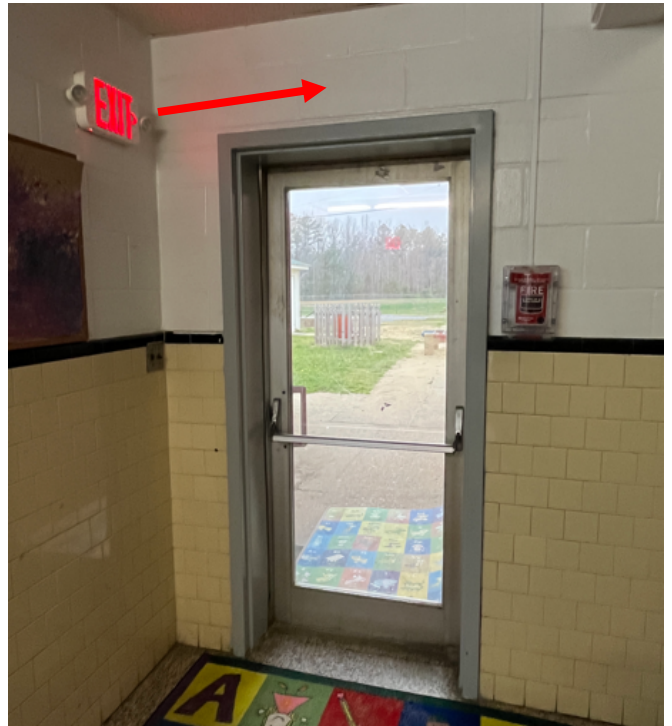
**PHOTO AB.06
IMPROPER ILLUMINATED EXIT SIGN LOCATION
(OSHA 1910.37 & NFPA 101)**

*Condition: Poor
Quantity: (1) Location*

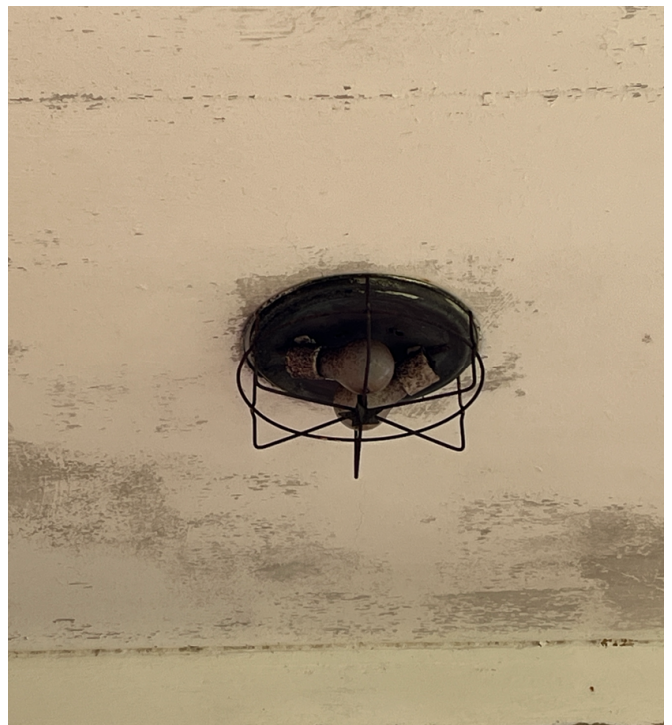
**PHOTO AB.07
INADEQUATE/INOPERABLE LIGHTING @
EXTERIOR EXIT CANOPY (OSHA 1910.37)**

*Condition: Poor
Quantity: Approx. (6) Locations*

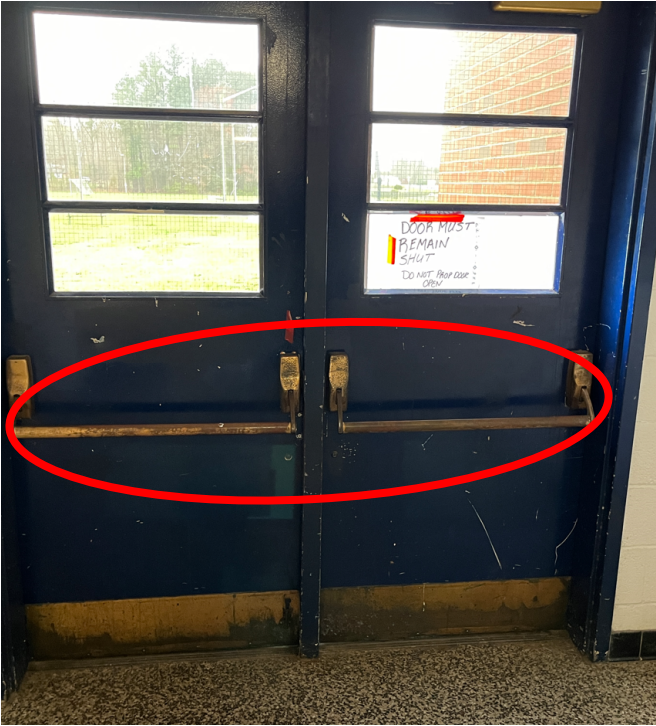
PHOTO AB.08
PANIC EXIT DOOR HARDWARE (TRAP HAZARD)

Condition: Fair
Quantity: Approx. (6) Double Doors
