OLD LADYSMITH ELEMENTARY SCHOOL (LOTUS ACADEMY)

7278 Ladysmith Road, Ruther Glen, Virginia 22546

Facility Condition Assessment

April 2, 2024

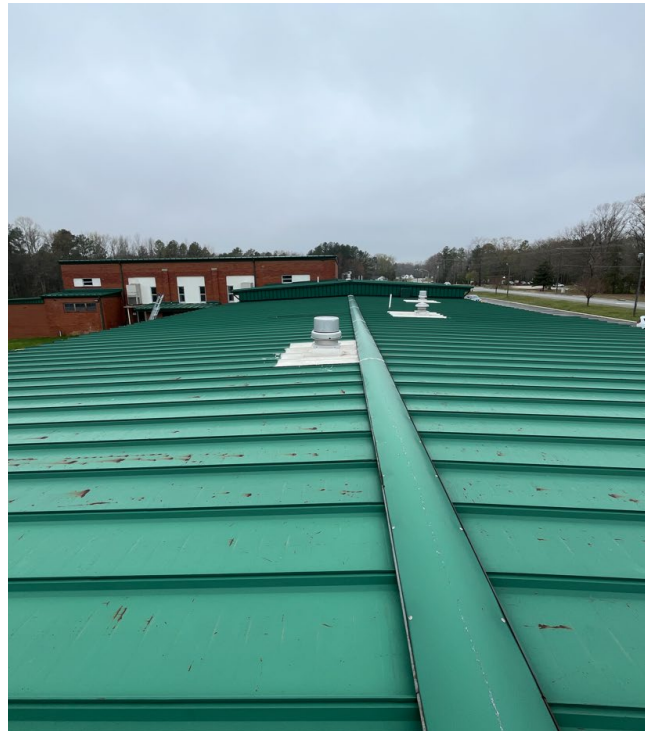
Condition: Poor / Fair

Quantity: Approx. 39,121 SF

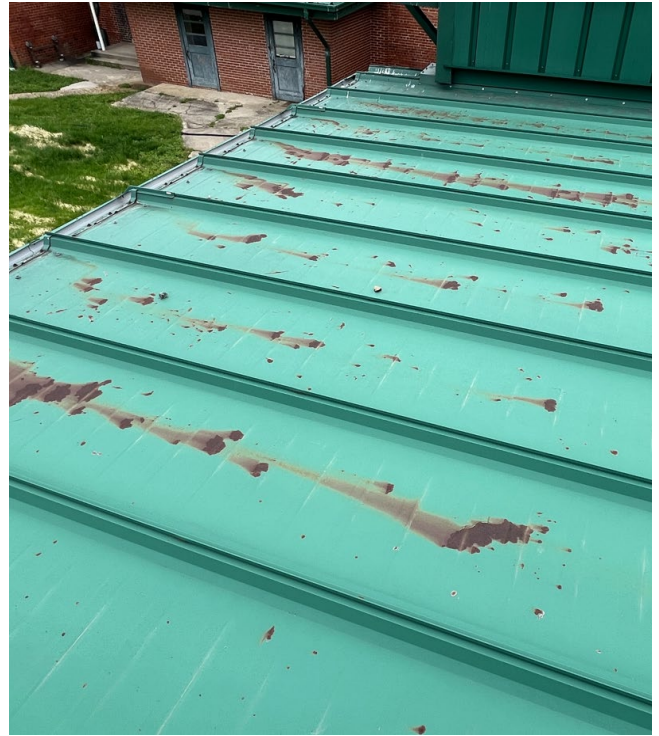
PHOTO AR.01B
PANEL RUST/DETERIORATION - SSM ROOF

Condition: Poor / Fair
Quantity: Approx. 39,121 SF

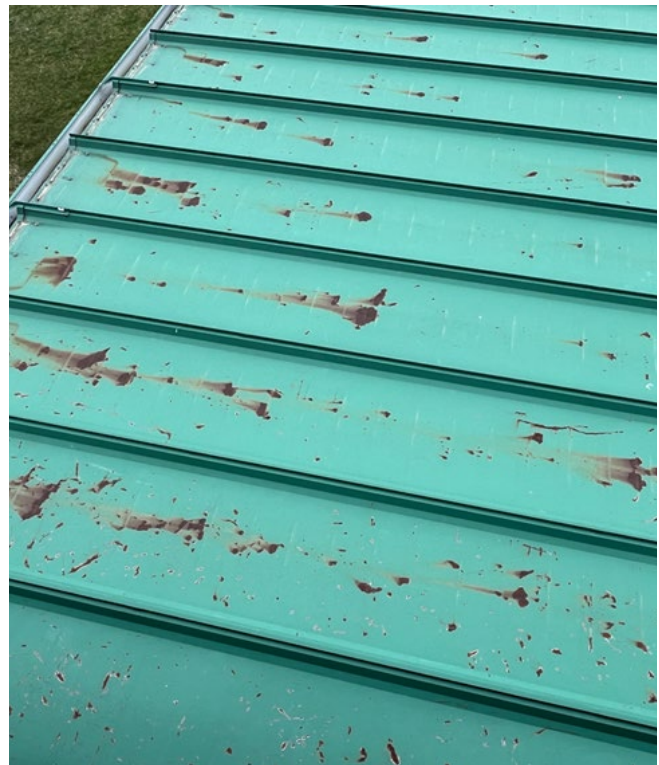
PHOTO AR.01C
PANEL RUST/DETERIORATION - SSM ROOF

Condition: Poor / Fair
Quantity: Approx. 39,121 SF

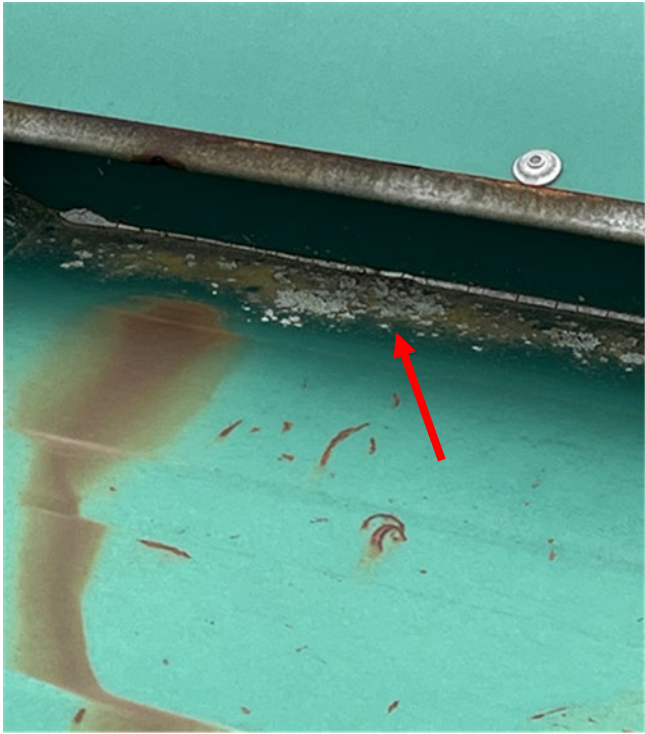
PHOTO AR.01D
PANEL RUST/DETERIORATION - SSM ROOF

Condition: Poor / Fair
Quantity: Approx. 39,121 SF

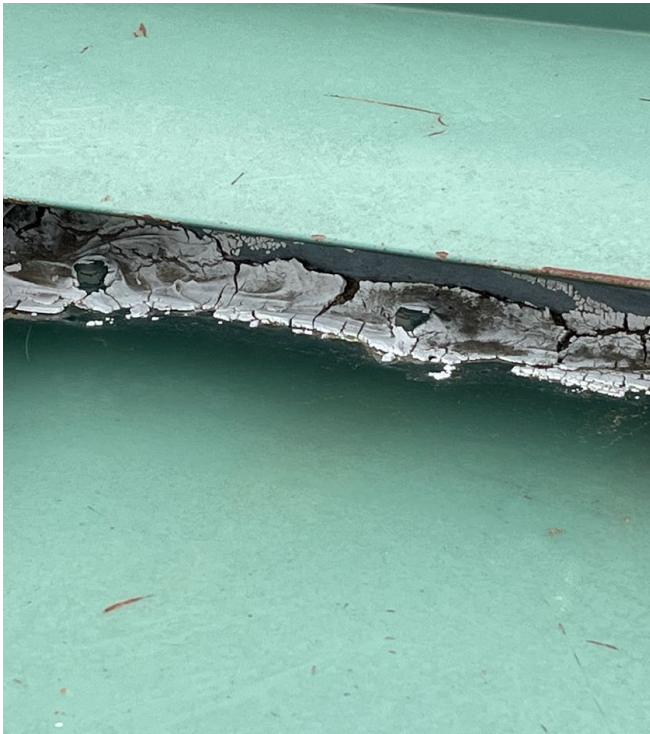
PHOTO AR.01E
DETERIORATED CAULKING REPAIRS - SSM ROOF

Condition: Poor
Quantity: Approx. 39,121 SF

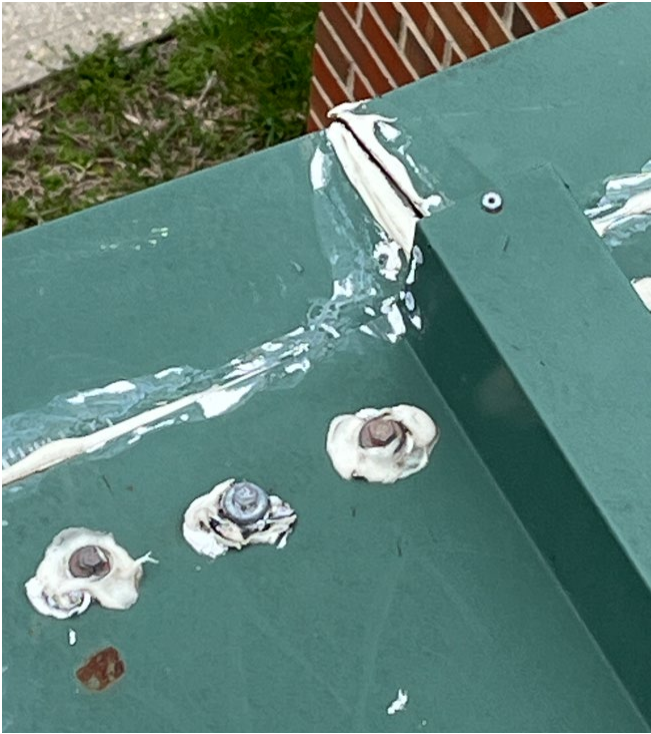
PHOTO AR.01F
DETERIORATED CAULKING REPAIRS - SSM ROOF

Condition: Poor
Quantity: Approx. 39,121 SF

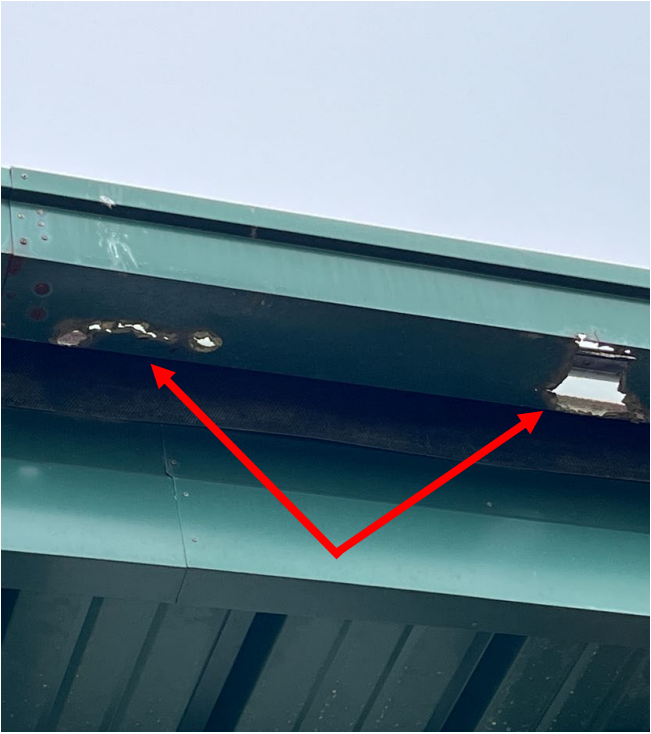
Additional significant issues were discovered during our inspection consisting of deteriorated/rusted gutters and downspouts as well as signs of water infiltration identified within the building.

PHOTO AR.02A
RUSTED GUTTERS

Condition: Poor
Quantity: Approx. 39,121 SF

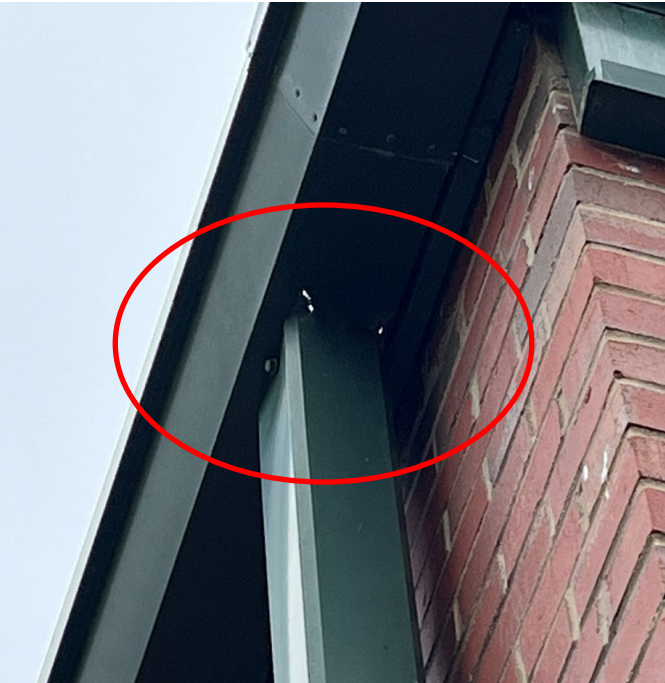
**PHOTO AR.02C
RUSTED GUTTERS & DOWNSPOUTS**

Condition: Poor
Quantity: Approx. 39,121 SF

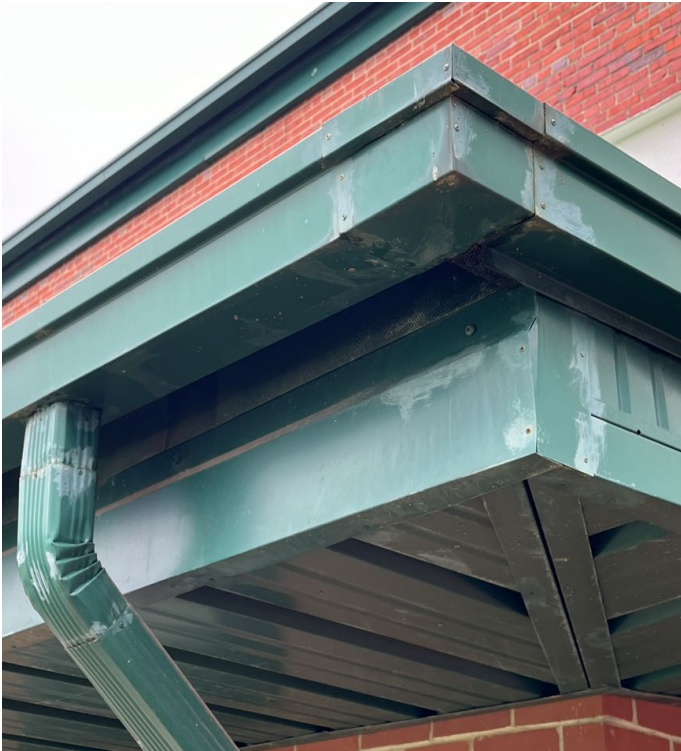
**PHOTO AR.02D
RUSTED GUTTERS & DOWNSPOUTS**

Condition: Poor
Quantity: Approx. 39,121 SF

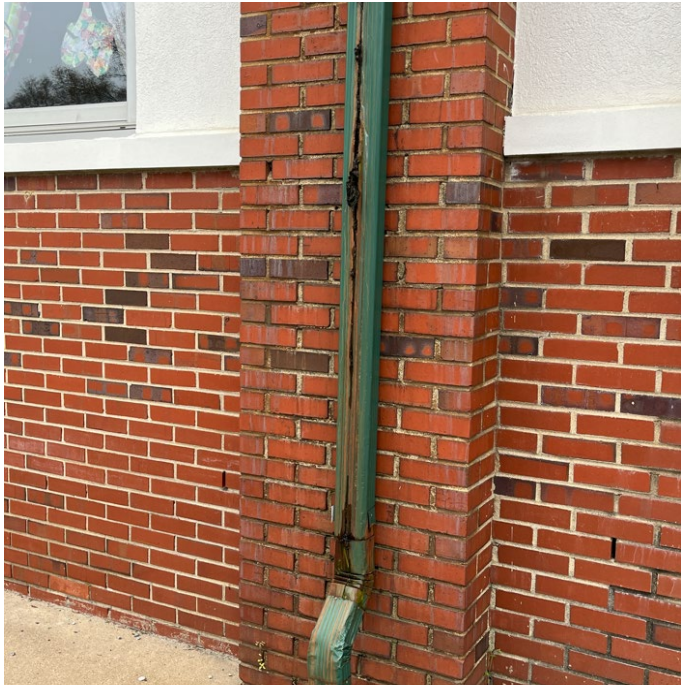
**PHOTO AR.02E
RUSTED DOWNSPOUTS**

Condition: Poor
Quantity: Approx. 39,121 SF

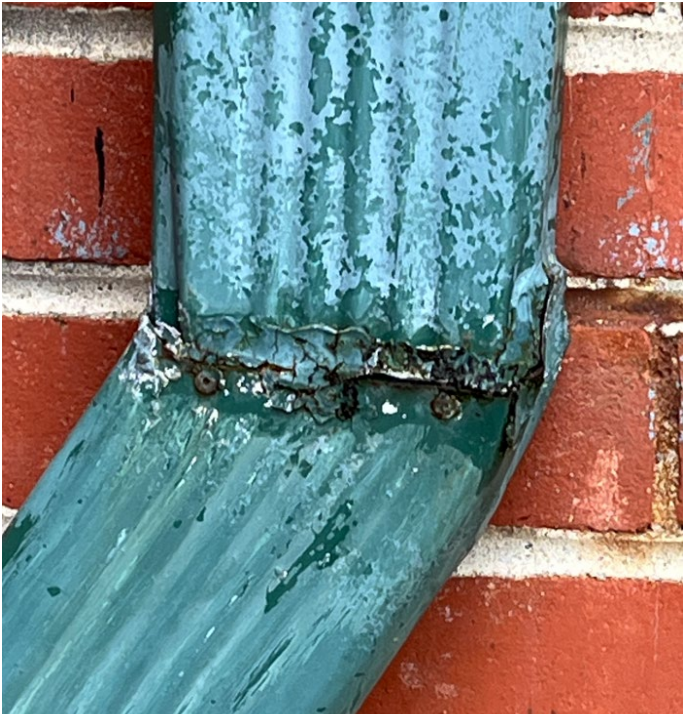
**PHOTO AR.02F
DETERIORATED DOWNSPOUTS**

*Condition: Poor
Quantity: Approx. 39,121 SF*

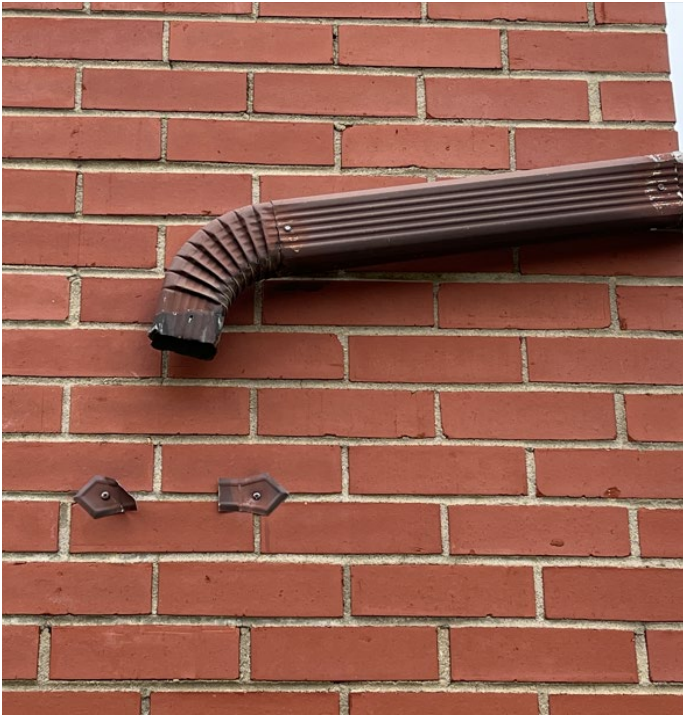
**PHOTO AR.02G
MISSING DOWNSPOUTS**

*Condition: Poor
Quantity: Approx. 39,121 SF*

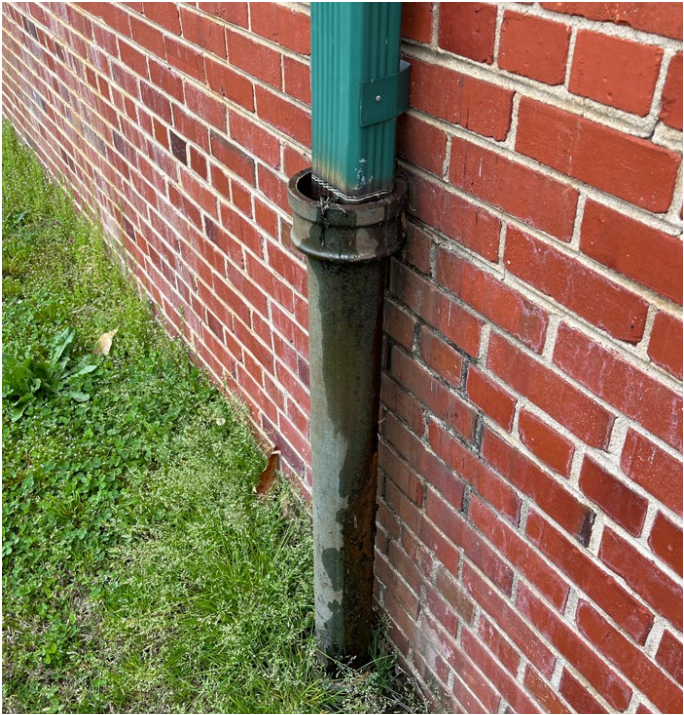
PHOTO AR.02H
CLOGGED/OVERFLOWING DOWNSPOUTS

Condition: Poor
Quantity: Approx. 39,121 SF

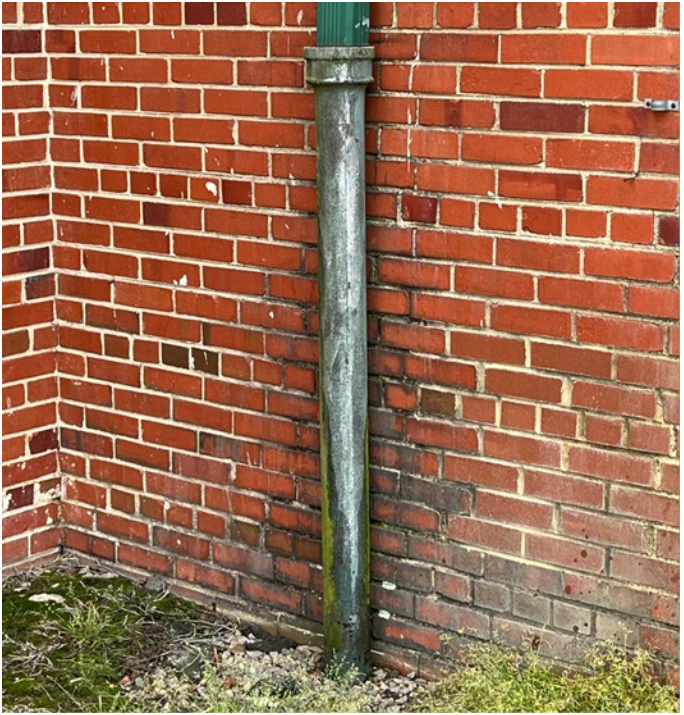
PHOTO AR.02I
CLOGGED/OVERFLOWING DOWNSPOUTS

Condition: Poor
Quantity: Approx. 39,121 SF

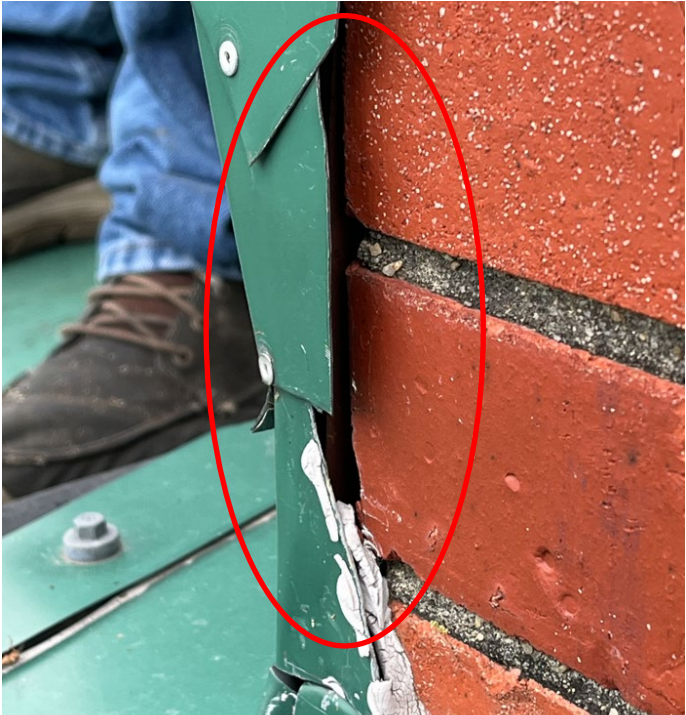
**PHOTO AR.03A
WALL FLASHING DETERIORATION**

Condition: Poor
Quantity: Approx. 39,121 SF

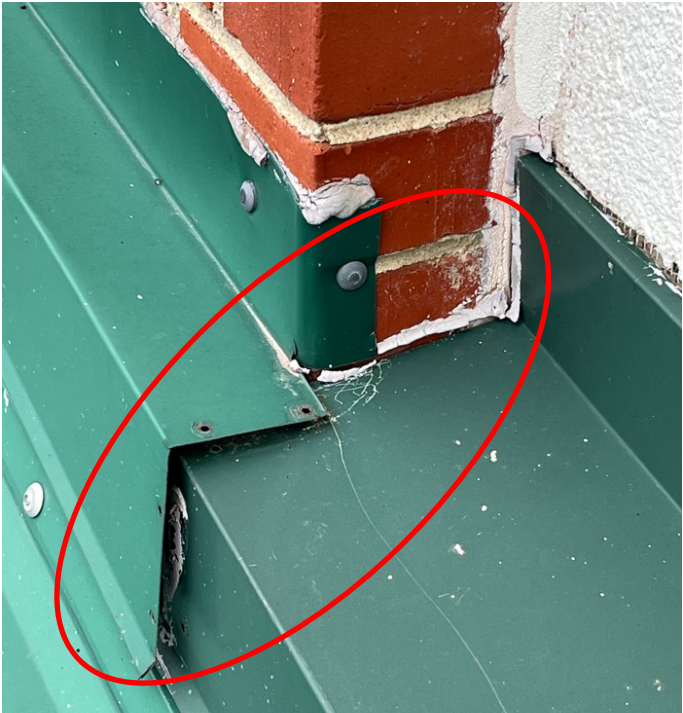
**PHOTO AR.03B
WALL FLASHING DETERIORATION**

Condition: Poor
Quantity: Approx. 39,121 SF

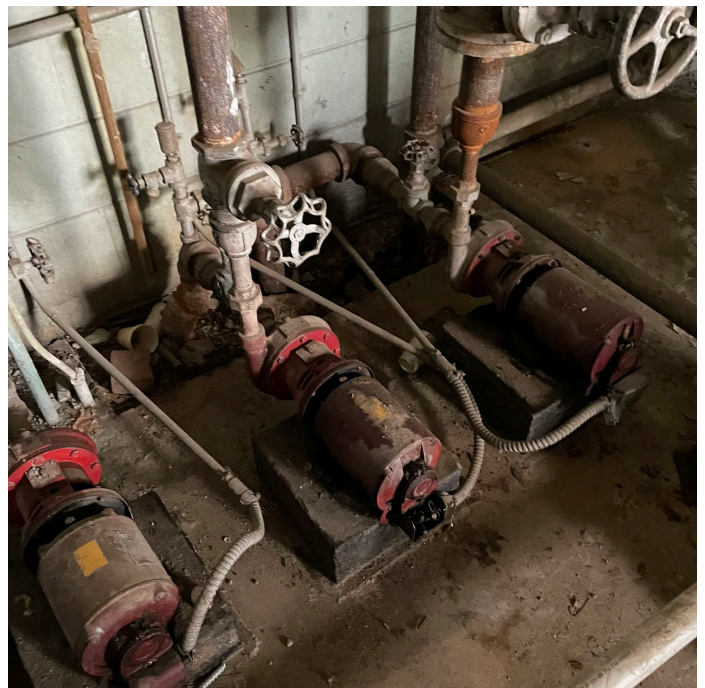
Central heating for the building used to be provided by two boiler plants. One consisted of one (1) natural gas fired boiler. Three (3) heating hot water pumps distributed water around the addition. The other boiler room is in the basement of the building and provided heating water to the original portion of the building via one (1) boiler. All the boilers, pumps, mechanical room piping, and associated accessories are all abandoned in place and in poor condition.

PHOTO M.01
HOT WATER PUMPS & PIPING

Condition: Abandoned
Quantity: (3)

1. All of the hydronic equipment is abandoned in place and in poor condition. All of the equipment should be removed, and the mechanical rooms could be converted to storage rooms.
2. The recently renovated classroom Bard style units are in good condition and have most of their expected life in them.
3. The terminal heating equipment appears in operable physical condition but are near the end of their expected life and should be considered for replacement or removal.
4. The general heating, cooling, and ventilation system for the unrenovated classroom wings are not ideal. The air terminals and sensors are in poor condition. The Bard style units are near the end of their life and should be considered for replacement.

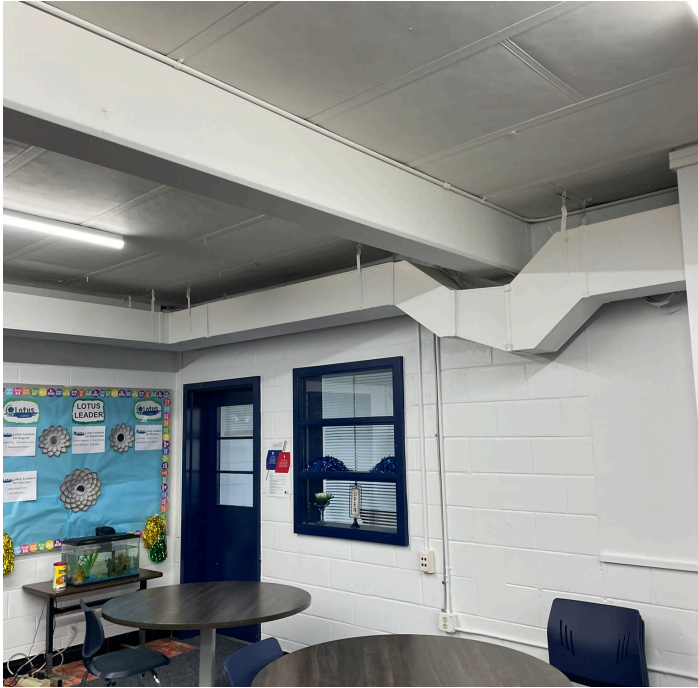
**PHOTO M.03
RENOVATED CLASSROOM AIR TERMINAL**

Condition: Good
Quantity: Approx. 12,135 SF

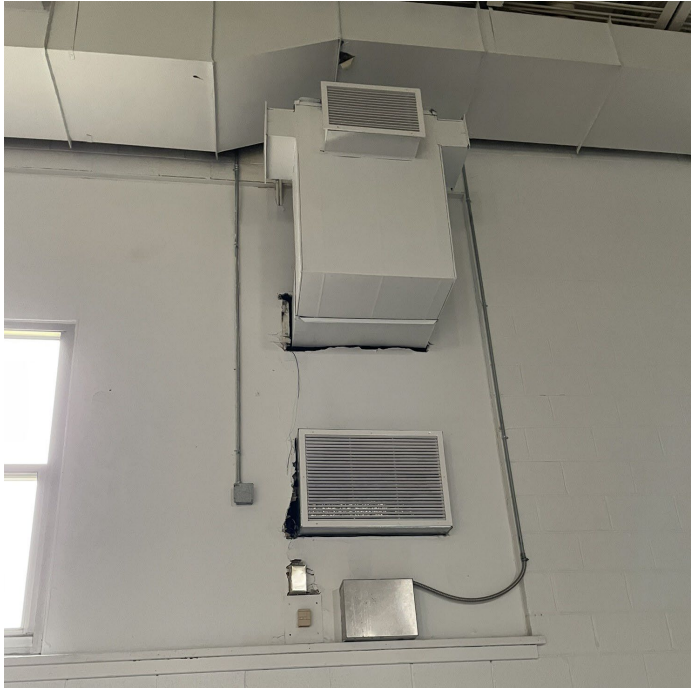
Ductwork and Air Terminals. There is minimal ductwork in this building. There are only two classroom Bard style units that have duct connections. The gymnasium Bard style units have minimal supply ductwork connections. There is additional ductwork in the gym connected to the abandoned AHU. The ductwork is in fair condition. Air terminals in the renovated portion of the building are clean and in good condition. The air terminals in the rest of the building are showing signs of rust and/or mold and need to be replaced.

**PHOTO M.05
OLD CLASSROOM AIR TERMINALS**

Condition: Poor
Quantity: Approx. 27,090 SF

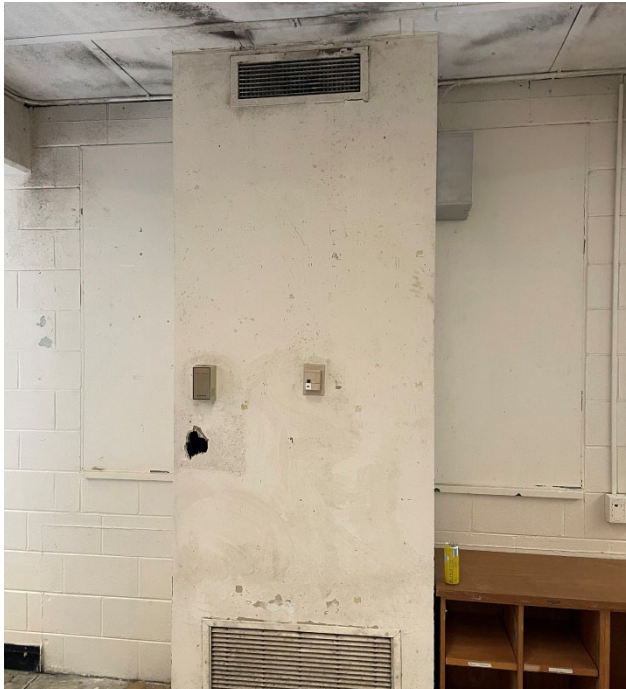
PHOTO M.06
ADMIN AREA PTAC

Condition: Fair
Quantity: (4)

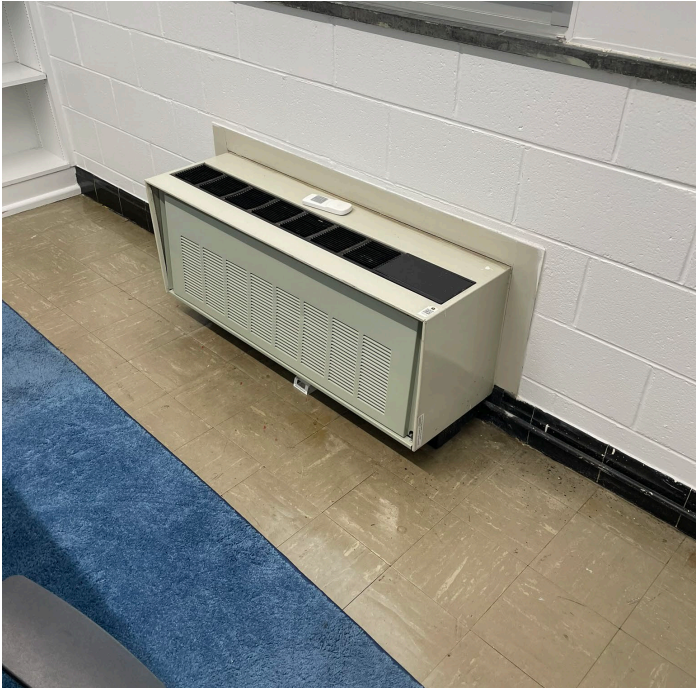
Decentralized HVAC equipment provides air conditioning and ventilation for the entire building. Every classroom has a single zone packaged exterior wall mounted Bard style heat pump units that were installed in 2009. The gymnasium is heated and cooled by four (4) packaged exterior wall mounted Bard style heat pump units. The older Bard units are in fair condition but will likely need to be replaced within the next five years. There is an existing AHU in a mechanical mezzanine that was abandoned in place that used to serve the gymnasium. The admin offices have PTAC units that are in fair condition. There is no cafeteria or kitchen in this building. The kitchen was converted to storage for the theater and the kitchen hood was abandoned in place. One group toilet was recently renovated and is served by two (2) ductless mini-split system heat pumps. These mini-splits are in good condition. There are roof-mounted exhaust fans serving the renovated group toilets. These exhaust fans are in good condition. There is one set of group toilets that does not have an exhaust fan connection. This will need to be added to be code compliant.

PHOTO M.07
KITCHEN HOOD

Condition: Abandoned
Quantity: (1)

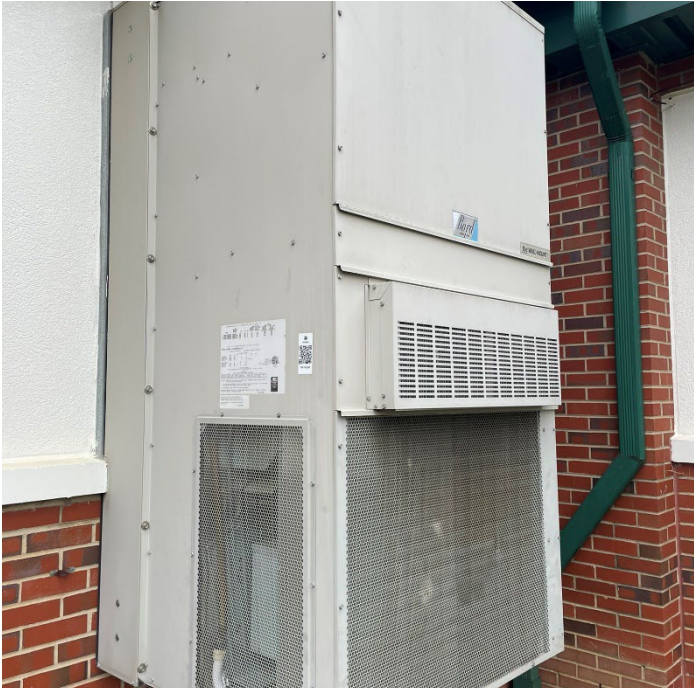
Terminal heating equipment provides heat for entrances of the building and in the older group toilets. Wall mounted electric cabinet unit heaters are surface mounted in the vestibules. Wall mounted electric unit heaters provide heating to the group toilets. The terminal heating equipment is in fair condition.

**PHOTO M.09
CABINET UNIT HEATER**

*Condition: Poor / Fair
Quantity: (5)*

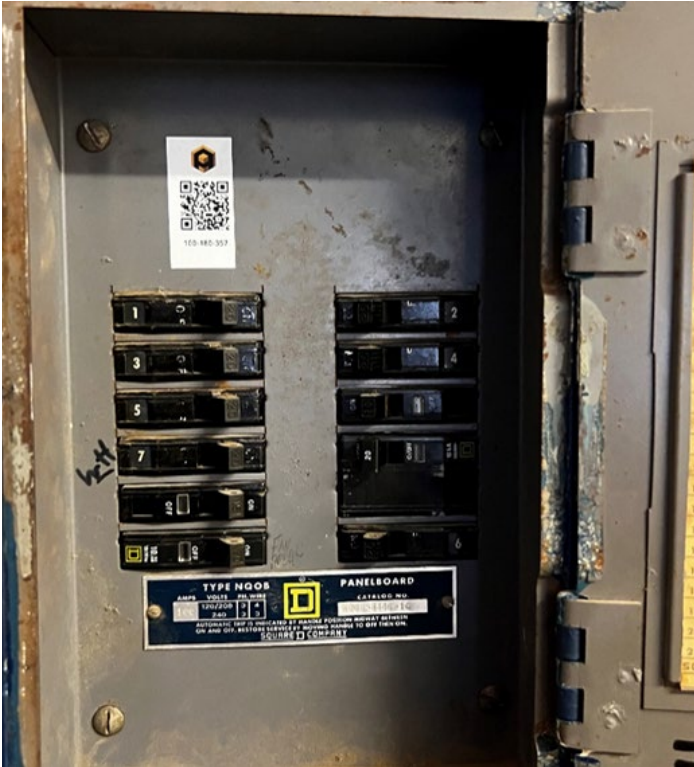
**PHOTO E.02B
EXISTING PANELS**

Condition: Poor
Quantity: Approx. 43,763 SF

1. The existing switchboard should be replaced with new equipment.
2. All panelboards associated with the service should be replaced due to the age of the panelboards.

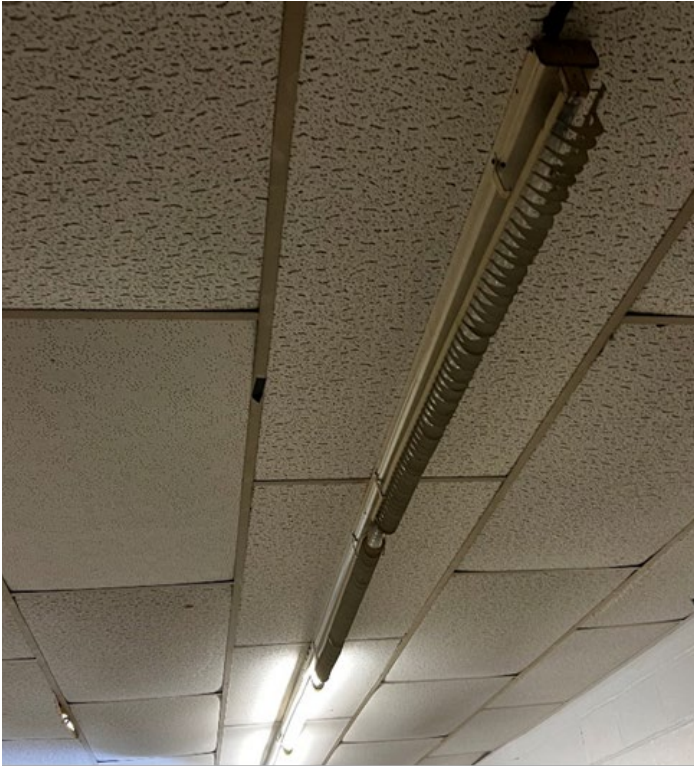
**PHOTO E.03
LIGHT FIXTURES (INCANDESCENT)**

Condition: Poor
Quantity: Approx. 43,763 SF

Interior lighting consists of a mixture of fixture types and lamp types, some have been converted to LED in 2016, but most of the light in the building needs to be replaced because it is in very poor condition. While the existing renovated fixtures are functional, the entire rest of the lighting should be replaced. The controllability is very limited and doesn't meet the current energy code, namely the International Energy Conservation Code (IECC). They consume much higher levels of energy, thus costing more to operate, and they provide poor lighting levels in areas of the building. Lighting controls are manual type only in many areas. There are no daylight harvesting or automatic lighting controls, which are also now required per the IECC.

All non-LED light fixtures should be replaced with efficient LED light fixtures and the existing battery-operated wall pack should be replaced. Additionally, the associated occupancy sensing, dimming, and daylight harvesting lighting controls should be replaced/added to reduce energy usage of the building. The incandescent exit signs should be upgraded, as applicable, to LED type and supplemental signs added where needed.

3. All existing interior non-LED light fixtures should be upgraded to LED light fixtures that conform to the current version of the IECC.
4. It is recommended that existing toggle switch lighting controls be replaced with code compliant lighting controls consisting of dimming, occupancy sensing, and daylight harvesting controls as mentioned above.

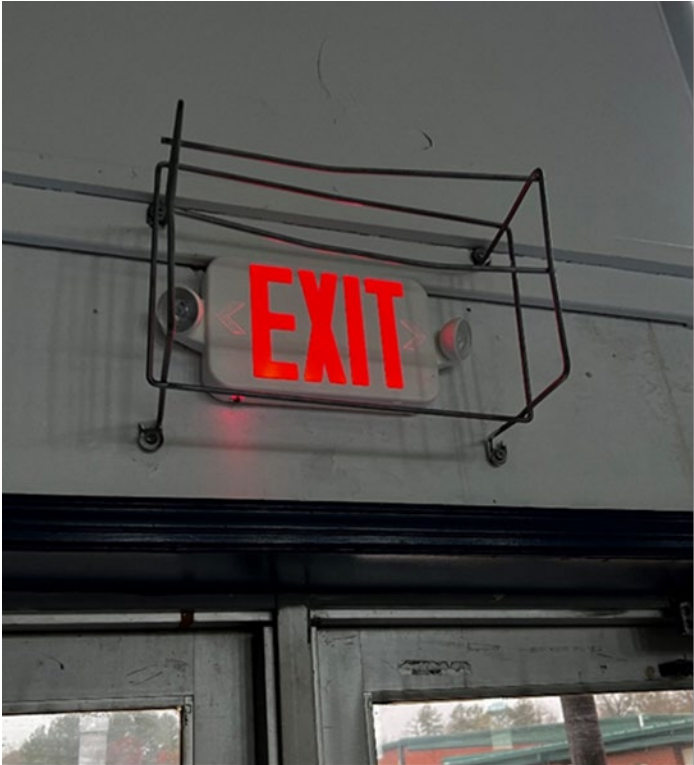
**PHOTO E.04
EXIT SIGN (INCANDESCENT)**

Condition: Good
Quantity: Approx. 43,763 SF

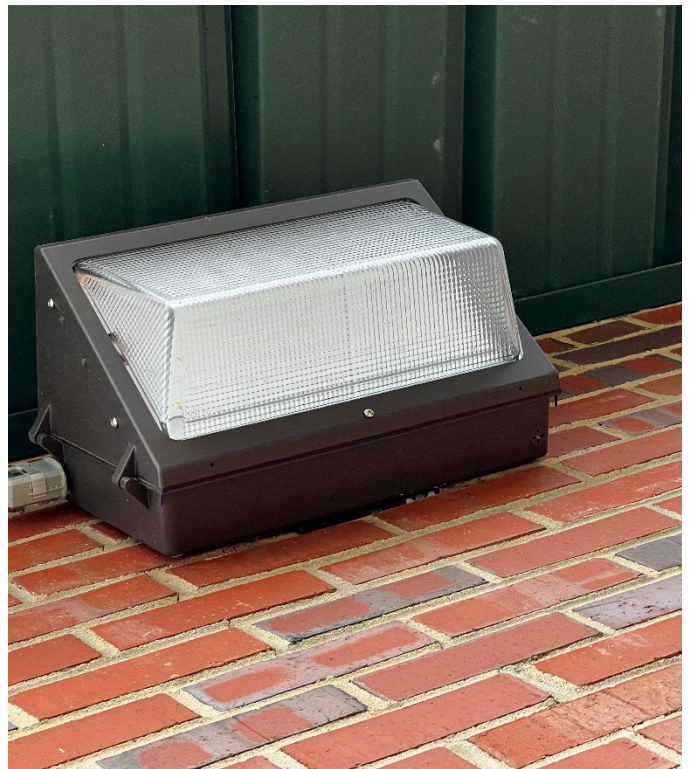
Exterior building mounted lighting consists predominately of wall mounted fluorescent light fixtures. These fixtures are currently functional, but all non-LED fixtures should be replaced with LED.

PHOTO E.05
EXTERIOR LIGHT FIXTURES (TYPICAL)

Condition: Good
Quantity: (20)

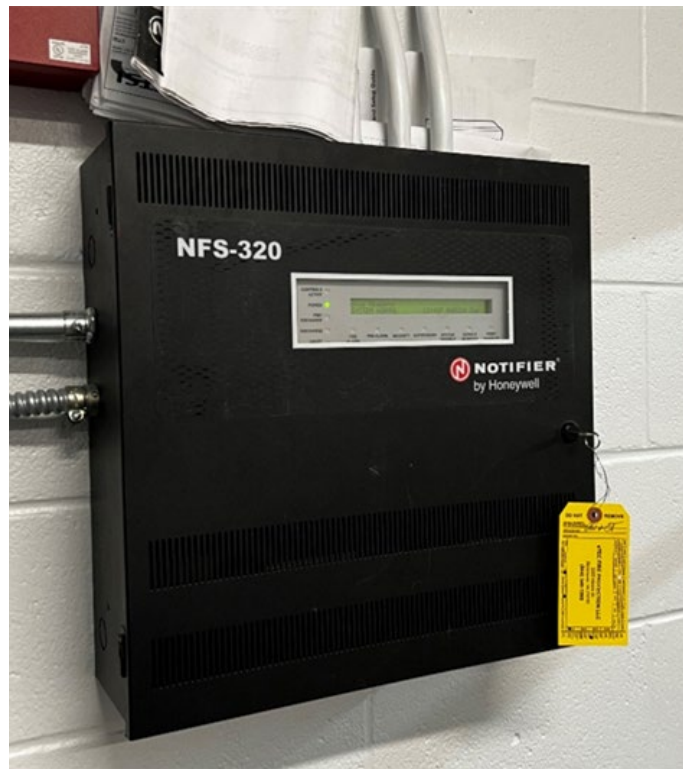
The **fire alarm system** main control panel is a Notifier NFS-320 series and contains peripheral equipment. The system consists of wall mounted audio/visual devices, manual pull stations located at most exit passages, but there were a few areas that were supposed to have notification devices that did not. Additional peripheral device should be added throughout the building. The existing fire alarm control panel is functional and does not need to be replaced.

PHOTO E.06
FIRE ALARM CONTROL PANEL

Condition: Good
Quantity: (1)

6. The existing fire alarm system can remain, but several associated peripheral equipment should be added.
7. It is recommended that the clock system be replaced with a wireless clock system that is standard for all rooms.

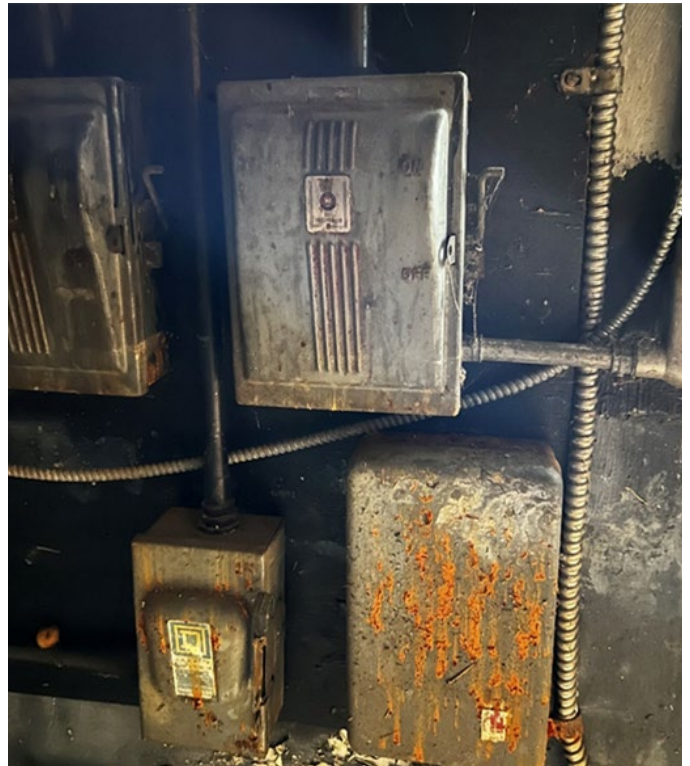
Local means of disconnects appear to be original to installation of equipment. Most of the mechanical equipment has been replaced since the building was original along with associated disconnects, and a few are in fair condition, but the overall system is in poor condition due to age and is due for replacement.

**PHOTO E.07
DISCONNECTS**

*Condition: Very Poor
Quantity: Approx. 43,763 SF*

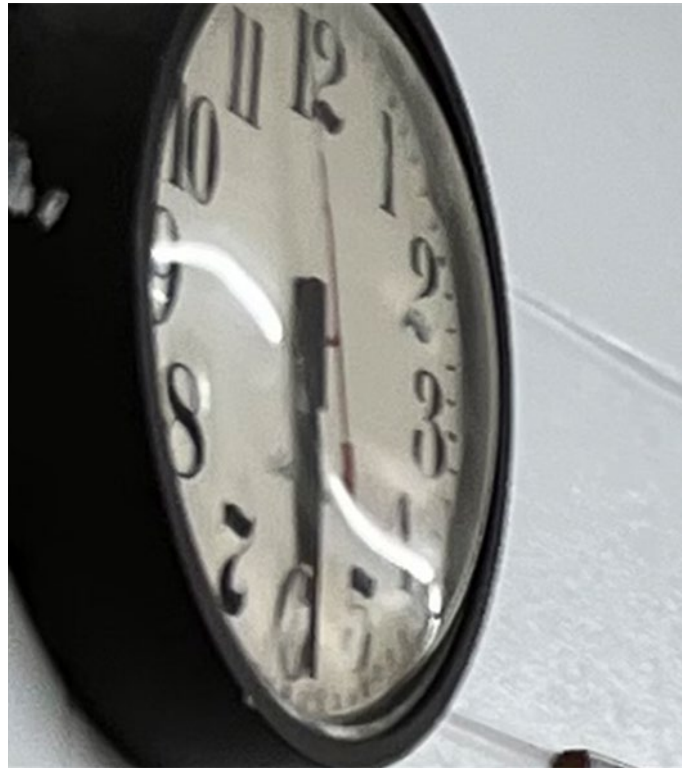
The **intercom/clock system** is not functioning properly in many places, as most of the clocks were displaying a different type. The existing system is currently a functional system that controls all intercommunications and clock scheduling throughout the facility. The system is in fair condition and does not need to be replaced in near future. Most of the clocks throughout the corridors are clocks. However, some classrooms utilize battery operated clocks that are not compatible with the clock system. It is recommended that the clock system be replaced with a newer system and standardized clocks be located throughout the school.

PHOTO E.08
CLOCK (TYPICAL)

Condition: Fair

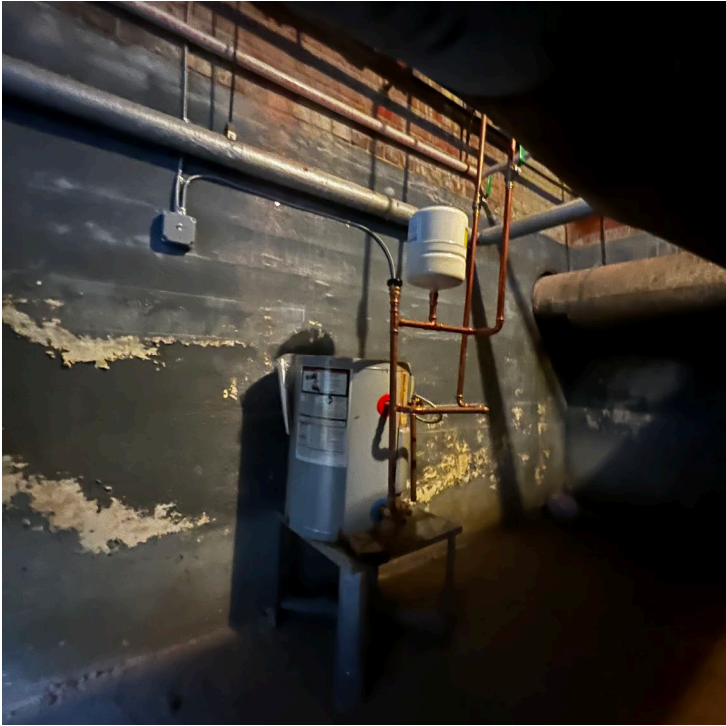
**PHOTO P.01
HOT WATER HEATER**

*Condition: Good
Quantity: (1)*

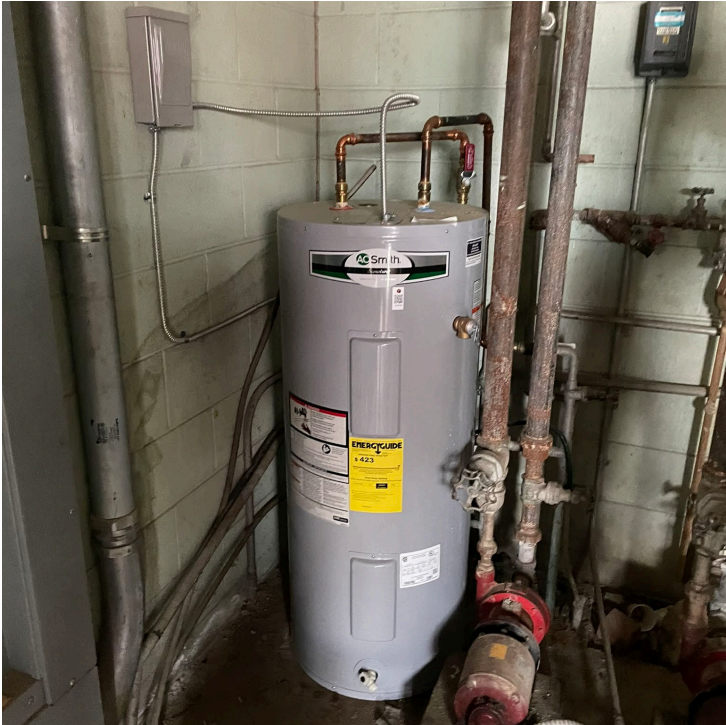
**PHOTO P.02
HOT WATER HEATER**

*Condition: Good
Quantity: (1)*

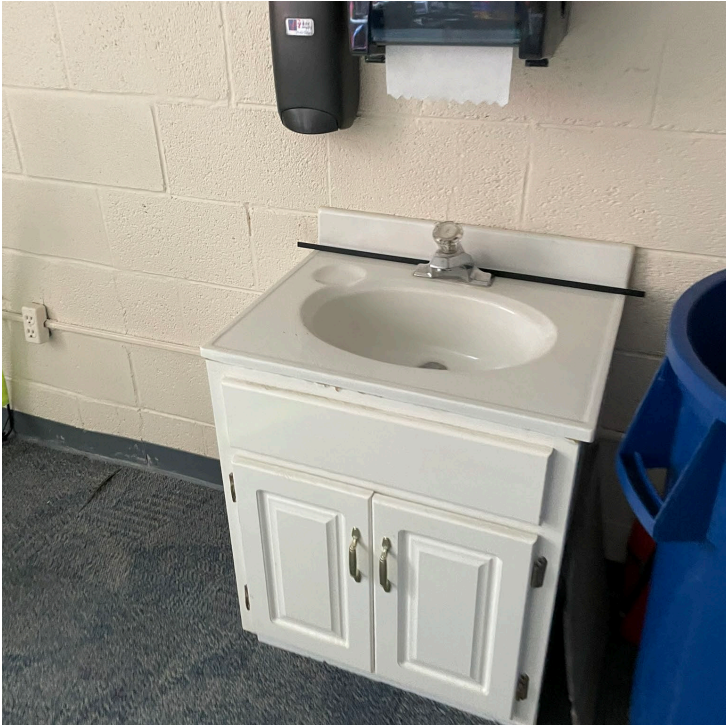
PHOTO P.03
CLASSROOM LAVATORY

Condition: Poor / Fair
Quantity: (30)

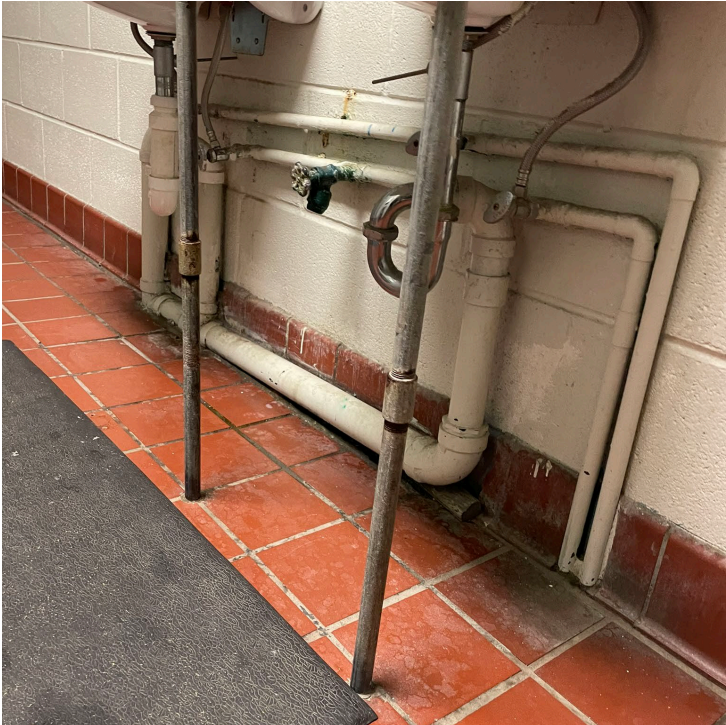
PHOTO P.04
LAVATORY DOMESTIC PIPING

Condition: Poor
Quantity: 500 lf

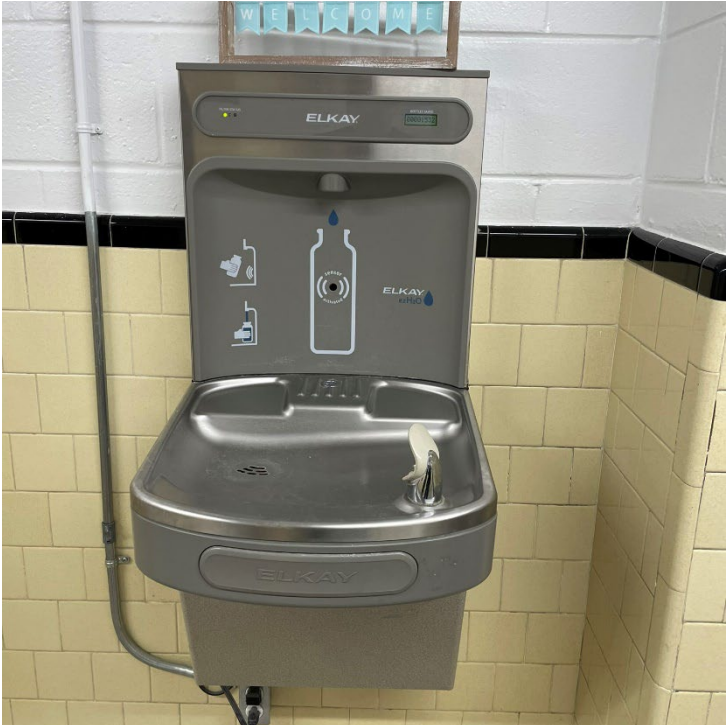
**PHOTO P.5
WATER COOLER**

*Condition: Good
Quantity: (4)*

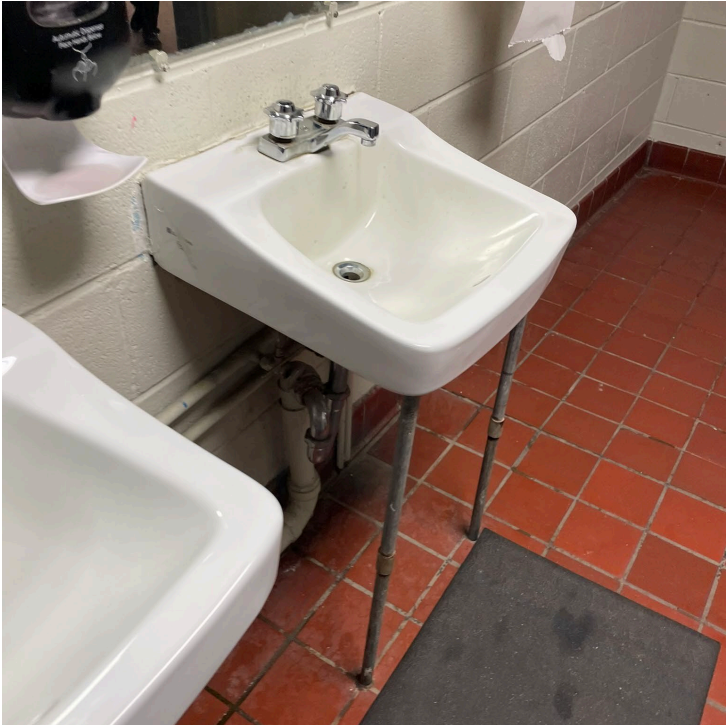
**PHOTO P.6
GROUP TOILET LAVATORY**

*Condition: Poor
Quantity: (6)*

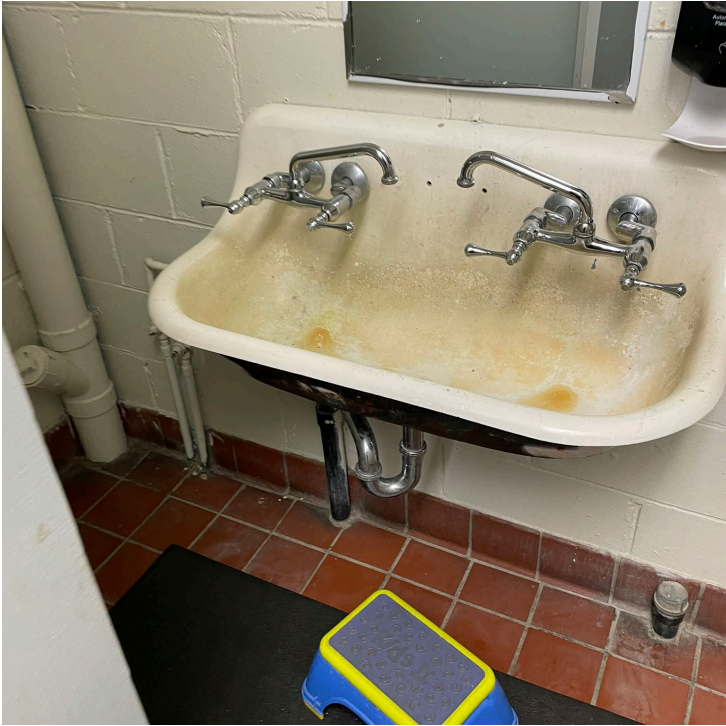
PHOTO P.7
GROUP TOILET LAVATORY DOUBLE SINK

Condition: Poor
Quantity: (2)

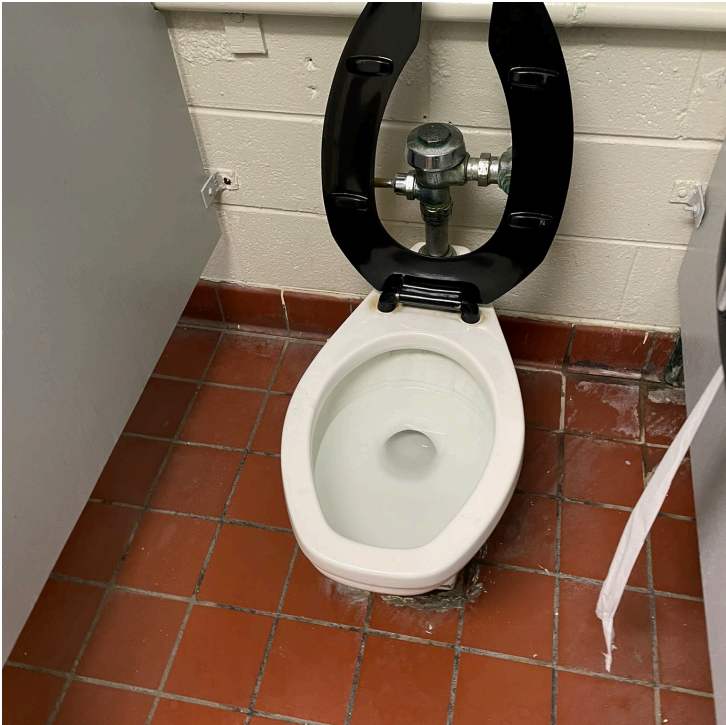
PHOTO P.8
WATER CLOSET

Condition: Poor
Quantity: (34)

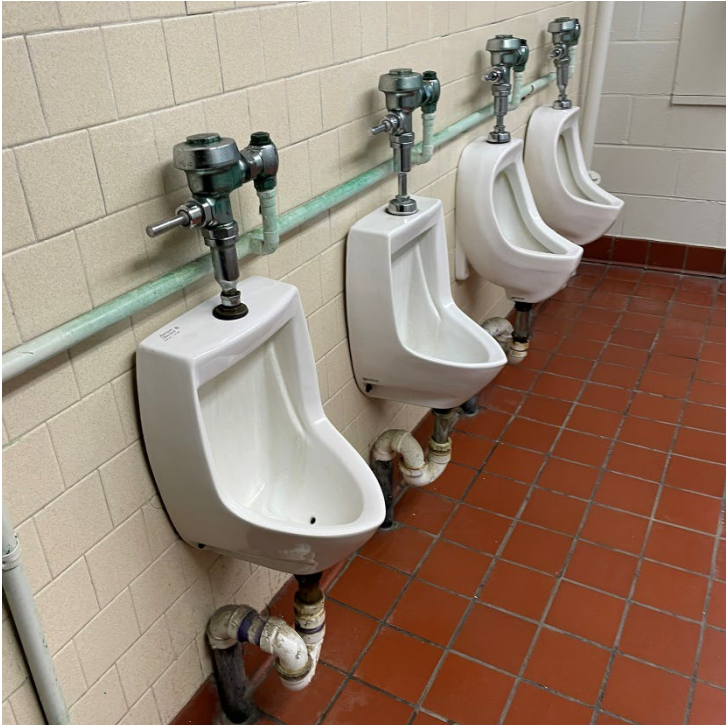
**PHOTO P.9
URINAL**

*Condition: Poor
Quantity: (4)*

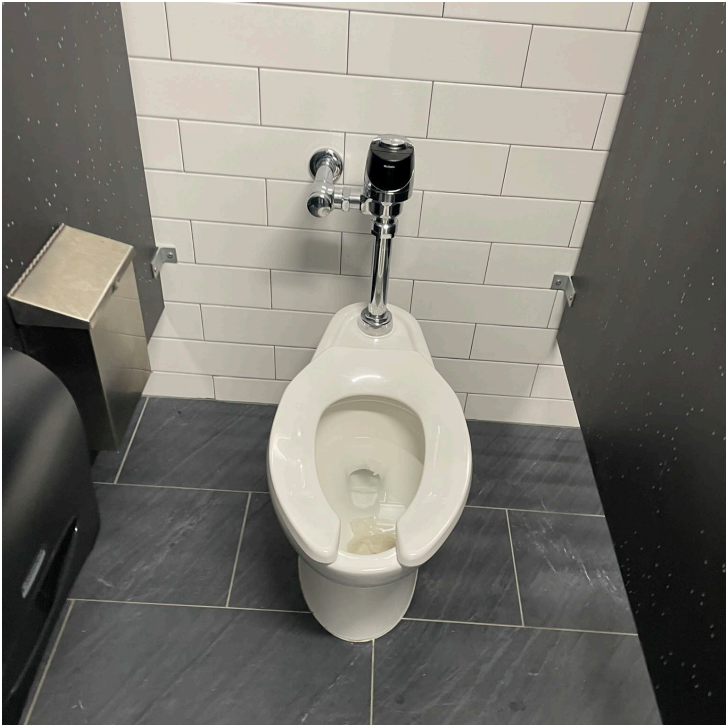
**PHOTO P.10
RENOVATED WATER CLOSET**

*Condition: Good
Quantity: 650 SF*

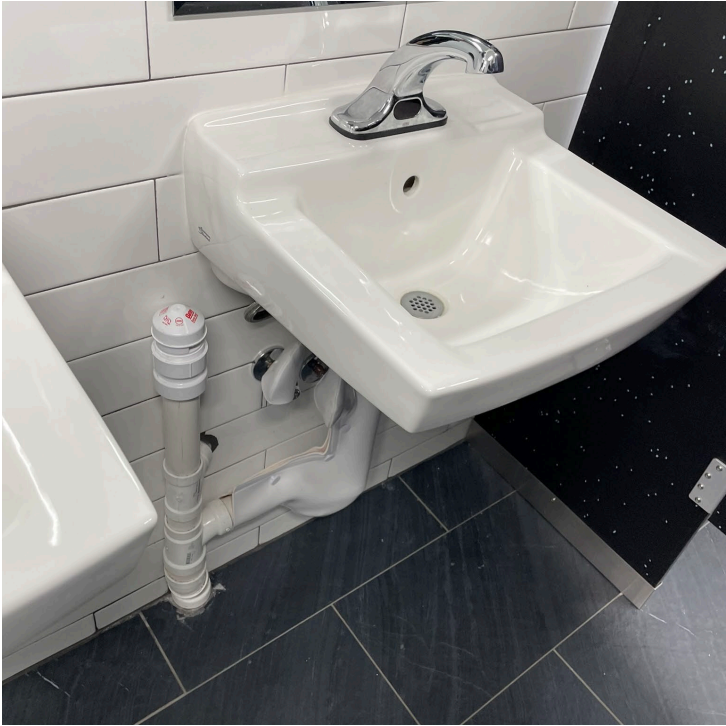
PHOTO P.11
RENOVATED LAVATORY

Condition: Good
Quantity: 650 sf
