OLD LADYSMITH ELEMENTARY SCHOOL (LOTUS ACADEMY)

7278 Ladysmith Road, Ruther Glen, Virginia 22546

Facility Condition Assessment

April 2, 2024

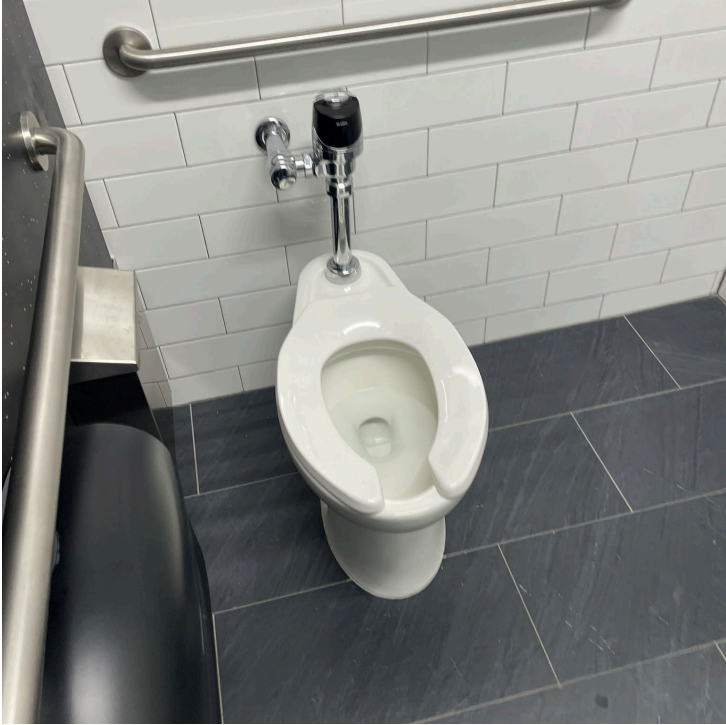
PHOTO P.12
RENOVATED WATER CLOSET

Condition: Good
Quantity: 650 sf

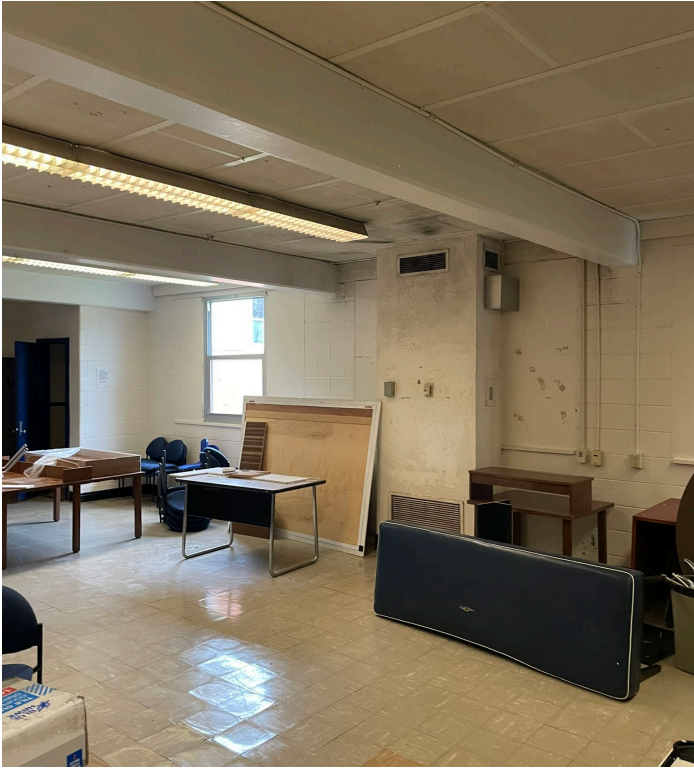
Old Ladysmith Elementary School is not protected with a fire suppression (sprinkler) system and does not have wall mounted fire extinguishers located throughout the corridors. Fire alarm pull stations are located adjacent to exterior exit doors and appear to be in working order. Major renovations may require the need for a full NFPA fire suppression (sprinkler) system. It is recommended that the fire protection system be upgraded to provide adequate fire suppression coverage throughout the school.

**PHOTO FS.2
GENERAL CLASSROOMS - SPRINKLER SYSTEM**

*Condition: Not Applicable
Quantity: None*

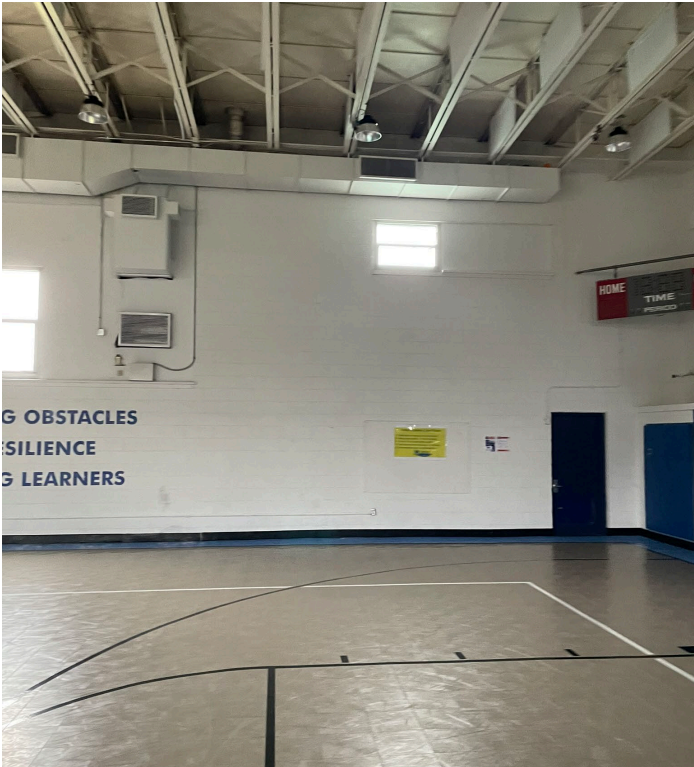
**PHOTO FS.3
MAIN GYMNASIUM - SPRINKLER SYSTEM**

*Condition: Not Applicable
Quantity: None*

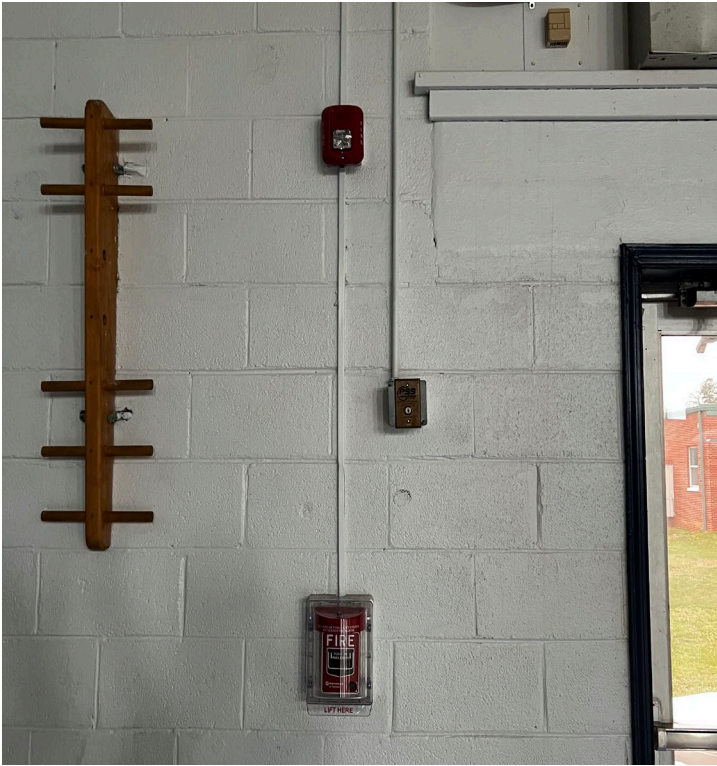
**PHOTO FS.4
FIRE ALARM SYSTEM**

*Condition: Good
Quantity: Approx. 43,763 SF*
