## SCHOOL BOARD OFFICE

### Facility Condition Assessment

Caroline County Public Schools

April 4, 2024

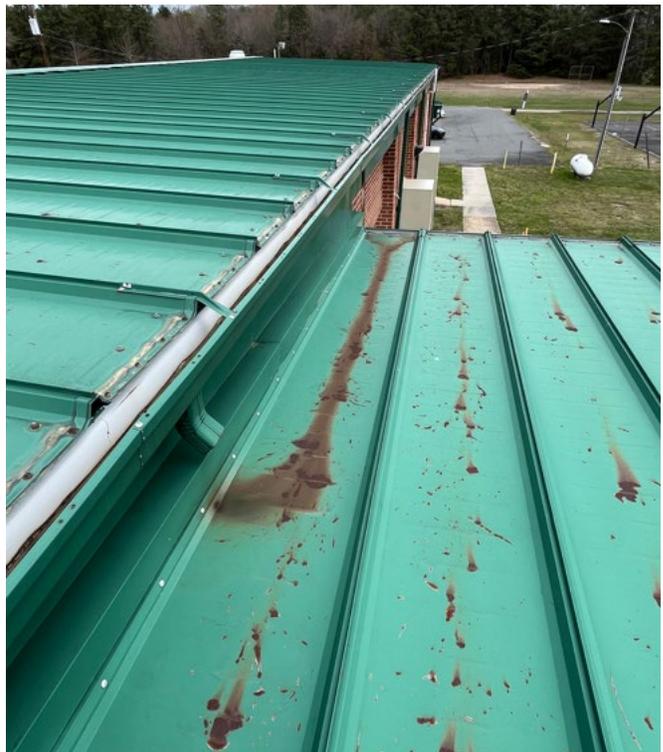
**PHOTO AR.01AB  
STANDING SEAM METAL PANEL ROOF**

*Condition: Poor*  
*Quantity: 36,955 SF*

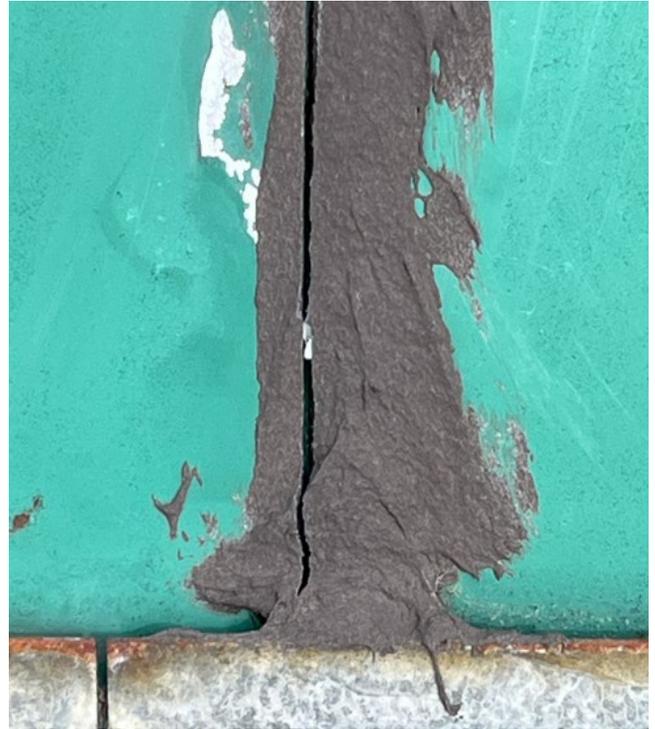
**PHOTO AR.02A**  
**RIDGE CAP SEALANT FAILURE**

*Condition: Poor*  
*Quantity: Approx. 110 LF*

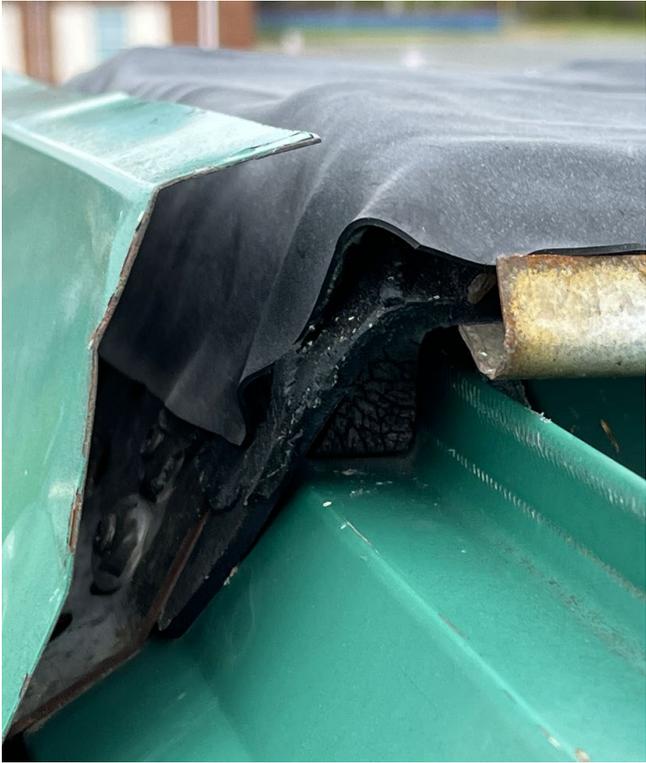
**PHOTO AR.03**  
**RIDGE END FLASHING**

*Condition: Poor*  
*Quantity: (6) Locations*

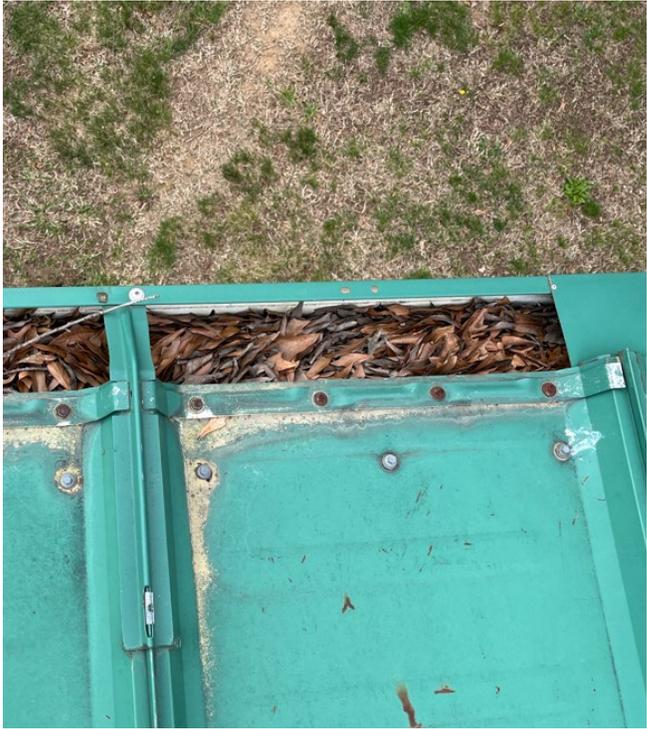
**PHOTO AR.04**  
**DEBRIS BUILD UP (GUTTER)**

*Condition: Poor / Fair*  
*Quantity: Approx. 1,320 LF*

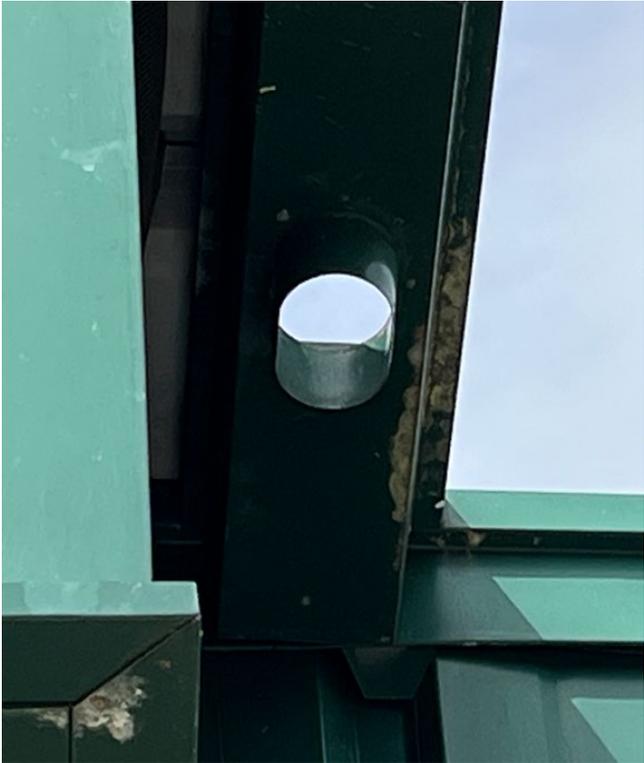
**PHOTO AR.05A  
RUSTED OR MISSING DOWNSPOUTS**

*Condition: Poor  
Quantity: Approx. (25) Location*

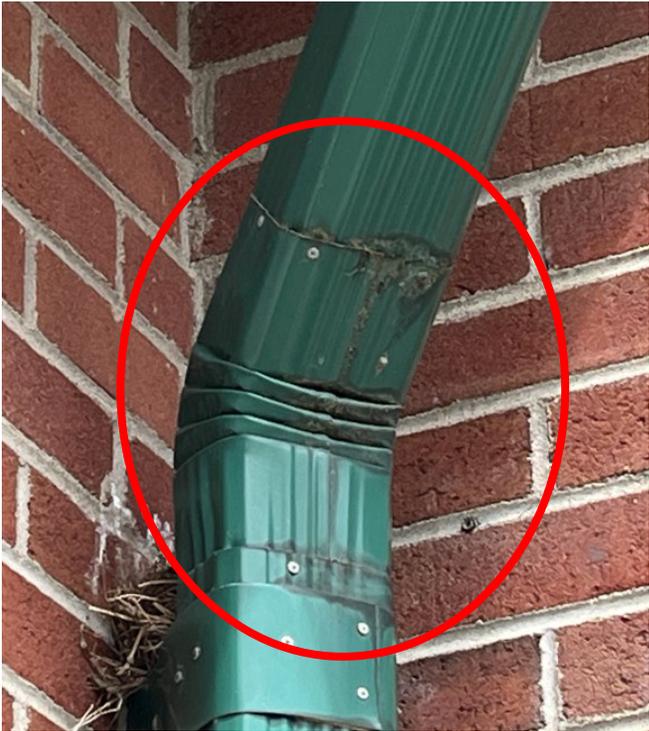
**PHOTO AR.05B  
RUSTED OR MISSING DOWNSPOUTS**

*Condition: Poor  
Quantity: Approx. (25) Location*

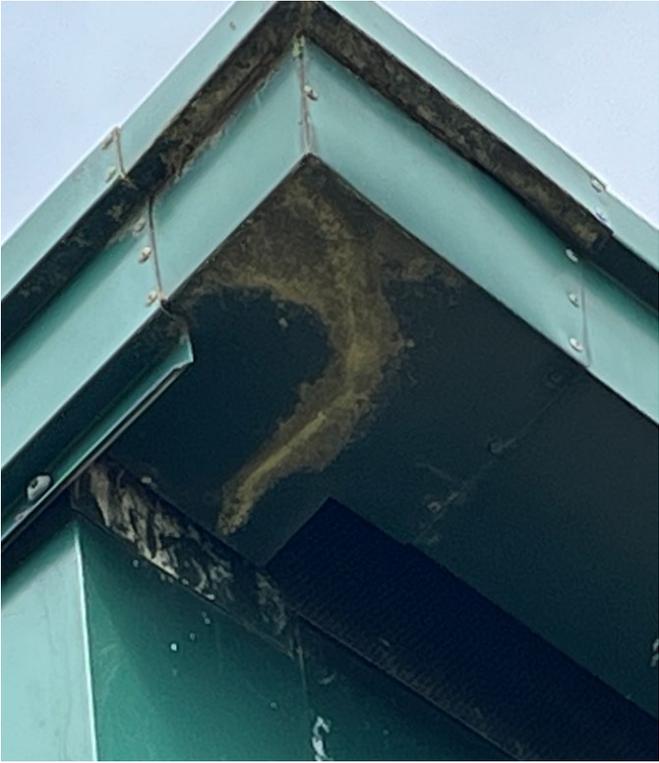
**PHOTO AR.06A**  
**RUSTED OR LEAKING GUTTERS**

*Condition: Poor*  
*Quantity: Approx. 950 LF*

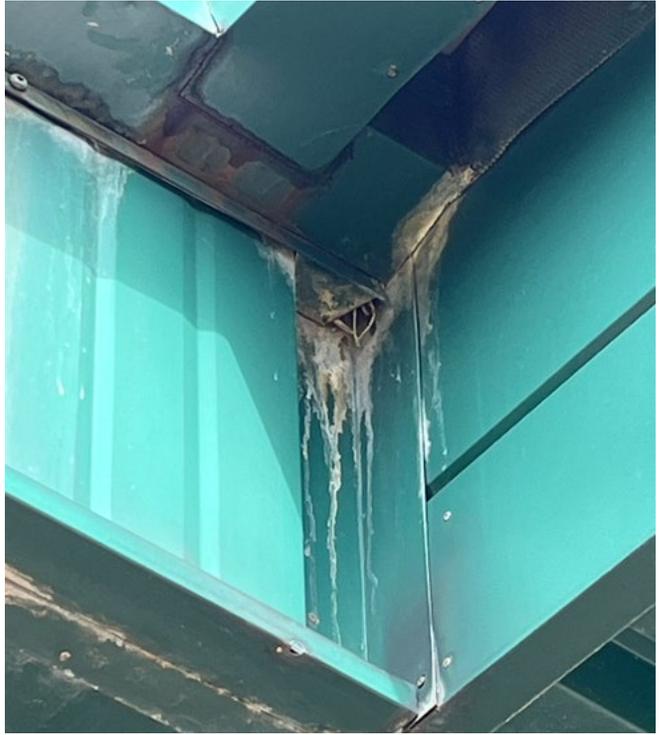
**PHOTO AR.06B**  
**RUSTED OR LEAKING GUTTERS**

*Condition: Poor*  
*Quantity: Approx. 950 LF*

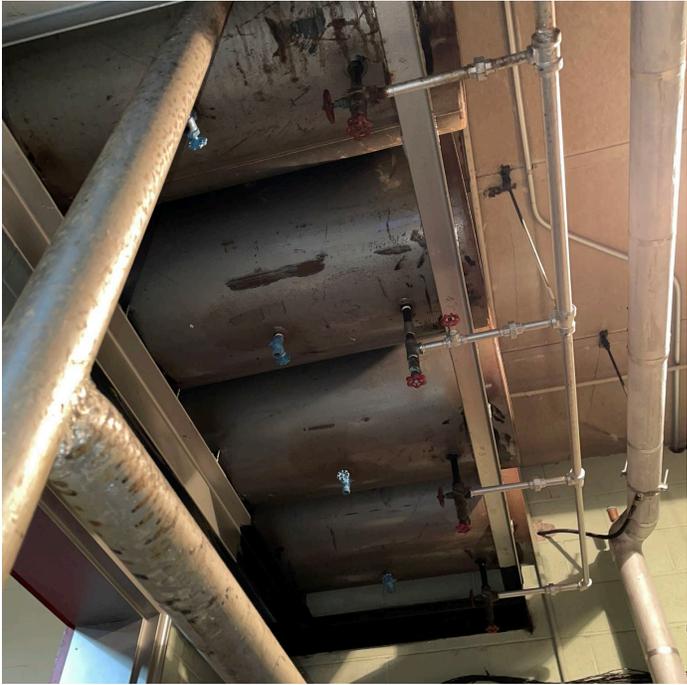
**PHOTO M.01**  
**HOT WATER EXPANSION TANKS**

*Condition: Abandoned*  
*Quantity: (4) Tanks*

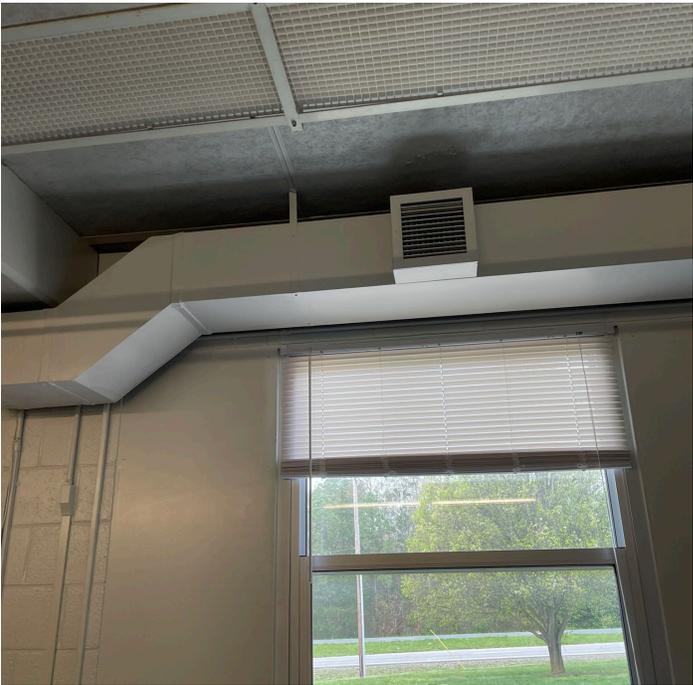
**PHOTO M.02**  
**DUCTWORK IN CLASSROOM**

*Condition: Good*  
*Quantity: Approx. 26 LF*

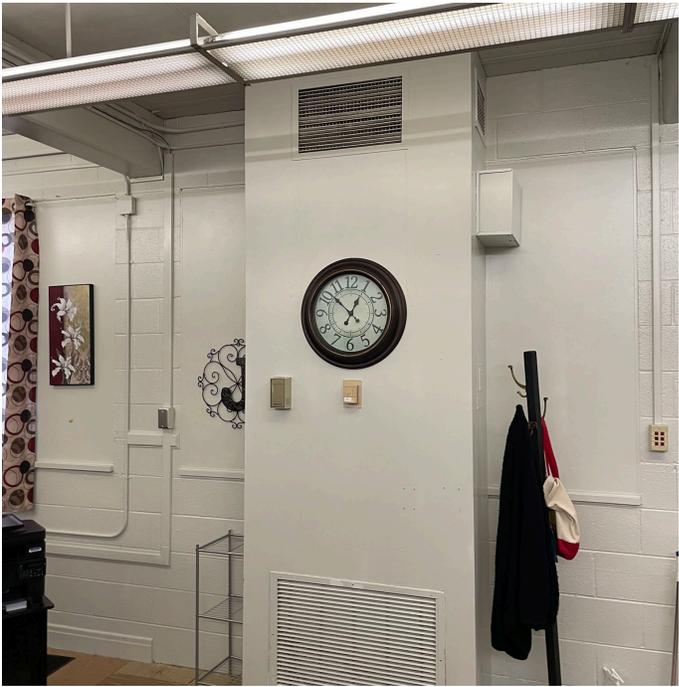
**PHOTO M.03A  
OFFICE AIR TERMINAL**

*Condition: Fair*  
*Quantity: Approx. 36,235 SF*

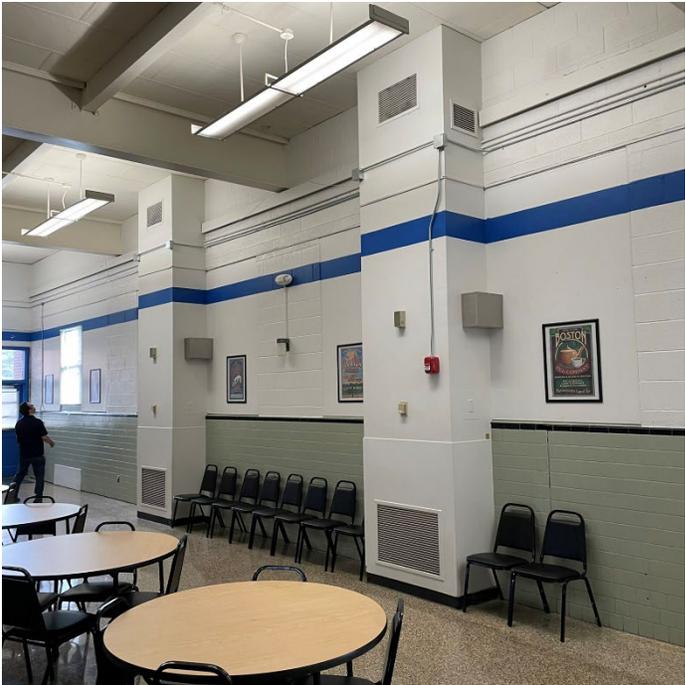
**PHOTO M.03B  
CAFETERIA AIR TERMINAL**

*Condition: Fair*  
*Quantity: Approx. 36,235 SF*

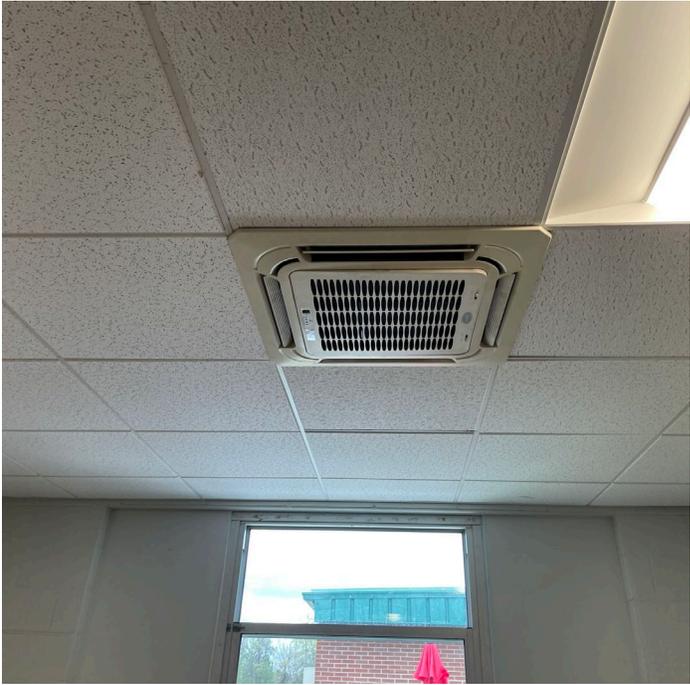
**PHOTO M.04  
SPLIT SYSTEM CASSETTE**

*Condition: Fair  
Quantity: (2)*

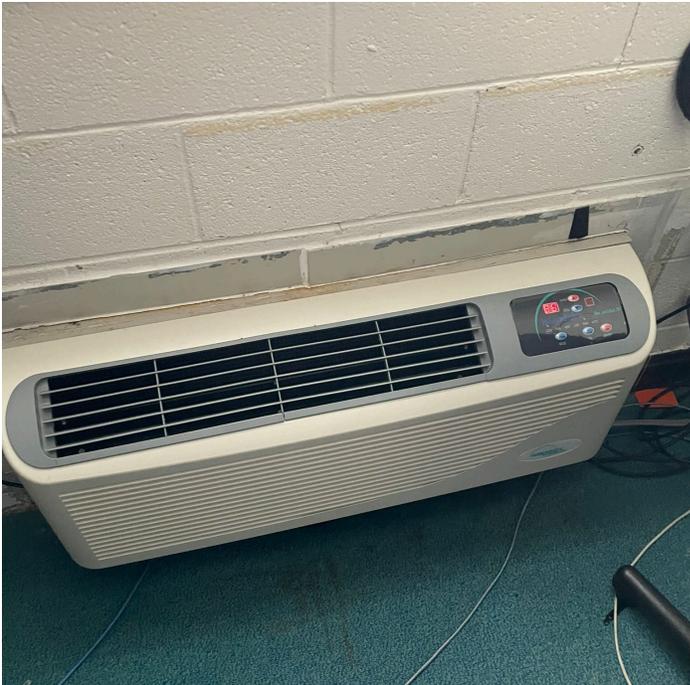
**PHOTO M.05  
ADMIN AREA PTAC**

*Condition: Fair  
Quantity: (4)*

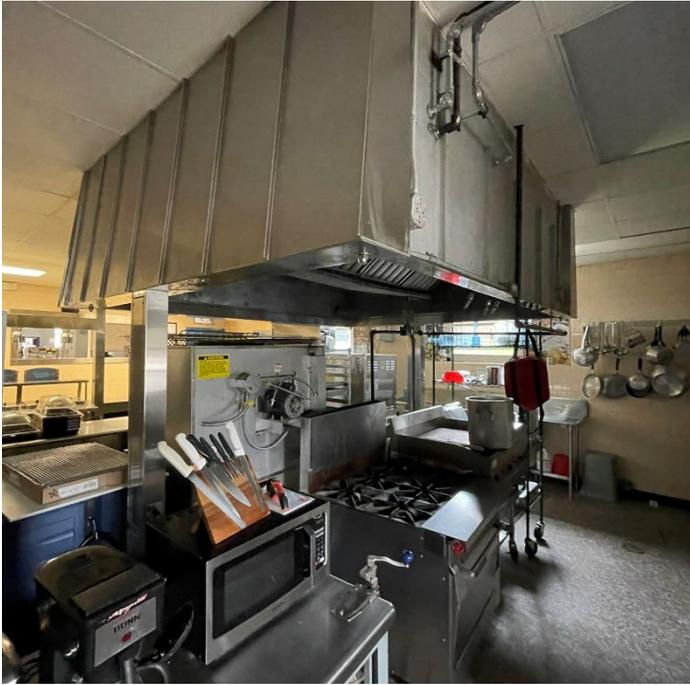
**PHOTO M.06  
KITCHEN HOOD**

*Condition: Fair  
Quantity: See Kitchen Section*

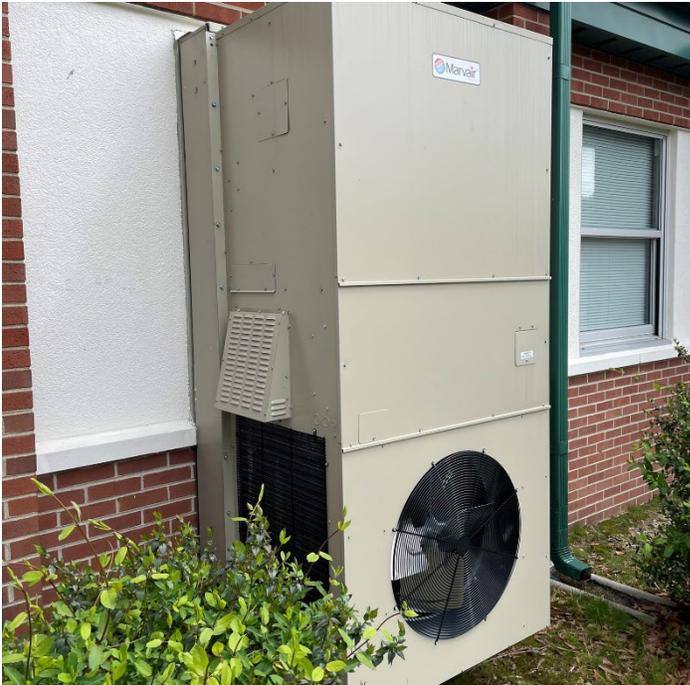
**PHOTO M.07  
CLASSROOM BARD UNIT**

*Condition: Fair  
Quantity: (28)*

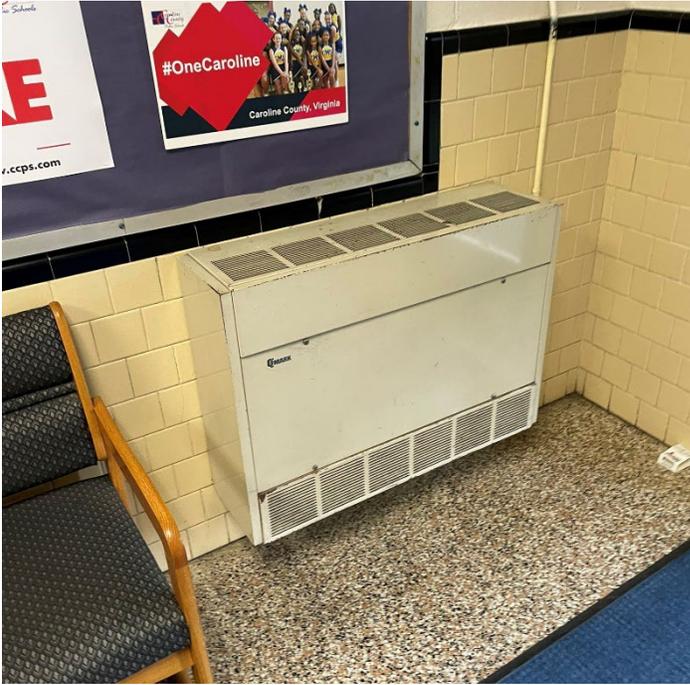
**PHOTO M.08  
CABINET UNIT HEATER**

*Condition: Poor  
Quantity: (6)*

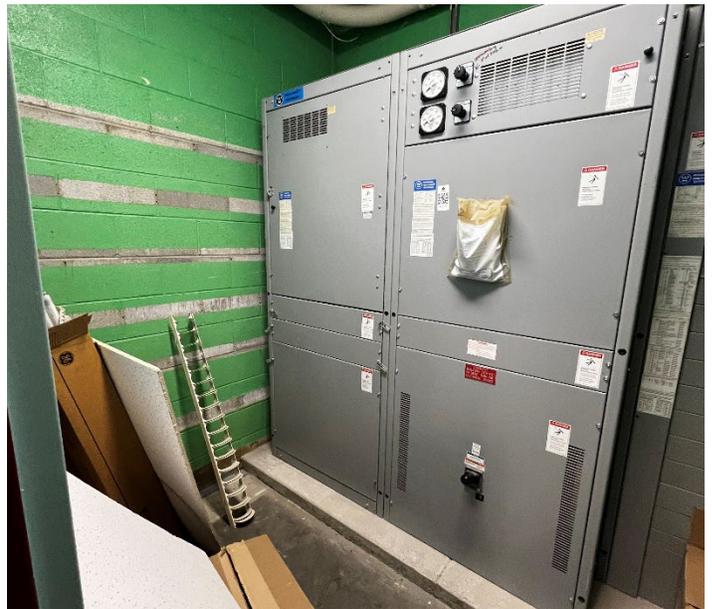
*Condition: Fair*

*Quantity: (1) Electrical Room*

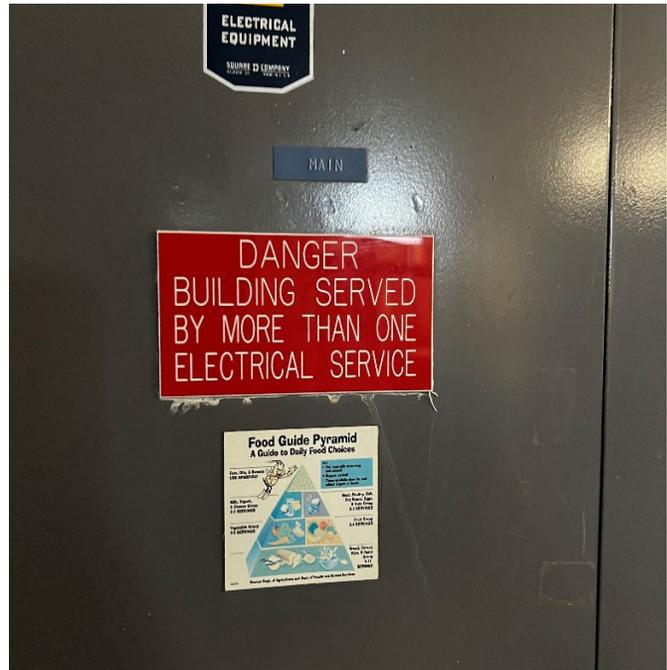
**PHOTO E.02  
ELECTRICAL SERVICE  
ENTRANCE PANEL**

**Power distribution** relies on a 480V 1200A switchboard, which was installed in 1993, and a 208V MDP that is part of the original building infrastructure. Unfortunately, the original equipment in the building is in very poor condition and should be replaced. While the switchboard and electrical equipment added in 1993 are in fair condition, they have been discontinued and finding replacement parts may be challenging. Therefore, it is recommended that all electrical equipment in the building be replaced.

*Condition: Poor  
Quantity: (1) Electrical Room*

1. The existing service entrance equipment should be replaced.
2. All panelboards associated with the service and associated wiring should be replaced.
3. The existing generator should be connected properly and stand by, and life safety load should be separated.

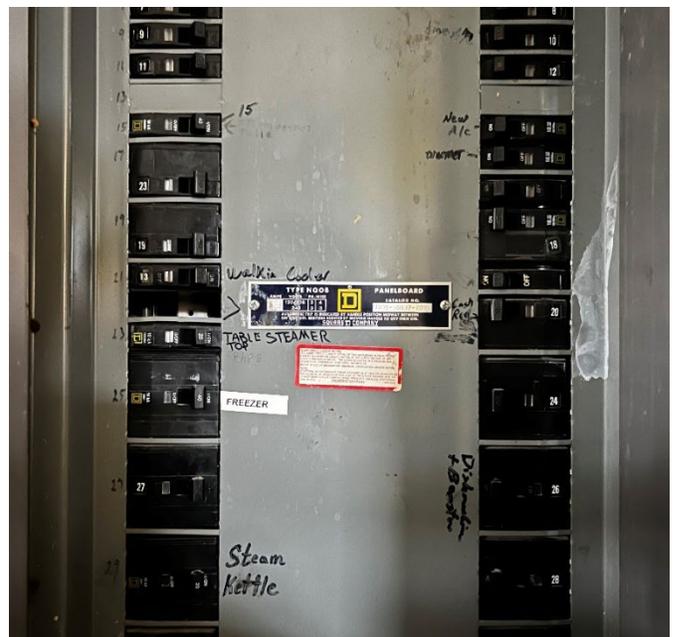
**PHOTO E.03  
EXISTING PANELS**

The remainder of the electrical gear throughout the facility has either remained original to the facility, been replaced, or been added for additions/renovations. Spot renovations in this building will end up more costly than a completely replacement. It is cost and time efficient that the entire electrical gear that is original to the building as well as the equipment added during renovations be replaced as well as all associated wiring in an overall system overall.

*Condition: Poor  
Quantity: Approx. 36,235 SF*

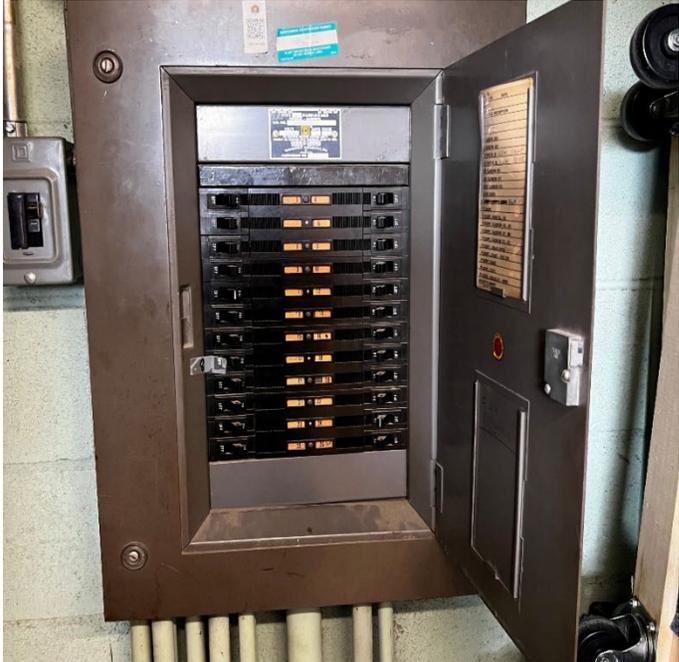
**PHOTO E.07  
EXISTING PANEL**

*Condition: Very Poor  
Quantity: Multiple throughout*

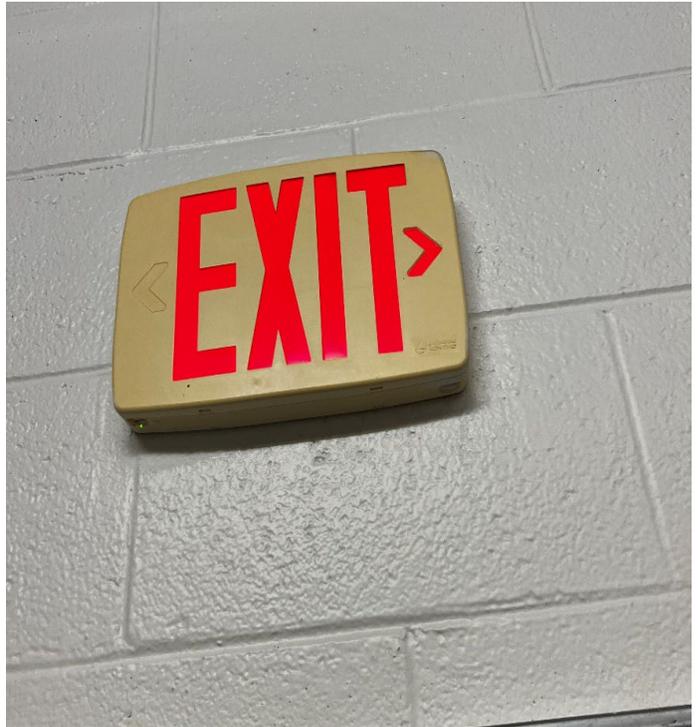
**PHOTO E.08**  
**EXIT SIGN**

*Condition: Poor*  
*Quantity: Multiple throughout*

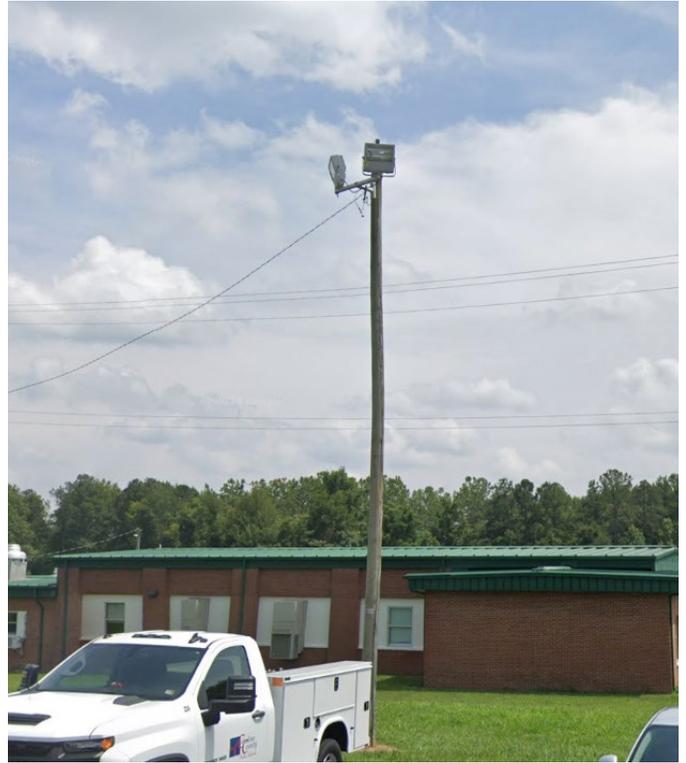
**Parking lot lighting** consists of pole mounted luminaires provided by the power company and they are distributed around the school. These fixtures are not full cutoff fixtures and do not provide adequate lighting levels. Due to the age of these fixtures, associated high energy consumption, and lack of coverage, it is recommended that they be replaced with LED, full cutoff type fixtures and supplemental light fixtures be added.

*Condition: Poor*

*Quantity: throughout parking lot*

6. All parking lot light fixtures, building and pole mounted, should be replaced with LED light fixtures that conform to the IECC and local zoning ordinances.

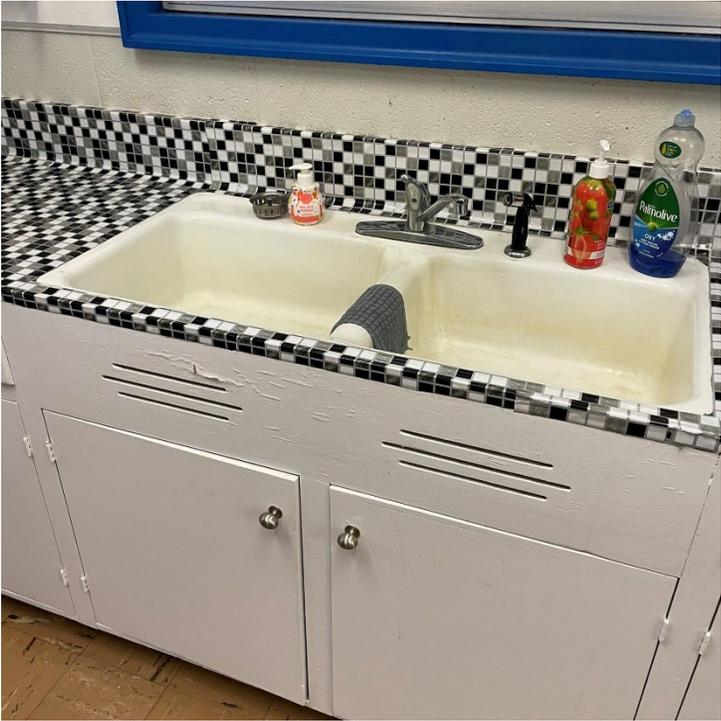
**PHOTO P.01**  
**OFFICE 2-COMPARTMENT SINK**

*Condition: Fair*  
*Quantity: See Architectural - Interior*

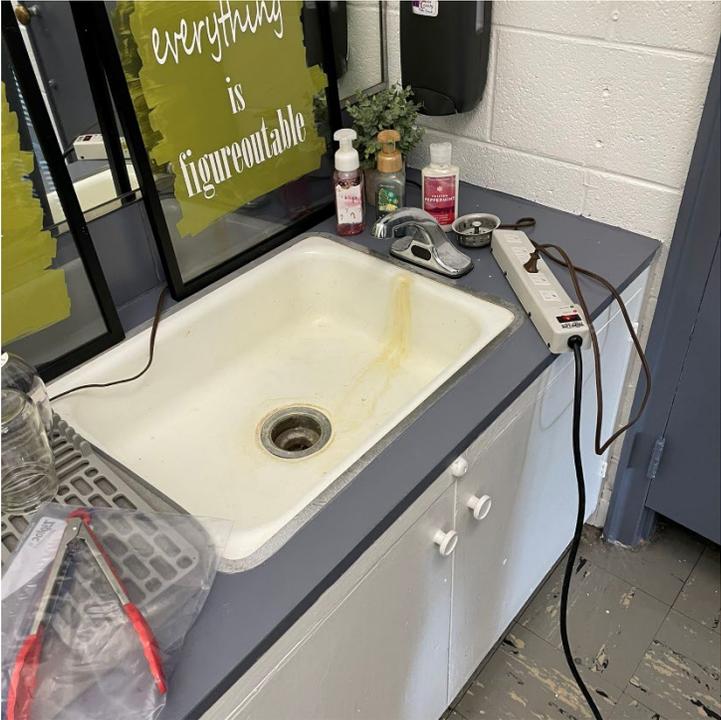
**PHOTO P.02**  
**OFFICE SINK**

*Condition: Fair*  
*Quantity: See Architectural - Interior*

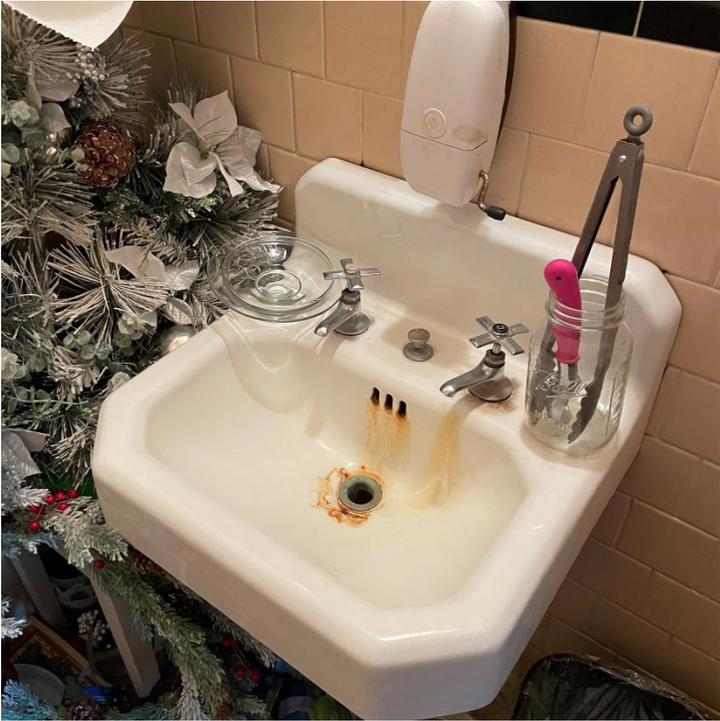
**PHOTO P.05**  
**SINGLE RESTROOM LAVATORY**

*Condition: Poor / Fair*  
*Quantity: See ADA Compliance*

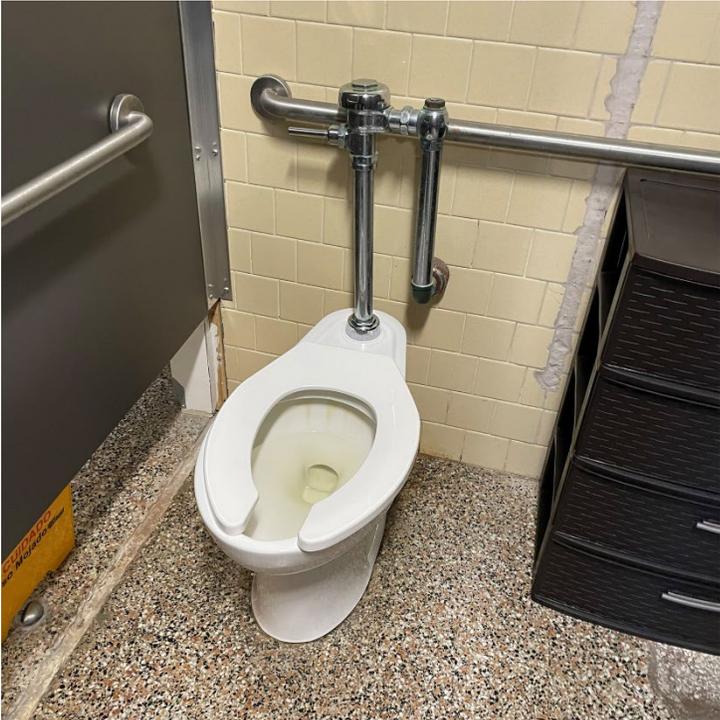
**PHOTO P.06**  
**WATER CLOSET**

**Plumbing Fixtures.** Water closets are floor mounted white vitreous china with manual flush valves. The water closets appeared in poor condition. The lavatories in gang restrooms are countertop style white vitreous china with automatic valves. The lavatories in gang restrooms appeared in fair condition. The lavatories in single restrooms are wall mounted white vitreous china with manual valves. These lavatories were in poor condition. The sinks in the offices are countertop style white vitreous china with a mixture of faucet styles. A portion of the sinks are 2-compartment sinks. The rest are single compartment sinks. The office sinks appeared in fair condition. The exterior exposed hose bibbs were showing signs of corrosion. The gas piping distributed throughout the kitchen is in fair condition. The kitchen 2 and 3-compartment sinks are stainless steel sinks with manual faucets. They appeared in good condition.

*Condition: Poor / Fair*  
*Quantity: See ADA Compliance*

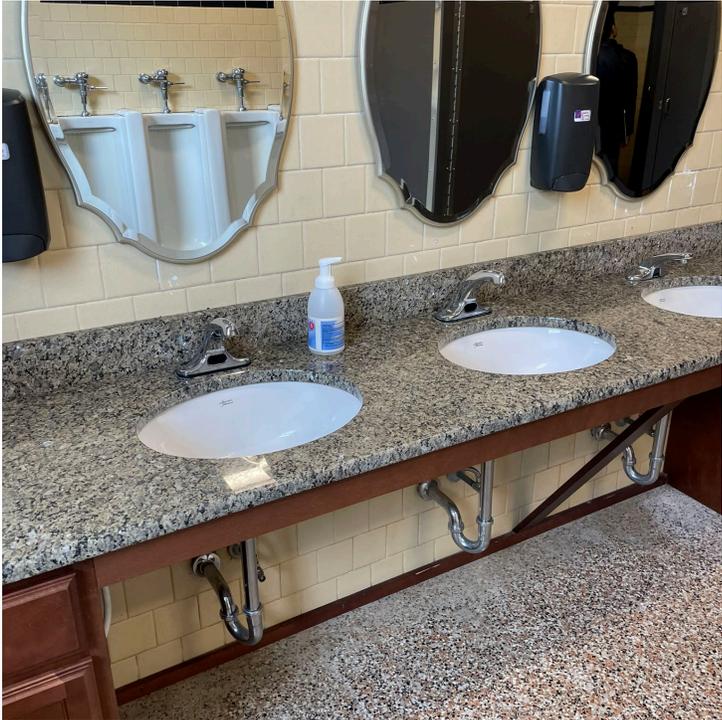
**PHOTO P.08**  
**GANG RESTROOM LAVATORY**

*Condition: Fair*  
*Quantity: See ADA Compliance*

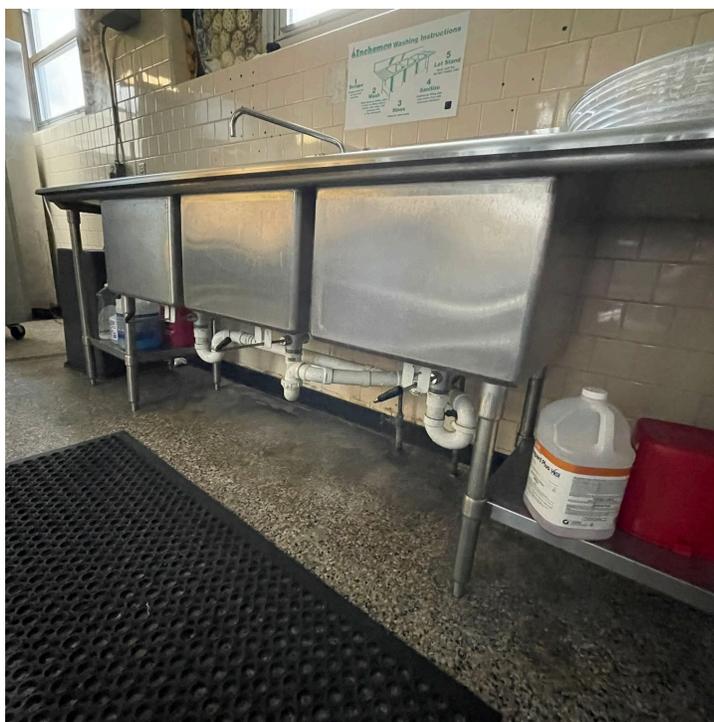
**PHOTO P.09  
KITCHEN SINK AND SANITARY DRAIN  
PIPING**

*Condition: Good, drain piping needs to be connected to floor sink via an indirect connection.*

*Quantity: (3)*

1. The plumbing systems are at or near the end of their life and should be considered for replacement within the next five (5) years.
2. The sanitary piping below the kitchen and slab was inaccessible and should be scoped with a camera to determine the condition. The piping is original to the building and is at or near the end of its expected life expectancy. The grease interceptor should be cleaned and inspected to determine the condition.

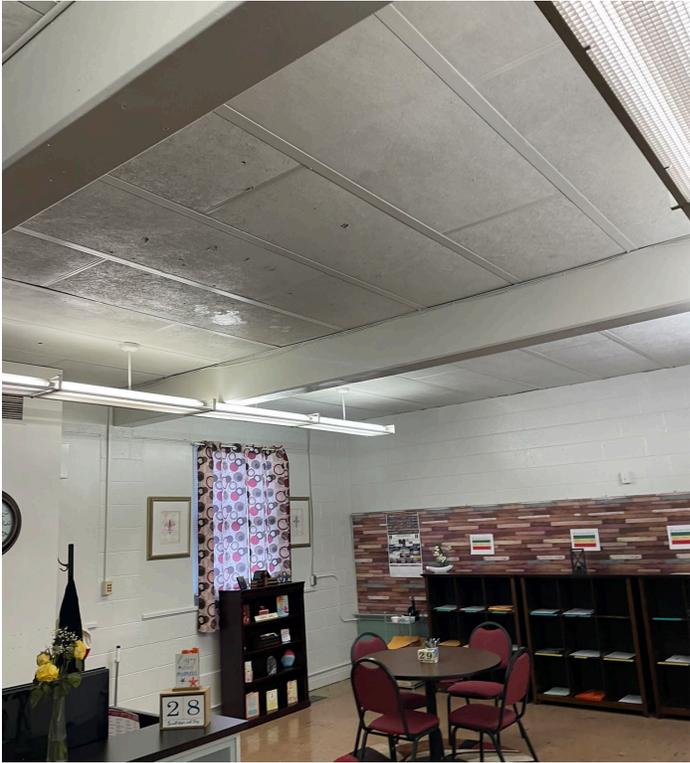
**PHOTO FS.2**  
**GENERAL OFFICE - SPRINKLER SYSTEM**

*Condition: Not Applicable*  
*Quantity: None*

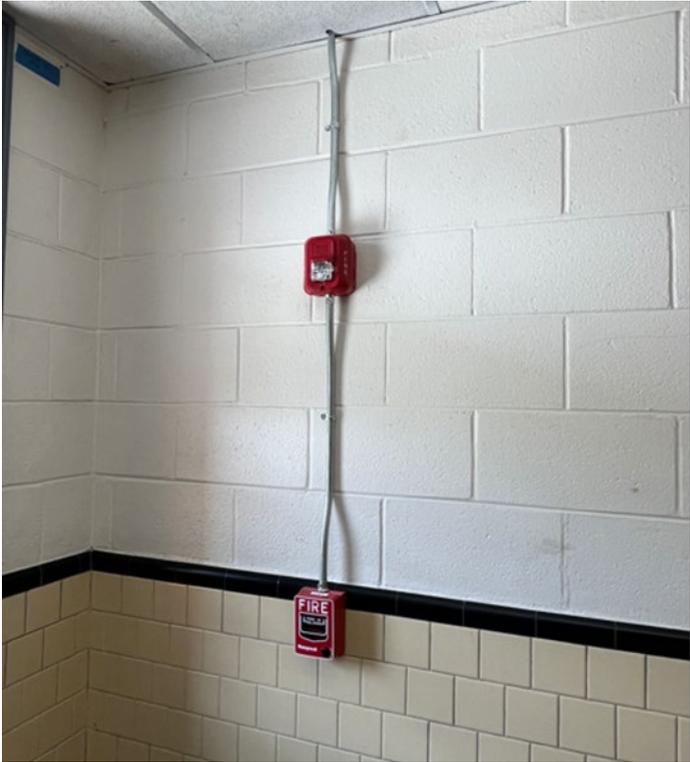
**PHOTO FS.3**  
**FIRE ALARM DEVICES**

*Condition: Good*  
*Quantity: Approx. 36,235 SF*

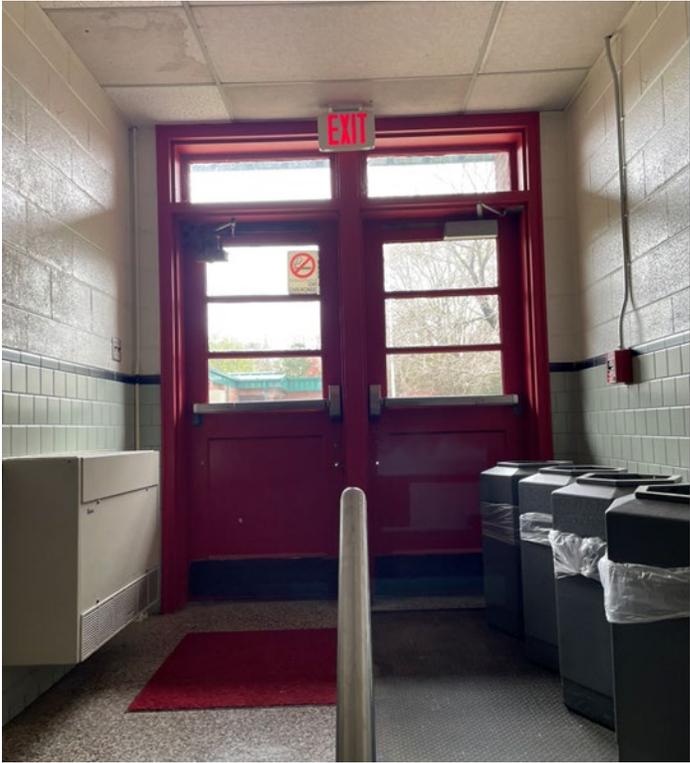
**PHOTO FS.4  
ILLUMINATED EXIT SIGNS**

*Condition: Good  
Quantity: Approx. 36,235 SF*

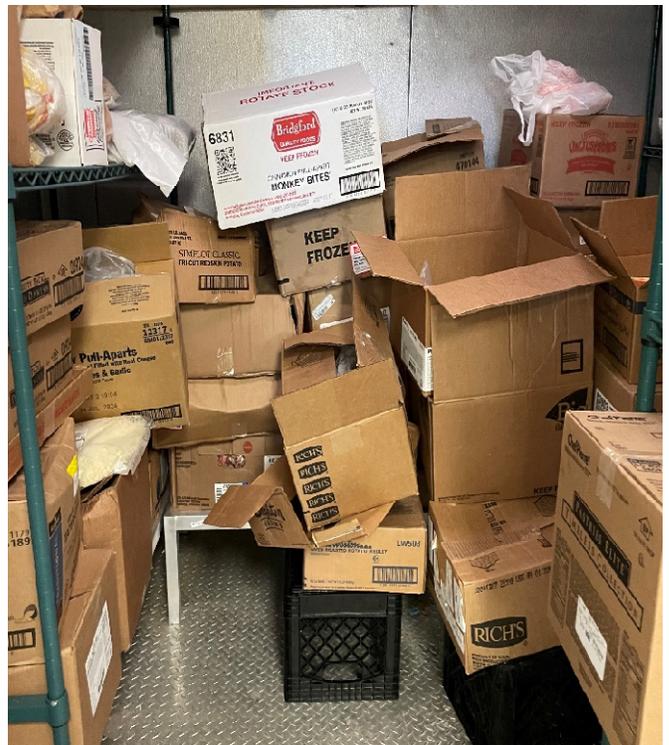
**PHOTO K.1**  
**THE FREEZER IS VERY DISORGANIZED AND**  
**THERE APPEARS TO BE A CARTON THAT WAS**  
**RECEIVED ON 2/19/20.**

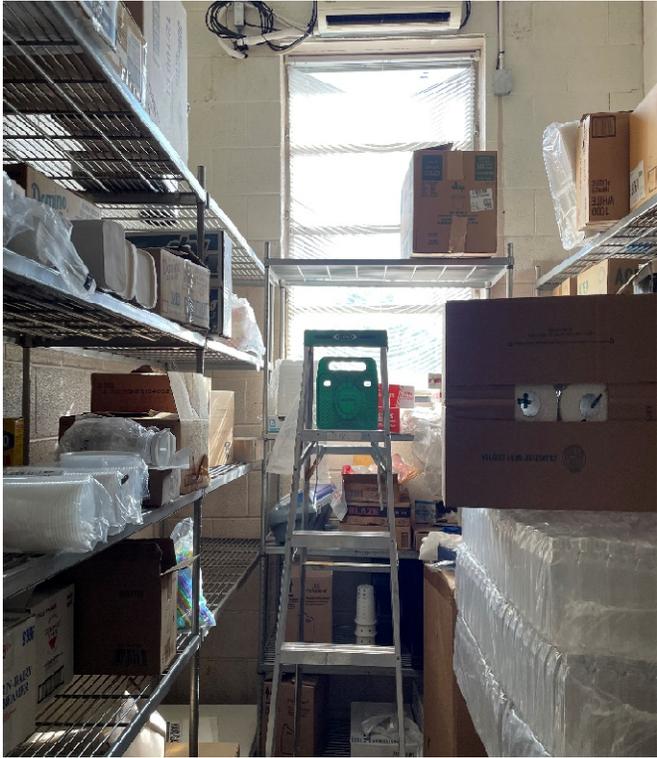
**PHOTO K.2**  
**THE WINDOW IN THE STORAGE ROOM**  
**LETS IN HEAT AND LIGHT WHICH MAY**  
**PREVENT THE TEMPERATURE TO BE KEPT**  
**BELOW THE REQUIRED 72 DEGREES.**

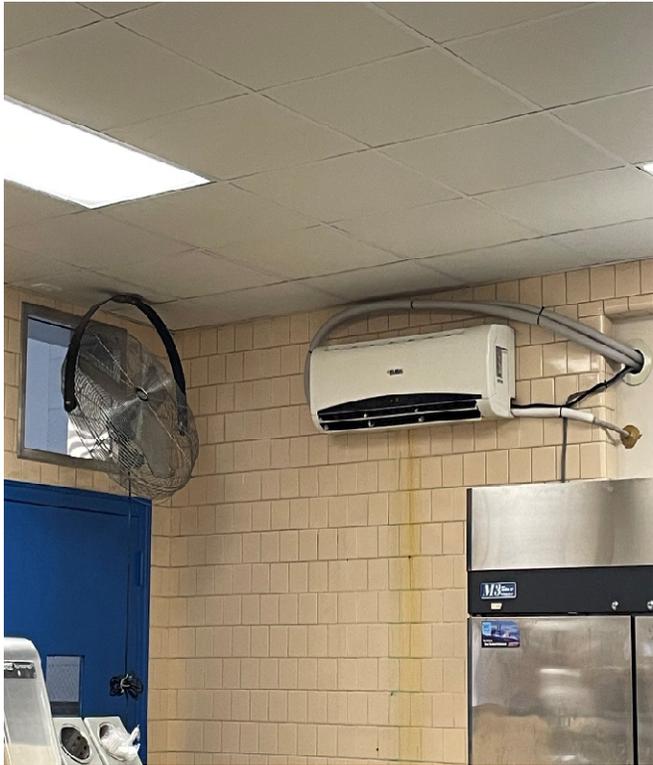
**PHOTO K.3**  
**SURFACE MOUNTED HEATERS AND FANS**  
**ARE DIFFICULT TO KEEP CLEAN.**
